DRILLING & FISHING TOOLS AND BHA INSPECTION REPORT

CUSTOMER:	KERUI OILFIELD SERVICE DMCC	RIG NO.:	--	DEPARTMENT:	Fishing	PAGE NO.:	Page 2 of 2	REPORT NO.:	ATS-KRU-24-11-4224-001
LOCATION:	ATS / AlJuhud Workshop	REF NO.:	--	PO/FIRE NO.:	KRPO2024-46	JOB NO.:	ATS-KRU-24-11-4224	DATE:	13/11/2024

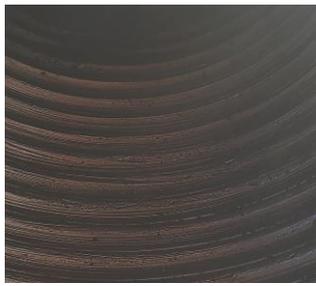
TOP SUB
DAMAGED SEAL

COMMENTS:	THE ABOVE-MENTIONED ITEM WAS INSPECTED (FULL BODY) AND FOUND "REJECTED" AT THE TIME OF INSPECTION. * TOP SUB: DAMAGED SEAL * WASHPIPE: MISSING CHROME + ID CORRODED * BOTTOM SUB: ID CORRODED		NAME OF INSPECTOR:	TAYYAB ABBASI	SIGNATURE: 	Reviewed by:	Hasan Omran	STAMP & SIGNATURE:
	QUALIFICATION:	ASNT NDT LEVEL-II	QUALIFICATION:	ASNT NDT LEVEL-II		Inspection Supervisor
