Customer:	Hilong Oil Services & Engineering	Date Of Service:	23-Dec-2023
Type Of Inspection:	CAT III INSPECTION	Report No:	ATS-12-23-2486-MB-001
Rig & Rig Number:	RIG-99	Specification:	API spec 7K

The Rig Was Equipped with Zhengzhou Baolai Machinery Manufacturing CO. Master Bushing, with The Following Specification:

Visual & Magnetic Particles Examination Report

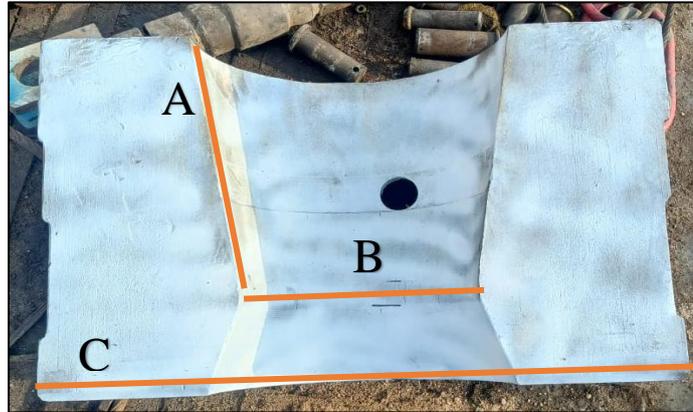
Dimensional Verification

Description:	OEM	Actual Value (mm)	Result
Length of taper (A):	324 new (15mm tolerance)	318	accept
Inside diameter of throat(B):	257.18 new (5mm tolerance)	260	accept
Outside diameter(C):	New 696.913 (5mm tolerance)	696	accept
