| Type Of Inspection: | CAT III INSPECTION | Report No: | ATS-12-23-2486-EL-001 |
| Rig & Rig Number: | RIG-99 | Specification: | API RP 8B |

| Equipment: | Square Shoulder – Tubing side door Elevator |

## Visual & Magnetic Particles Examination Report

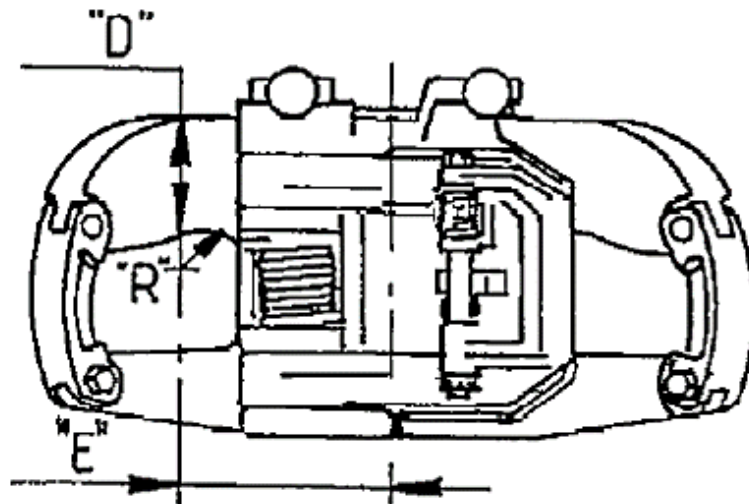
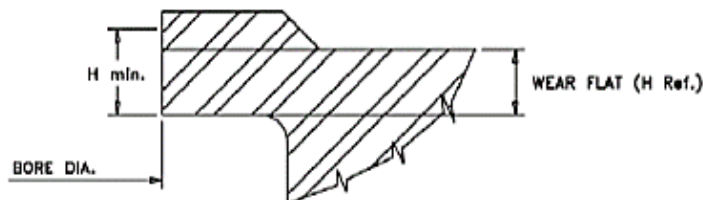
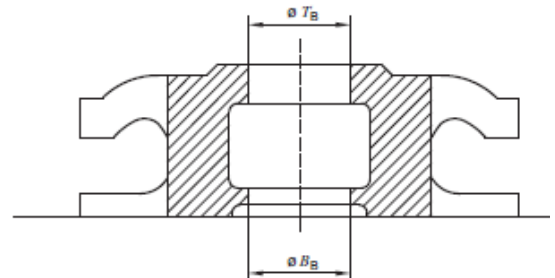
| OREINTATION | DESCRIPTION | VALUES | OEM VALUES | RESULT |
| RIGHT | The maximum allowable wear tolerance of (D) | 90 mm | 84 mm | Accepted |
| | The distance "E" from the center line to the center of Arc | 155 mm | 155 mm | Accepted |
| | The designed value for radius "R" at the force point | 45 mm | 45 mm | Accepted |
| LEFT | The maximum allowable wear tolerance of (D) | 89 mm | 84 mm | Accepted |
| TOP | Maximum Allowable (Worn) Load Shoulder Bore TB | 103.5 mm | 105.13 mm<br>Max | Accepted |
| BOTTOM | Maximum Allowable (Worn) Load Shoulder Bore BB | 102.5 mm | 105.13 mm<br>Max | Accepted |
| - | The minimum allowable thickness of the elevator load bearing point contact surface (H) | 90 mm | 70 mm | Accepted |

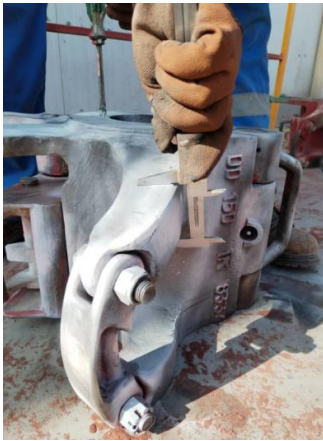
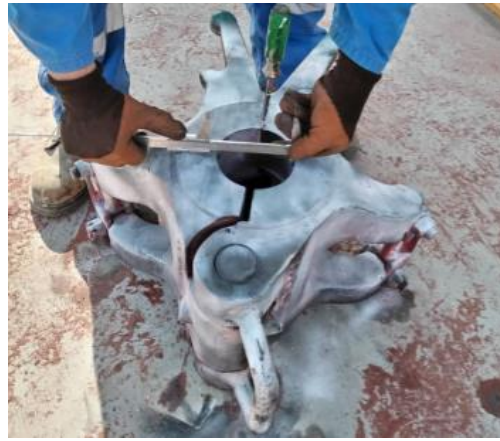
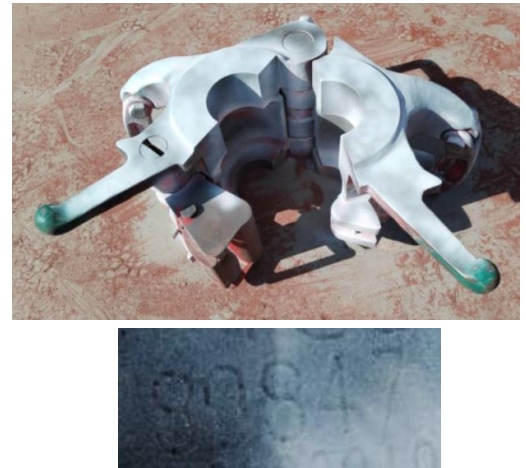
| Serial Number | Description of the examined equipment | Result |
|---|---|---|
| S/N: | 80847 | |

Visual and MPI carried out for the above description and found free of surface defects at the time of inspection

Identification of any part found to have a defect and a description of the defect: **None**

Particulars of any repair, renewal or alteration required to remedy the defect identified above: **None**
