**ABERDEEN TECHNICAL SERVICES AND GENERAL TRANSPORTATION**  
**SQUARE SHOULDER ELEVATOR - CAT III INSPECTION REPORT**

<b>Customer:</b>	<b>Hilong Oil Services &amp; Engineering</b>	<b>Date Of Service:</b>	<b>15-01-2024</b>
<b>Type Of Inspection:</b>	<b>CAT III INSPECTION</b>	<b>Report No:</b>	<b>ATS-12-23-2486-EL-003</b>
<b>Rig &amp; Rig Number:</b>	<b>RIG-99</b>	<b>Specification:</b>	<b>API RP 8B</b>

Equipment:	Square Shoulder – Tubing side door Elevator
Model/SN:	DD27/8-150
SN:	80901
Size:	2 7/8”
SWL:	150 T
Date of Manufacture:	09-2018
Manufacturer:	Jiangsu Rutong Petro-Machinery Co. Ltd.
Reference Standard:	API RP 8B
Next Examination Date:	After 06 Months

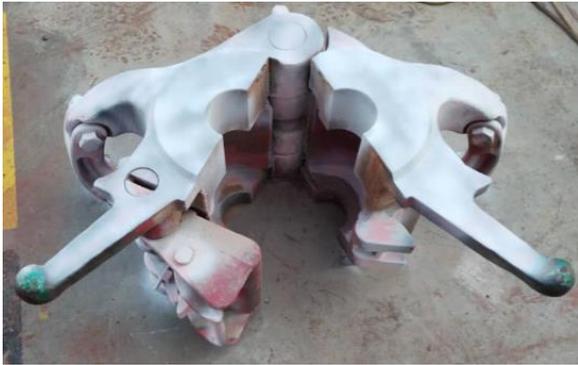
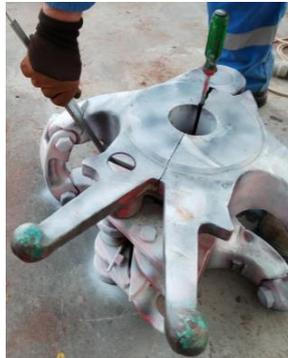
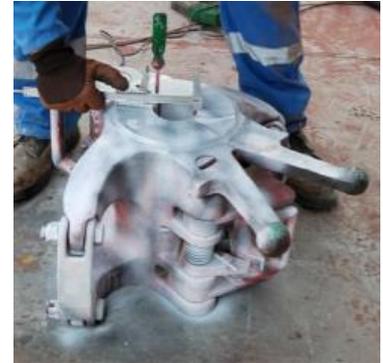
Serial Number	Description of the examined equipment	Result
80901	Square Shoulder – 2 7/8” Tubing side door Elevator	Pass
S/N:	80901

Visual and MPI carried out for the above description and found free of surface defects at the time of inspection

Identification of any part found to have a defect and a description of the defect: **None**

Particulars of any repair, renewal or alteration required to remedy the defect identified above: **None**
