Customer:	Hilong Oil Services & Engineering	Date Of Service:	15-01-2024
Type Of Inspection:	CAT III INSPECTION	Report No:	ATS-12-23-2486-EL-004
Rig & Rig Number:	RIG-99	Specification:	API RP 8B

Equipment:	Square Shoulder – Tubing side door Elevator
Model/SN:	DD31/2-150
SN:	80904
Size:	3 1/2"
SWL:	150 T
Date of Manufacture:	09-2018
Manufacturer:	Jiangsu Rutong Petro-Machinery Co. Ltd.
Reference Standard:	API RP 8B
Next Examination Date:	After 06 Months

ABERDEEN TECHNICAL SERVICES AND GENERAL TRANSPORTATION
SQUARE SHOULDER ELEVATOR - CAT III INSPECTION REPORT

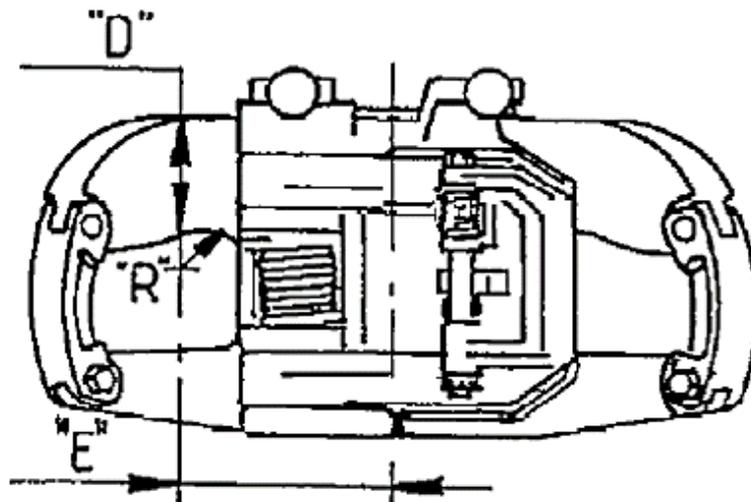
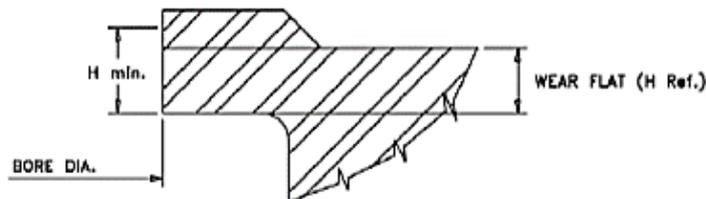
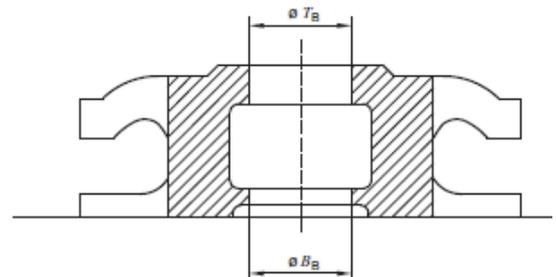
- The Elevator Has Been Inspected and Found Conformable to the Relevant Standard(s)
- Elevator Found Ready for CAT III Inspection.

Action	Result
• Visually check for the serial number and Identification	Pass
• Prepare and clean the elevator body and accessories to the extent necessary for inspection.	Pass
• Visually check for any damage, missing parts or cracks	Pass
• Dismantle the elevator to the extent necessary to perform the CAT III inspection.	Pass
• Visually check & MPI as per manufacture's recommendations	Pass
• Visually check for damage, deformation or cracks on the hinge's Ears, handles, Critical areas & hinges	Pass
• Measure the wear of bores, and ear thickness as per manufacture's recommendations.	Pass
• Visually check after Reassembly	Pass
• Repaint the Elevator	Pass
• Prepare and submit the inspection report.	Pass

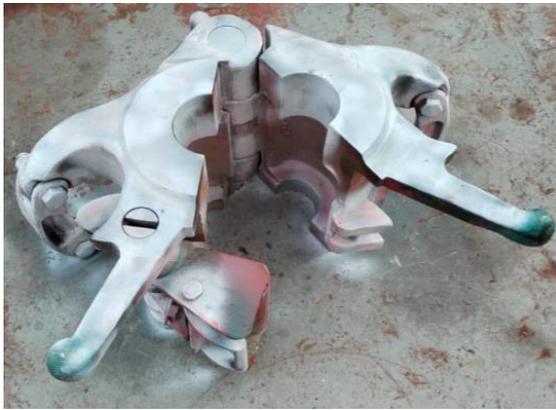
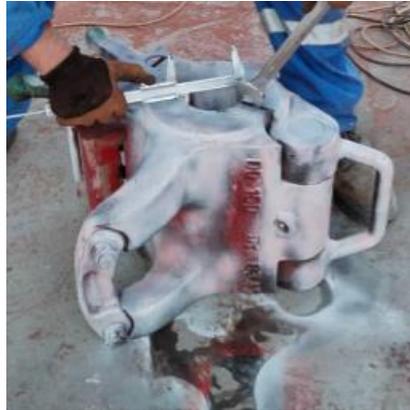
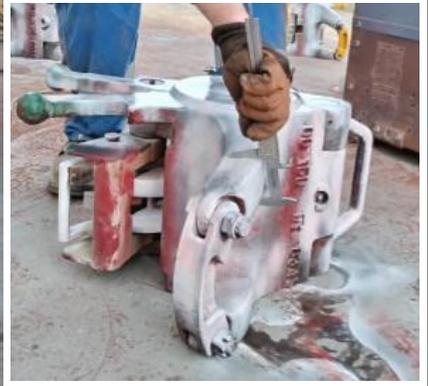
Visual and MPI carried out for the above description and found free of surface defects at the time of inspection

Identification of any part found to have a defect and a description of the defect: **None**

Particulars of any repair, renewal or alteration required to remedy the defect identified above: **None**
