Customer:	Hilong Oil Services & Engineering	Date Of Service:	25-Dec-2023
Type Of Inspection:	CAT IV INSPECTION	Report No:	ATS-12-23-2541-EL-001
Rig & Rig Number:	RIG-100	Specification:	API RP 8B

The Rig Was Equipped with SJ PETROUM MACHINERY CO. Elevator Links, with The Following Specification:

Equipment:	Elevator Links
Model/SN:	81001-L-3744 / 81001-R-3744 - JZG 41
Date of Manufacture:	Aug-2018
Manufacturer:	China
Reference Standard:	API RP 8B
Next Examination Date:	After 01 Year

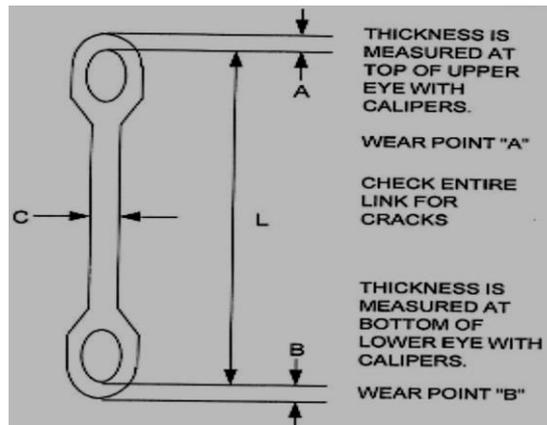
Elevator Links	Elevator Link1 / SN:			Elevator Link2 / SN:		
	Wear Point A	Wear Point B	Link Body C	Wear Point A	Wear Point B	Link Body C
Nominal	89 mm	44.5 mm	63.5 mm	89 mm	44.5 mm	63.5 mm
Measured	98 mm	55 mm	65 mm	98 mm	55 mm	65 mm
Result	Accepted	Accepted	Accepted	Accepted	Accepted	Accepted

** Visual And MPI Was Carried out on the whole links and Found **Satisfactory for Further Use.**

** CAT IV Inspection Was Carried Out on the Elevator Links and Found **Accepted** At The Time of Inspection.

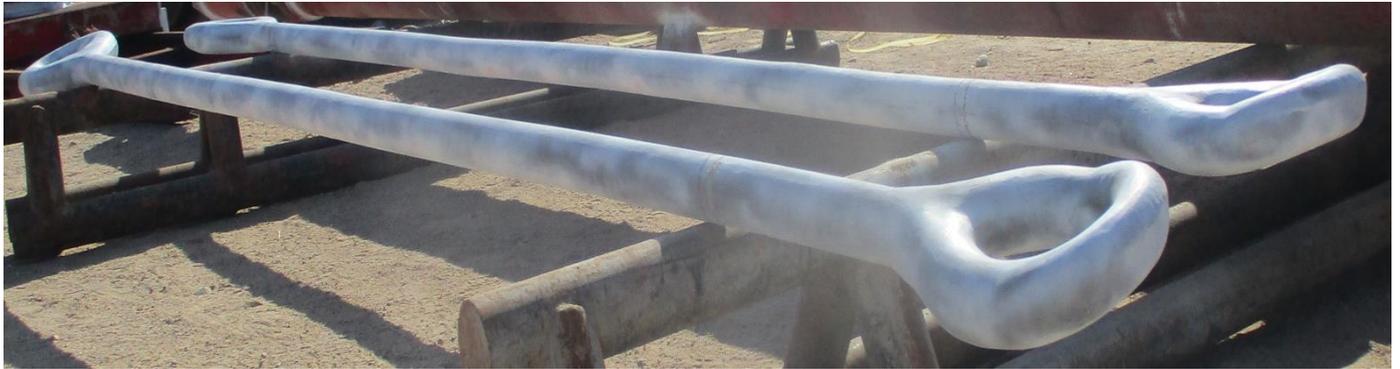
Serial Number	Description of the examined equipment	Result
Rig 100	Elevator Link	Pass
S/N:	81001-L-3744 / 81001-R-3744

Visual and MPI carried out for the above description and found free of surface defects at the time of inspection
