Customer:	Hilong Oil Services & Engineering	Date Of Service:	01-Jan-2024
Type Of Inspection:	CAT III INSPECTION	Report No:	ATS-12-23-2541-MB-001
Rig & Rig Number:	RIG-100	Specification:	API spec 7K

The Rig Was Equipped with Zhengzhou Baolai Machinery Manufacturing CO. Master Bushing, with The Following Specification:

Equipment:	Master Bushing
Model/SN:	ZP275 / BL180803
Date of Manufacture:	-
Manufacturer:	Zhengzhou Baolai Machinery Manufacturing CO
Reference Standard:	API RP 7K

Visual & Magnetic Particles Examination Report

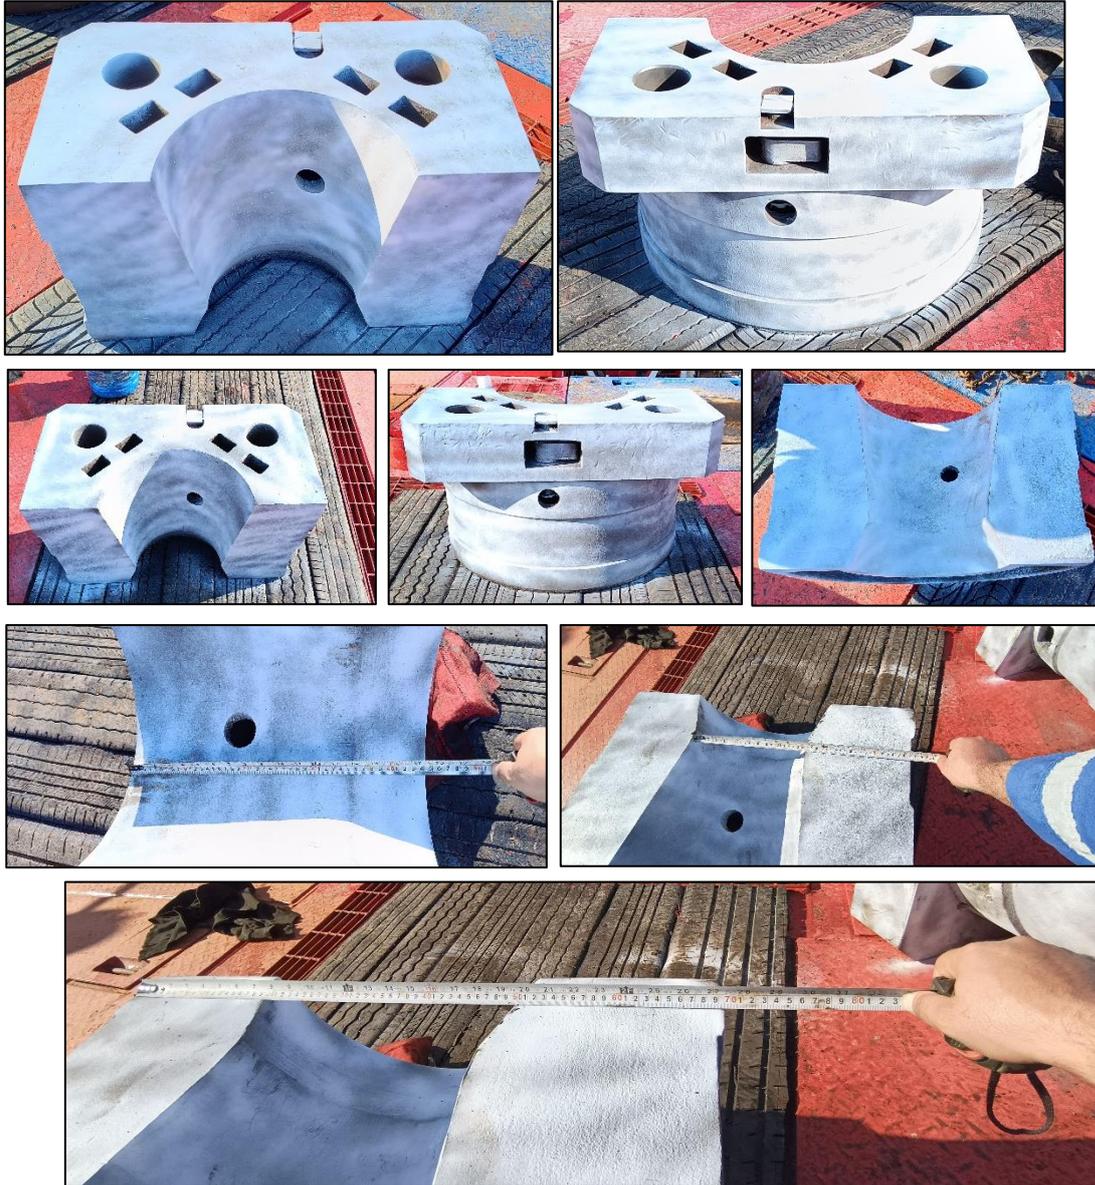
PICTORIAL:

** Visual And MPI Was Carried out on The Critical Areas Of The master bushing and Found **Satisfactory for Further Use.**

** CAT III Inspection Was Carried Out on the master bushing and Found **Accepted** At The Time of Inspection.

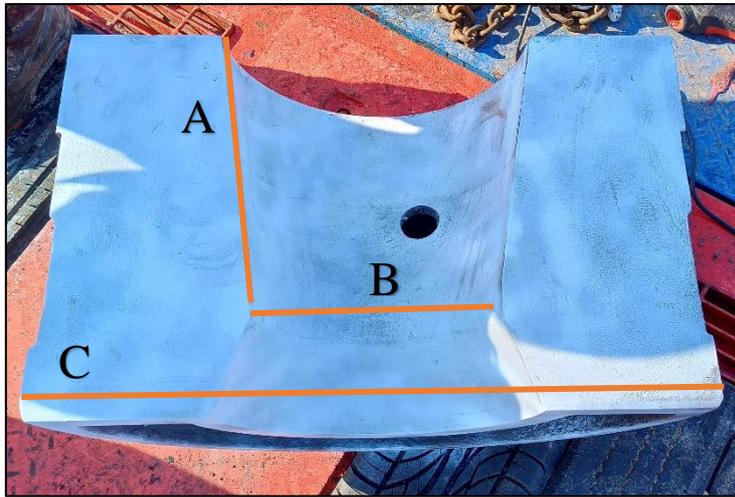
Dimensional Verification

Description:	OEM	Actual Value (mm)	Result
Length of taper (A):	324 new (15mm tolerance)	312	accept
Inside diameter of throat(B):	257.18 new (5mm tolerance)	262	accept
Outside diameter(C):	New 696.913 (5mm tolerance)	696	accept
