<b>Customer:</b>	<b>Hilong Oil Services &amp; Engineering – Rig 100</b>	<b>Date Of Service:</b>	<b>30-DEC-2023</b>
<b>Type Of Inspection:</b>	<b>CAT IV INSPECTION</b>	<b>Report No:</b>	<b>ATS-12-23-2541-PWS-001</b>
<b>Location:</b>	<b>Hamdan Industrial Area</b>	<b>Specification:</b>	<b>API RP 8B</b>

The Rig Was Equipped with NOV Power Swivel, with The Following Specification:

Equipment:	Power Swivel
Model:	S-150 HEAD
S/N:	XK-18-1067675
Marker & Date of Manufacture:	NOV-29-2018
Ref Standard:	API RP 8B
Inspection Frequency:	Every 5 Years

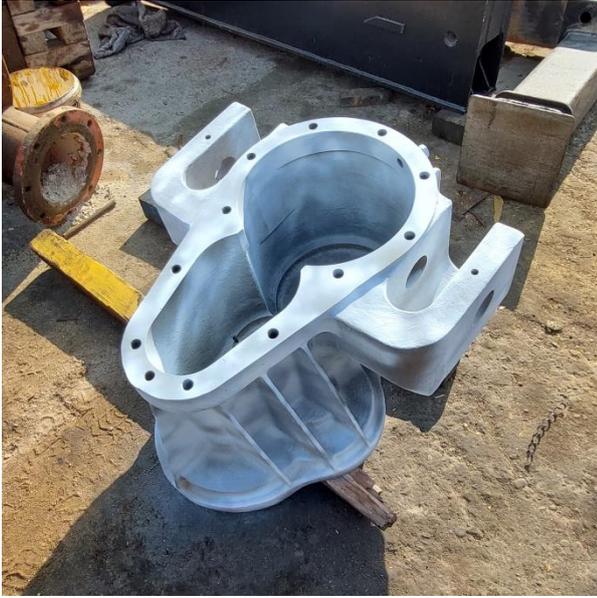
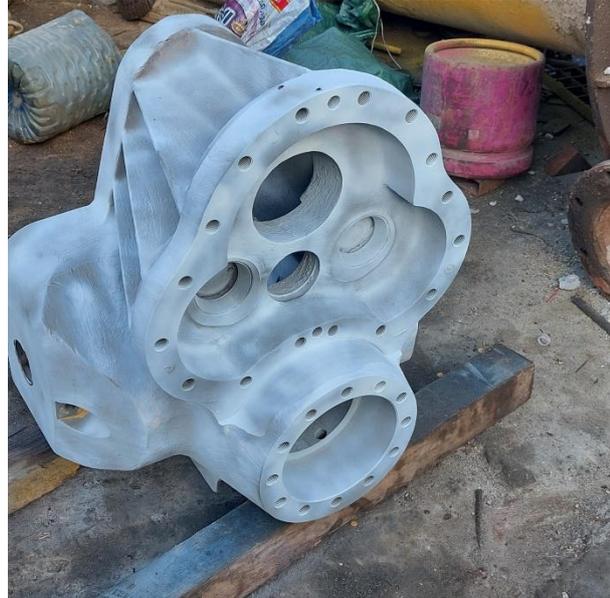
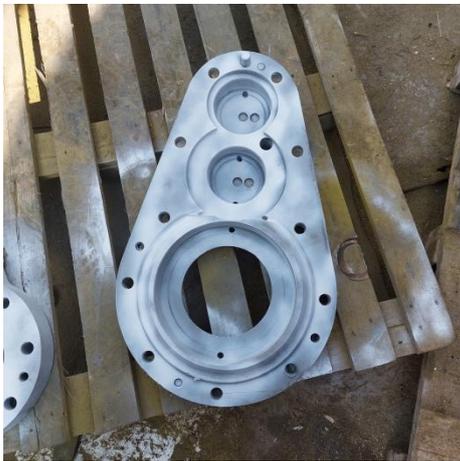
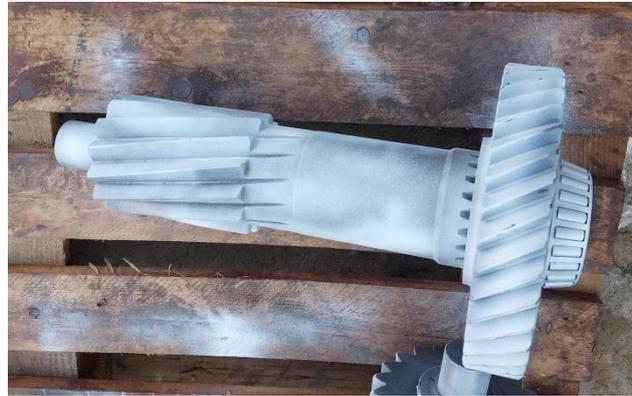
**PICTORIAL:**

\* Visual and MPI Was Carried Out on the Available Critical& Welding Areas of the power swivel and Found **Satisfactory for Further Use.**

\*\* CAT IV Inspection Was Carried Out on power swivel and Found **Accepted** at The Time of Inspection.

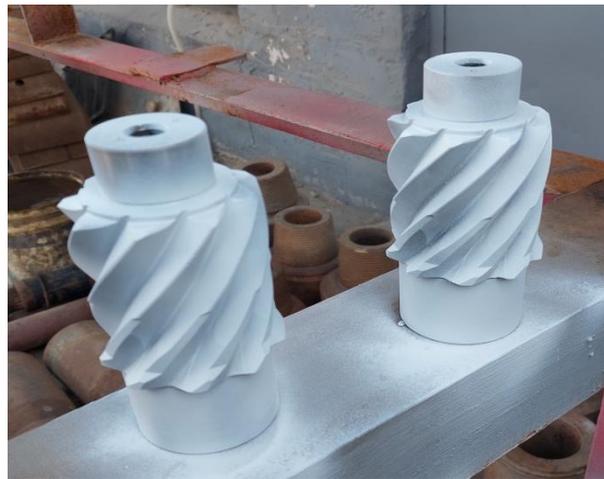
Serial Number	Description of the examined equipment	Result
XK-18-1067675	Final stage pinion gear	Pass
S/N:	05420-0000 (1), 05420-0000 (8)

Visual and MPI carried out for the above description and found free of surface defects at the time of inspection

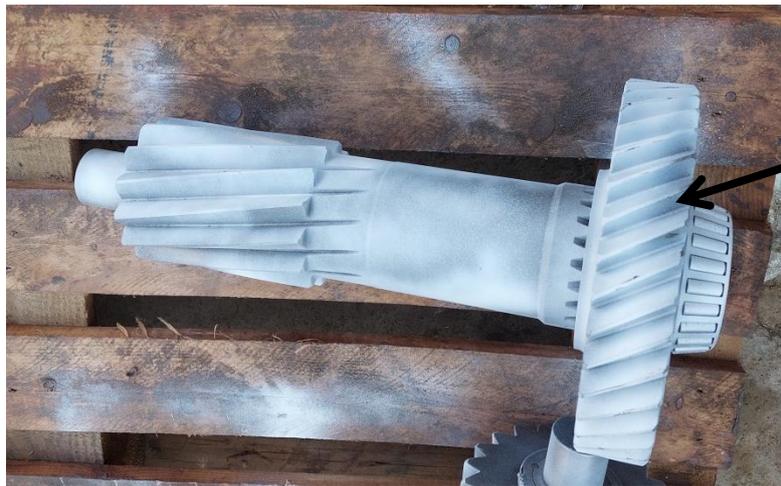
Serial Number	Description of the examined equipment	Result
XK-18-1067675	First stage gear	Pass
S/N:	05419-0000-1

Visual and MPI carried out for the above description and found free of surface defects at the time of inspection

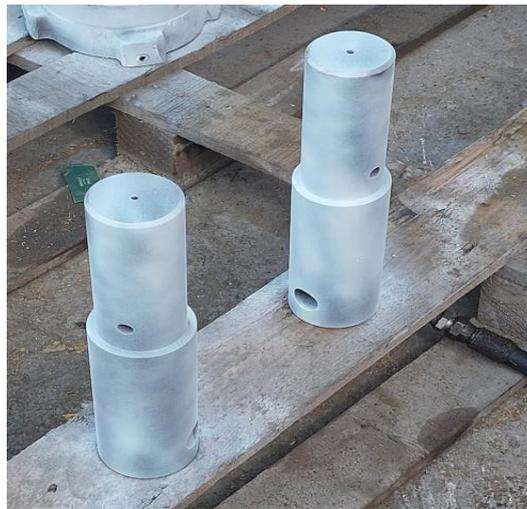
Serial Number	Description of the examined equipment	Result
XK-18-1067675	Bail pins	Pass
S/N:	47287803-2, 47287803-4

Visual and MPI carried out for the above description and found free of surface defects at the time of inspection

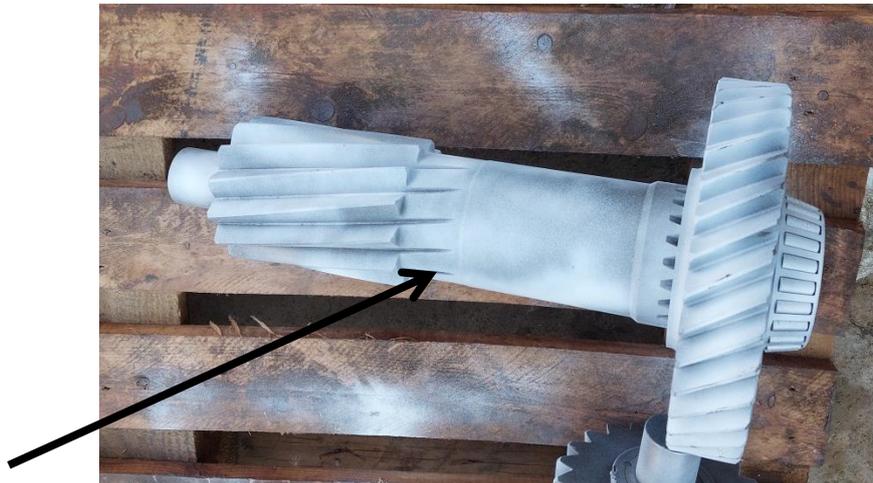
Serial Number	Description of the examined equipment	Result
XK-18-1067675	Second shaft pinion gear	Pass
S/N:	05421-0000-2

Visual and MPI carried out for the above description and found free of surface defects at the time of inspection

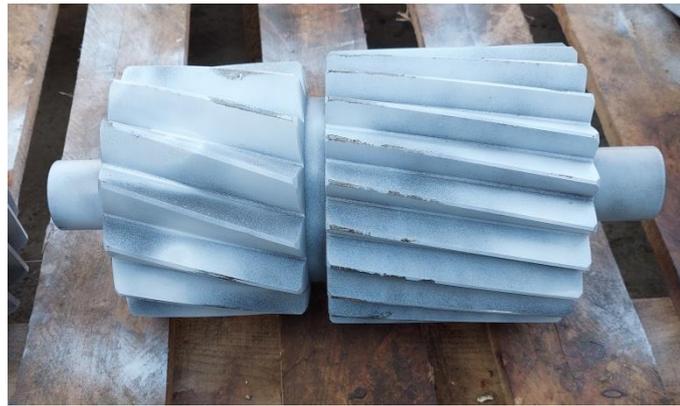
Serial Number	Description of the examined equipment	Result
XK-18-1067675	Final stage pinion gear	Pass
S/N:	06350-000

Visual and MPI carried out for the above description and found free of surface defects at the time of inspection

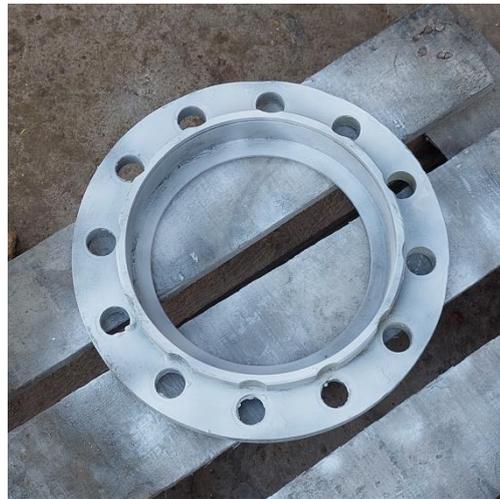
Serial Number	Description of the examined equipment	Result
XK-18-1067675	Lower bearing retainer	Pass
S/N:	271609-3

Visual and MPI carried out for the above description and found free of surface defects at the time of inspection

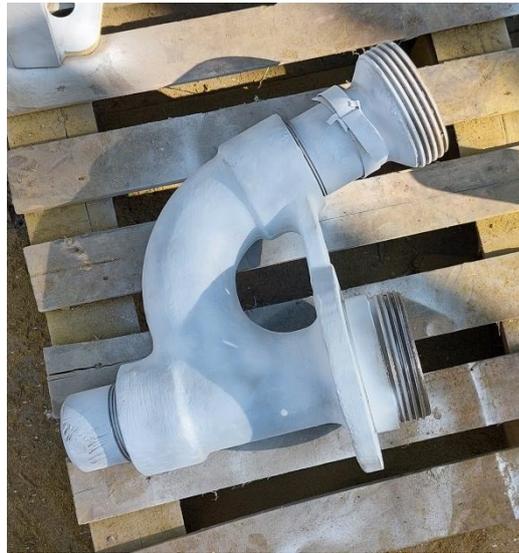
Serial Number	Description of the examined equipment	Result
XK-18-1067675	gooseneck	Pass
S/N:	10452115-001

Visual and MPI carried out for the above description and found free of surface defects at the time of inspection

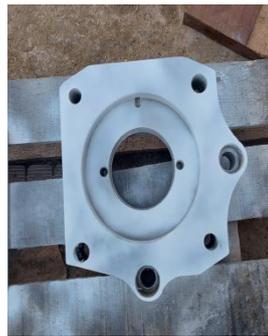
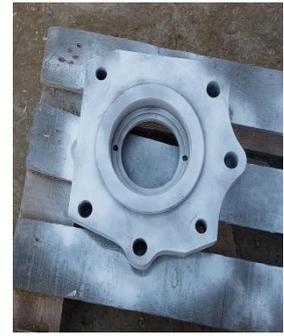
Serial Number	Description of the examined equipment	Result
XK-18-1067675	Motor adapter	Pass
S/N:	47287800-1 , 38059431-1

Visual and MPI carried out for the above description and found free of surface defects at the time of inspection

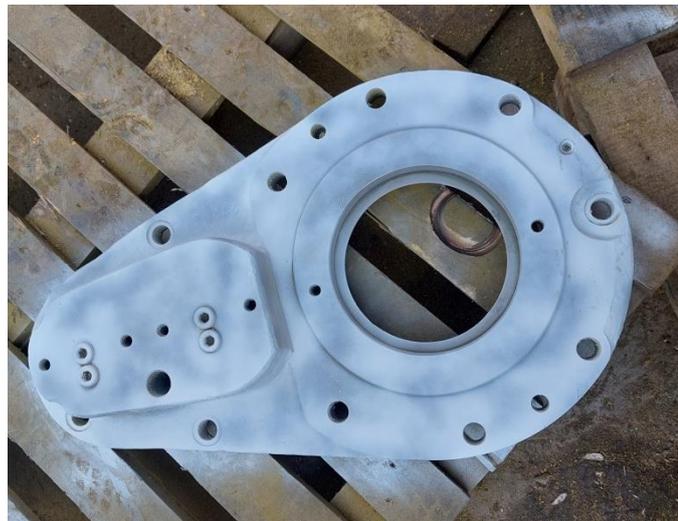
Serial Number	Description of the examined equipment	Result
XK-18-1067675	Stop cover	Pass
S/N:	10470034-001

Visual and MPI carried out for the above description and found free of surface defects at the time of inspection

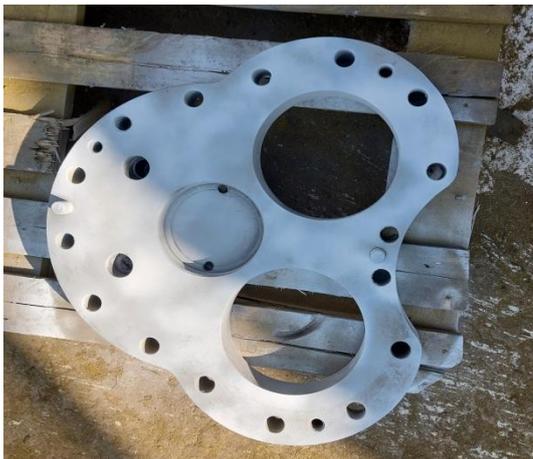
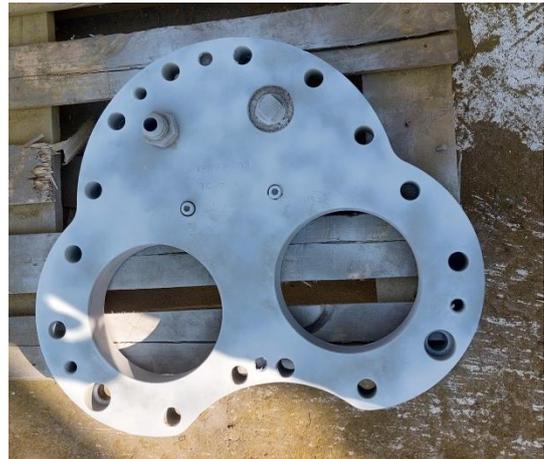
Serial Number	Description of the examined equipment	Result
XK-18-1067675	Lower cover	Pass
S/N:	219391-005

Visual and MPI carried out for the above description and found free of surface defects at the time of inspection

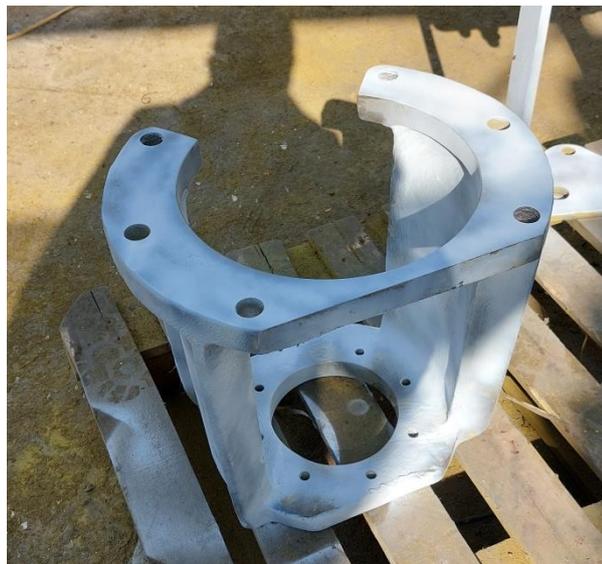
Serial Number	Description of the examined equipment	Result
XK-18-1067675	bonnet	Pass
S/N:	HL100B035

Visual and MPI carried out for the above description and found free of surface defects at the time of inspection

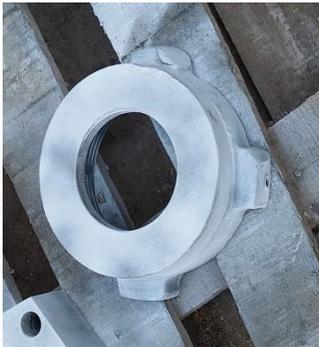
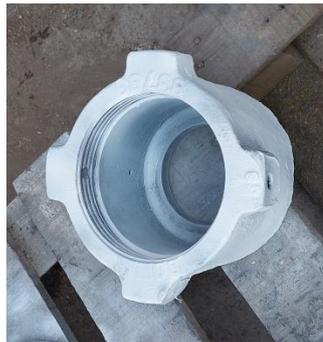
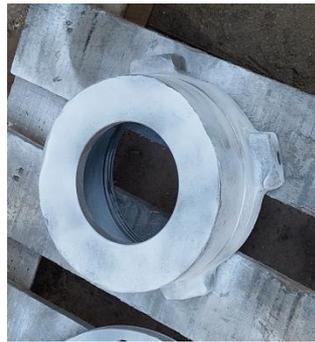
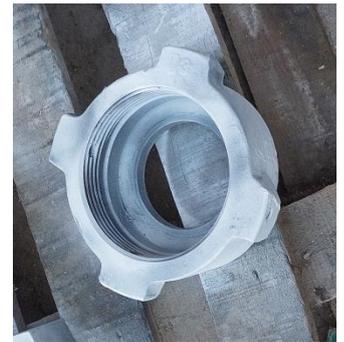
Serial Number	Description of the examined equipment	Result
XK-18-1067675	Wash pipe nuts	Pass
S/N:	10384083-001, 10459015-001

Visual and MPI carried out for the above description and found free of surface defects at the time of inspection

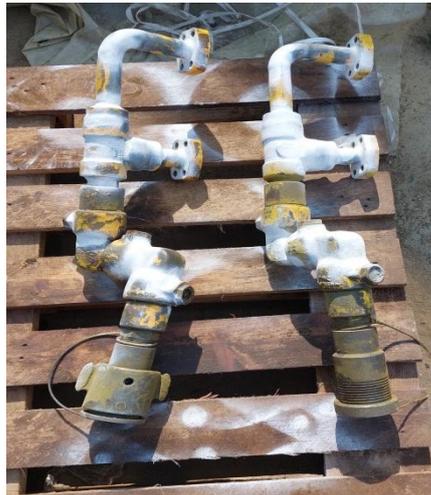
Serial Number	Description of the examined equipment	Result
XK-18-1067675	Hydraulic Pipe	Pass
S/N:	HP-01 , HP-02

Visual and MPI carried out for the above description and found free of surface defects at the time of inspection

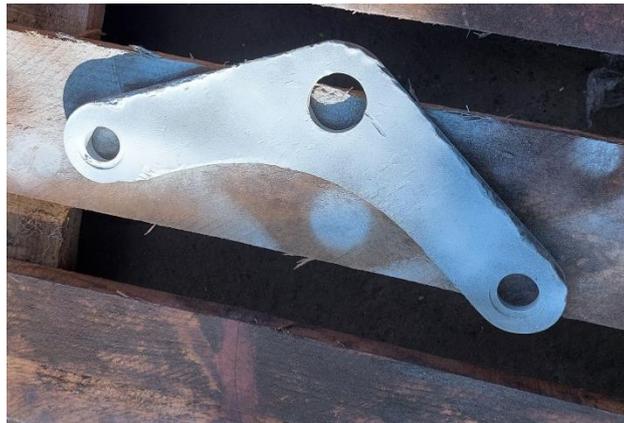
Serial Number	Description of the examined equipment	Result
XK-18-1067675	Wrench hook	Pass
S/N:	10452230-002

Visual and MPI carried out for the above description and found free of surface defects at the time of inspection

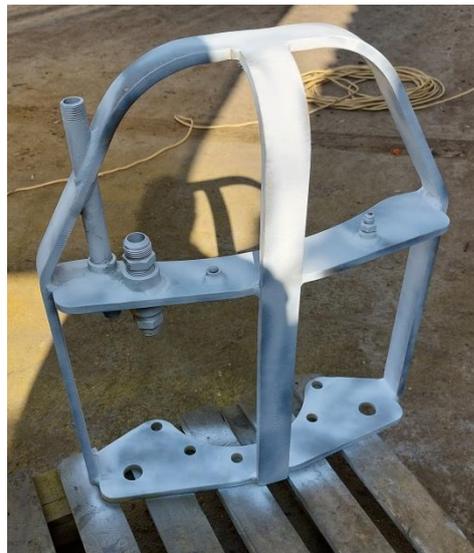
Serial Number	Description of the examined equipment	Result
XK-18-1067675	guard	Pass
S/N:	217062-012-BSC-D

Visual and MPI carried out for the above description and found free of surface defects at the time of inspection

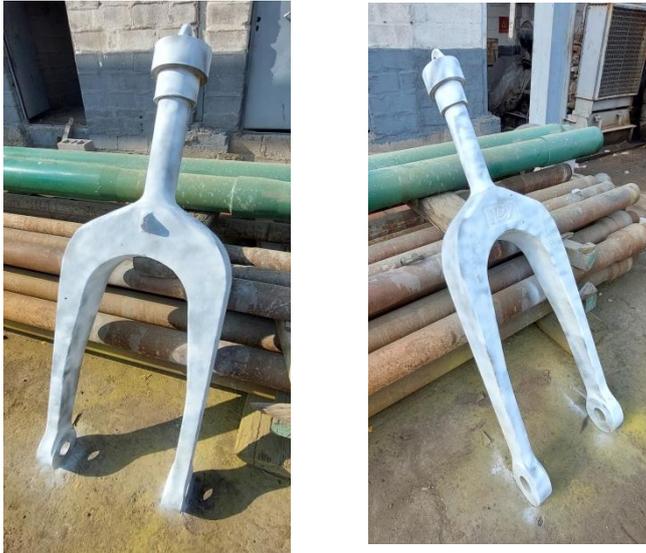
Serial Number	Description of the examined equipment	Result
XK-18-1067675	bail	Pass
S/N:	47324738-1

Visual and MPI carried out for the above description and found free of surface defects at the time of inspection

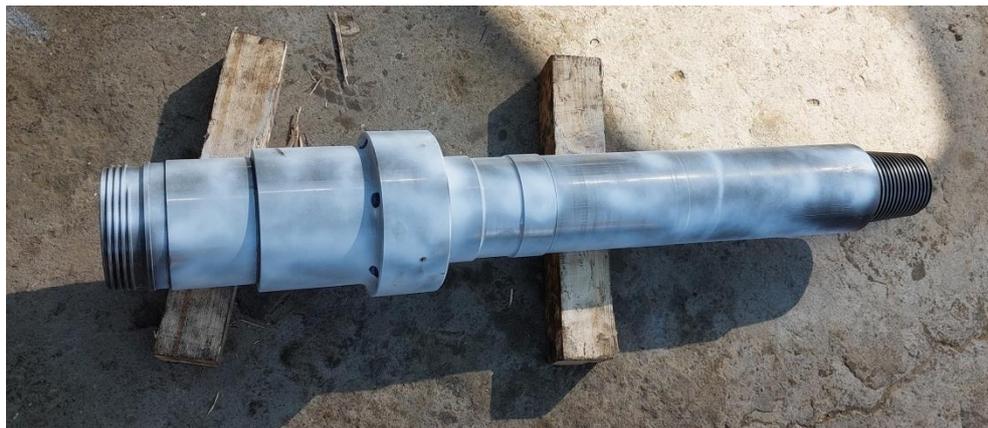
Serial Number	Description of the examined equipment	Result
XK-18-1067675	Main shaft	Pass
S/N:	10459919-001

Visual and MPI carried out for the above description and found free of surface defects at the time of inspection

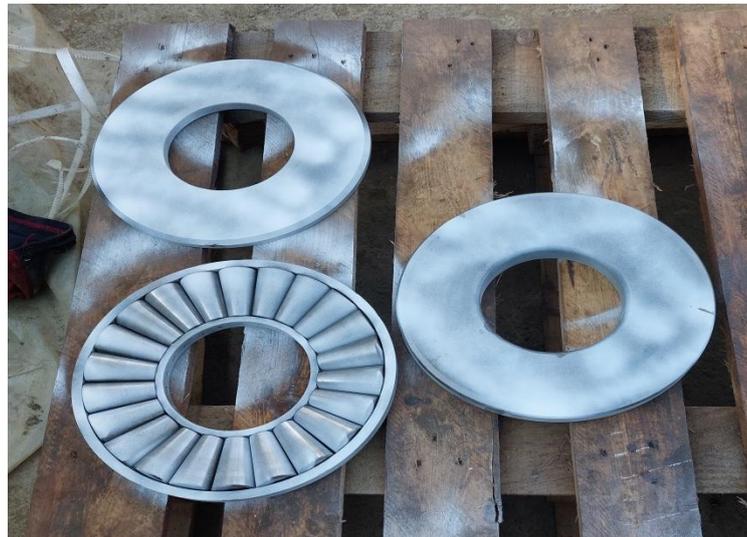
Serial Number	Description of the examined equipment	Result
XK-18-1067675	Thrust bearing	Pass
S/N:	VFT9570 + 11404

Visual and MPI carried out for the above description and found free of surface defects at the time of inspection

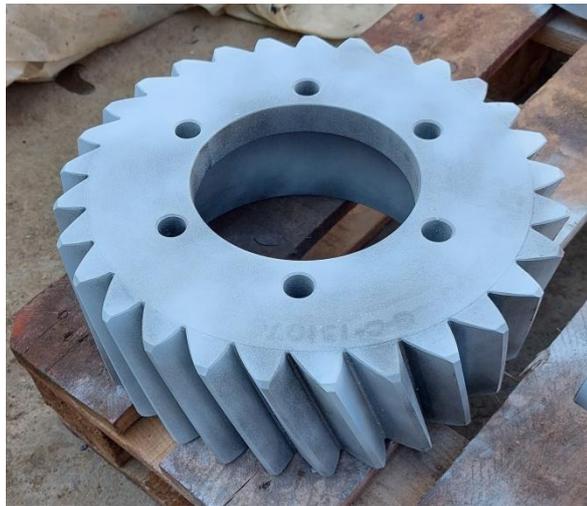
Serial Number	Description of the examined equipment	Result
XK-18-1067675	Helical gear	Pass
S/N:	05142-0000

Visual and MPI carried out for the above description and found free of surface defects at the time of inspection

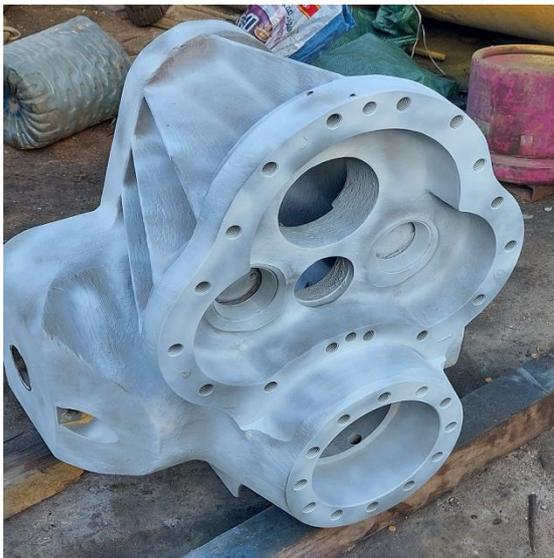
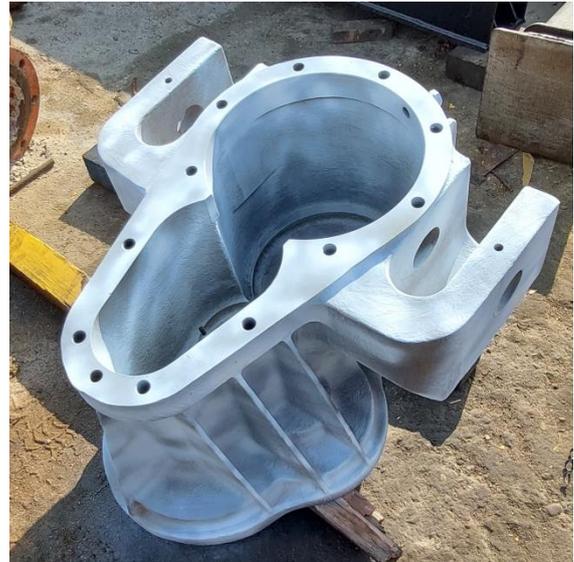
Serial Number	Description of the examined equipment	Result
XK-18-1067675	housing	Pass
S/N:	37059439-1

Visual and MPI carried out for the above description and found free of surface defects at the time of inspection

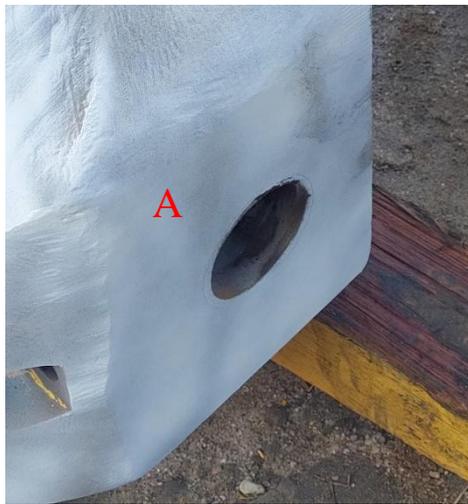
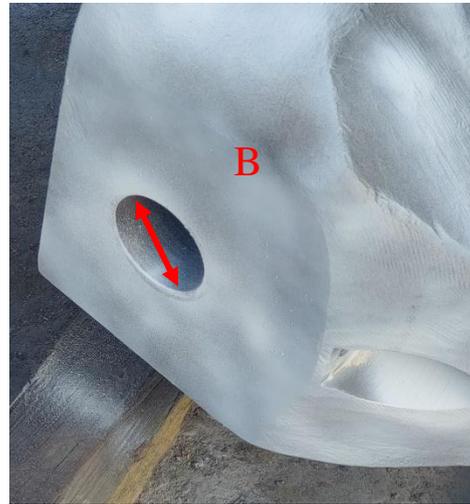
Serial Number	Description of the examined equipment	Result
XK-18-1067675	housing	Pass
S/N:	37059439-1

Length:	NA	
Description:	OEM	Actual Value (mm)
Maximum Hole Internal Diameter(A):	Shall be Verified by the client	64
Maximum Hole Internal Diameter(B):	Shall be Verified by the client	64

Visual and MPI carried out for the above description and found free of surface defects at the time of inspection

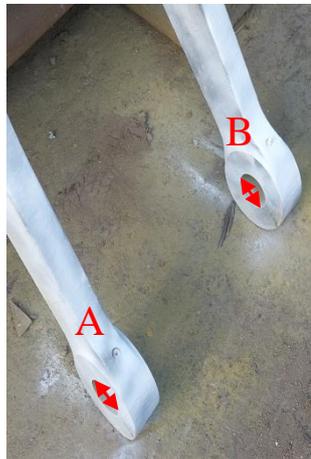
Serial Number	Description of the examined equipment	Result
XK-18-1067675	Bail	Pass
S/N:	47324738-1

Length:	NA	
Description:	OEM	Actual Value (mm)
Maximum Hole Internal Diameter(A):	Shall be Verified by the client	63.88
Maximum Hole Internal Diameter(B):	Shall be Verified by the client	63.86

Visual and MPI carried out for the above description and found free of surface defects at the time of inspection  
 Identification of any part found to have a defect and a description of the defect: **None**  
 Particulars of any repair, renewal or alteration required to remedy the defect identified above: **None**

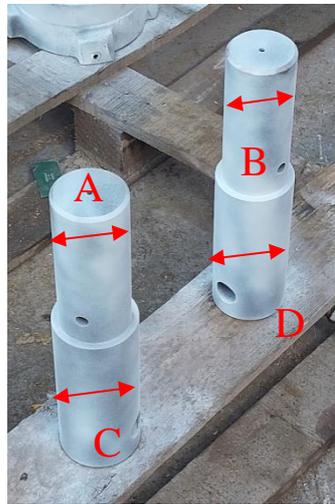
Serial Number	Description of the examined equipment	Result
XK-18-1067675	Bail pin	Pass
S/N:	47287803-1, 47287803-3

Visual and MPI carried out for the above description and found free of surface defects at the time of inspection

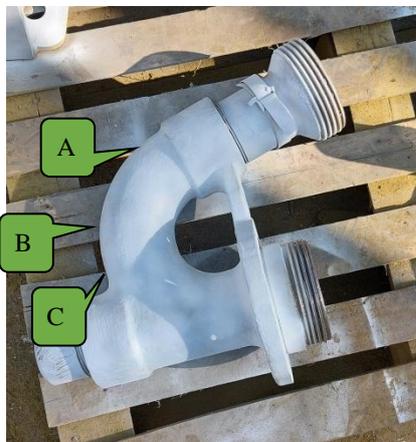
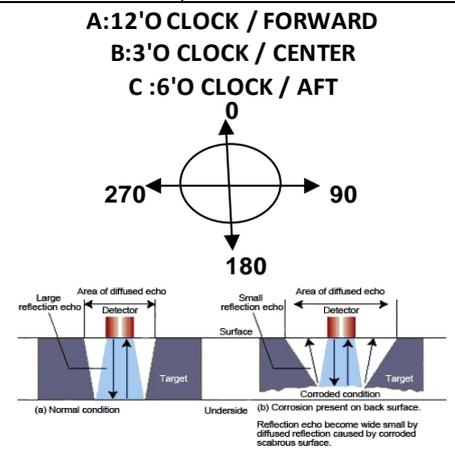
Serial Number	Description of the examined equipment	Result
10452115-001	Gooseneck	Accepted

ANGLES	UT WALLTHICKNESS POSITION MEASURED IN MM								MINIMUM THICKNESS
	A	B	C	D	E	F	G	H	
0°	13.09	13.12	12.59	-	-	-	-	-	6.98
90°	13.05	12.89	12.85	-	-	-	-	-	
180°	13.12	12.99	12.94	-	-	-	-	-	
270°	12.97	13.03	12.75	-	-	-	-	-

Visual and MPI carried out for the above description and found free of surface defects at the time of inspection

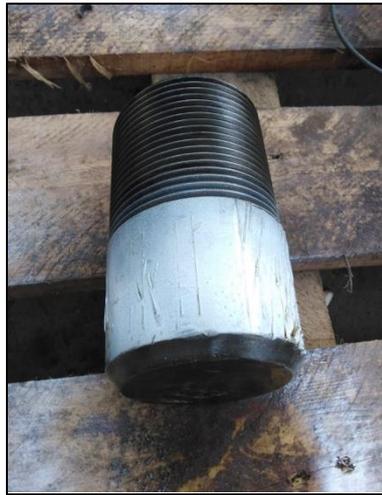
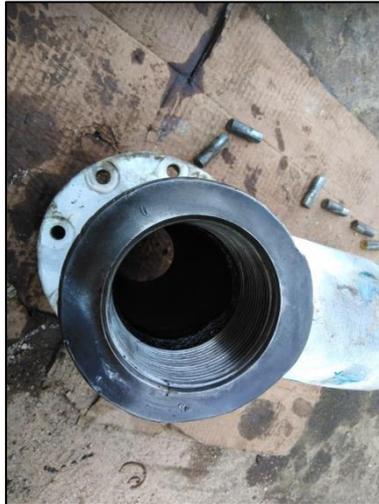
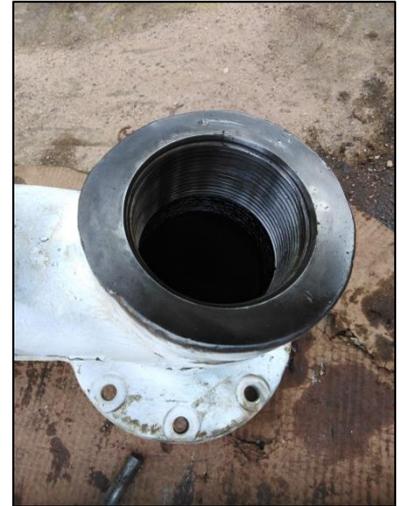
Serial Number	Description of the examined equipment	Result
XK-18-1067675	Wire line plug and Thraeds	Pass
S/N:	317921/005

Visual and black light inspection carried out for the **Wire line plug and threads** and found free of surface defects at the time of inspection
