Customer:	Hilong Oil Services & Engineering	Date Of Service:	29-02-2024
Type Of Inspection:	CAT III INSPECTION	Report No:	ATS-02-24-2999-AS-001
Rig & Rig Number:	RIG-100	Specification:	API RP 7L

Equipment:	Pneumatic Slip (Drill pipe slip) , 125TONS , CHD
SN:	80801
Date of Manufacture:	2018-08
Manufacturer/Model:	JIANGSU RUTONG PETRO-MACHINERY CO / CHD
Reference Standard:	API RP 7L
Next Examination Date:	After 06 Months

## Visual & Magnetic Particles Examination Report

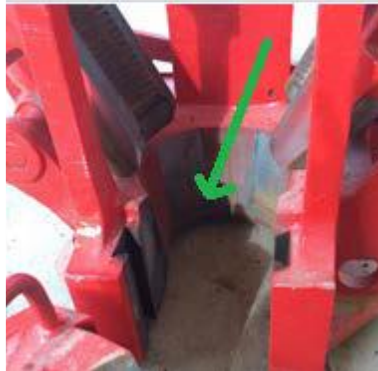
DESCRIPTION	VALUES	OEM VALUES	RESULT
The allowable Maximum wear on the outside surface of the slip and Inside Surface of the Spider	0.80	1.6	Accepted

\*\* Visual And MPI Was Carried out on the critical areas and load bearing components of the slip and Found **Satisfactory for Further Use**.

\*\* CAT III Inspection Was Carried Out on the slip and Found **Accepted** At The Time of Inspection

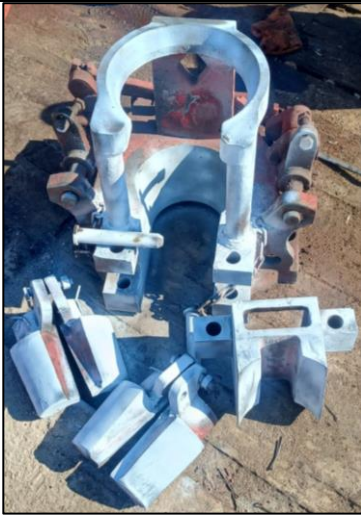
Serial Number	Description of the examined equipment	Result
80801	Pneumatic Slip (Drill pipe slip) , 125 TONS , CHD	Pass
S/N:	80801

Visual and MPI carried out for the above description and found free of surface defects at the time of inspection

Identification of any part found to have a defect and a description of the defect: **None**

Particulars of any repair, renewal or alteration required to remedy the defect identified above: **None**
