Customer:	Hilong Oil Services & Engineering	Date Of Service:	01-03-2024
Type Of Inspection:	CAT III INSPECTION	Report No:	ATS-02-24-2999-AS-002
Rig & Rig Number:	RIG-100	Specification:	API RP 7L

Equipment:	Pneumatic Slip (Drill pipe slip) , 125TONS , CHD
SN:	2H922
Date of Manufacture:	-
Manufacturer/Model:	JIANGSU RUTONG PETRO-MACHINERY CO / CHD
Reference Standard:	API RP 7L
Next Examination Date:	After 06 Months

## Visual & Magnetic Particles Examination Report

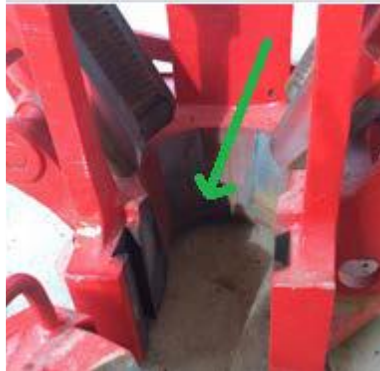
DESCRIPTION	VALUES	OEM VALUES	RESULT
The allowable Maximum wear on the outside surface of the slip and Inside Surface of the Spider	0.635	1.6	Accepted

\*\* Visual And MPI Was Carried out on the critical areas and load bearing components of the slip and Found **Satisfactory for Further Use.**

\*\* CAT III Inspection Was Carried Out on the slip and Found **Accepted** At The Time of Inspection

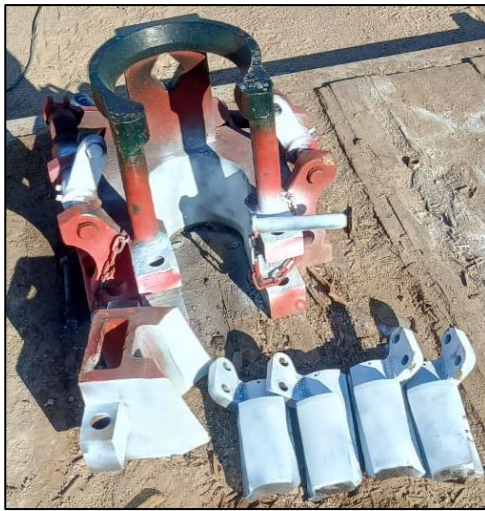
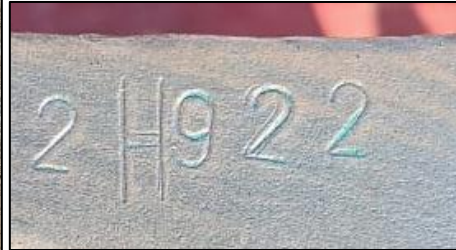
Visual and MPI carried out for the above description and found free of surface defects at the time of inspection

Identification of any part found to have a defect and a description of the defect: **None**

Particulars of any repair, renewal or alteration required to remedy the defect identified above: **None**
