Customer:	Hilong Oil Services & Engineering	Date Of Service:	29-02-2024
Type Of Inspection:	CAT III INSPECTION	Report No:	ATS-02-24-2999-HS-003
Rig & Rig Number:	RIG-100	Specification:	API RP 7L

The Rig Was Equipped with JIANGSU RUTONG PETRO-MACHINERY CO. Hand Slip, with The Following Specification:

Equipment:	Hand Slip (Drill pipe slip), Size: 3 1/2"
SN:	806128
Date of Manufacture:	-
Manufacturer/Model:	JIANGSU RUTONG PTERO-MACHINERY CO
Reference Standard:	API RP 7L
Next Examination Date:	After 06 Months

Visual & Magnetic Particles Examination Report

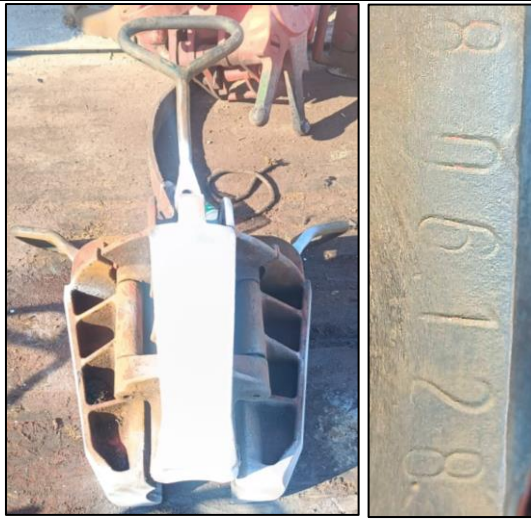
Serial Number	Description of the examined equipment	Result
806128	Drill pipe slips, SDML, 3 1/2	Pass
S/N:	806128

Visual and MPI carried out for the above description and found free of surface defects at the time of inspection

Identification of any part found to have a defect and a description of the defect: **None**

Particulars of any repair, renewal or alteration required to remedy the defect identified above: **None**
