Customer:	Hilong Oil Services & Engineering	Date Of Service:	01-03-2024
Type Of Inspection:	CAT III INSPECTION	Report No:	ATS-02-24-2999-HS-005
Rig & Rig Number:	RIG-100	Specification:	API RP 7L

Equipment:	Hand Slip (Drill pipe slip), SDML 3 1/2 X 2 7/8
SN:	806137
Date of Manufacture:	-
Manufacturer/Model:	JIANGSU RUTONG PTERO-MACHINERY CO
Reference Standard:	API RP 7L
Next Examination Date:	After 06 Months

## Visual & Magnetic Particles Examination Report

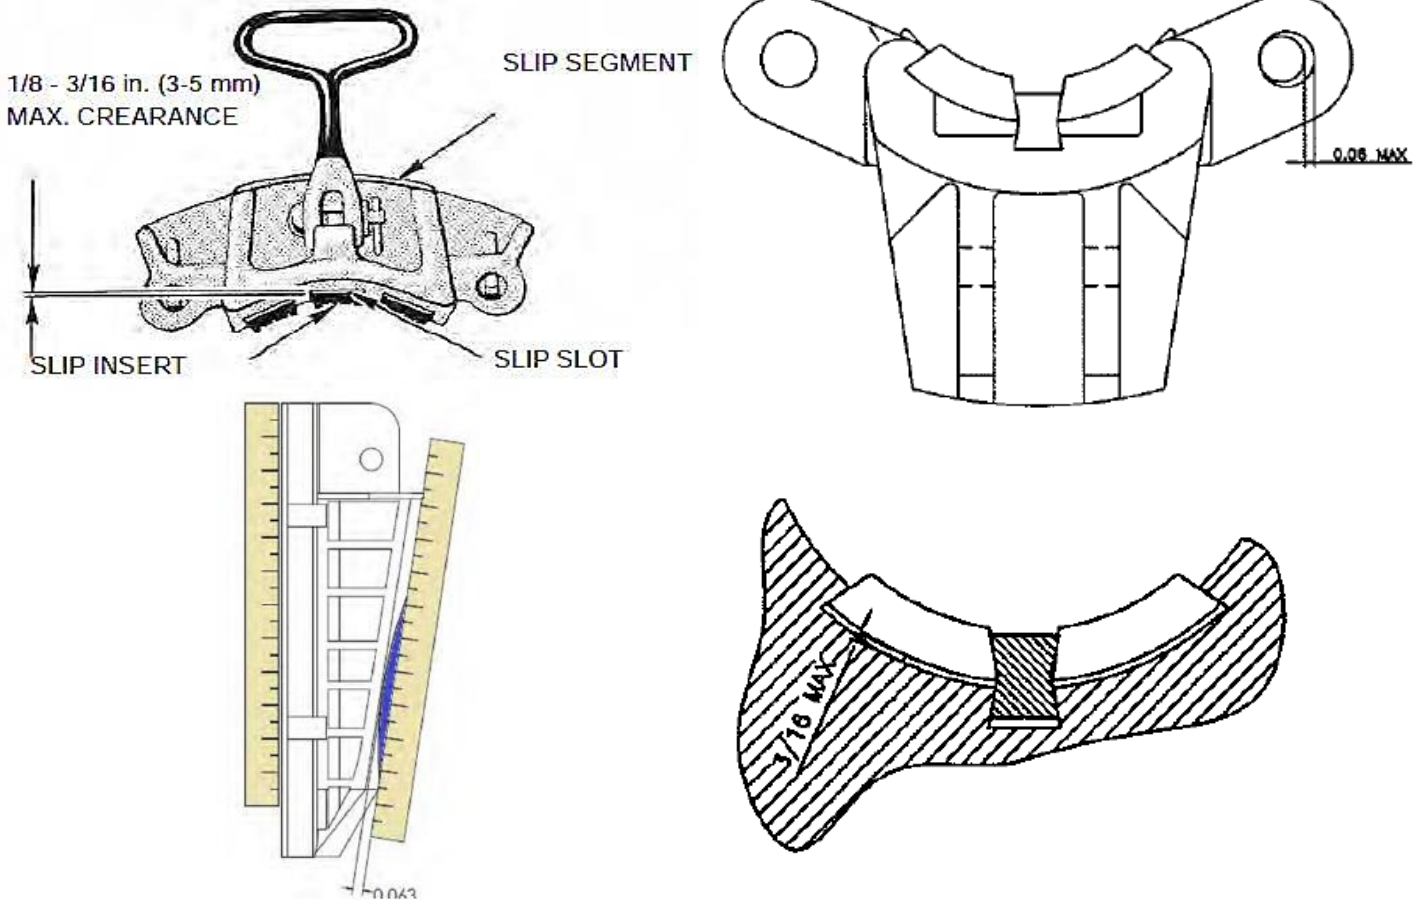
- The Drill pipe Slip Has Been Inspected and Found Conformable to the Relevant Standard(s)
- The Rig was equipped with JIANGSU RUTONG PTERO-MACHINERY CO. LTD Drill pipe Slip.
- Drill pipe Slip Found Stripped Down for CAT III Inspection.

Action	Result
• Visually check for the serial number and Identification	Pass
• Prepare and clean the slip body and accessories to the extent necessary for inspection.	Pass
• Visually check for any damage, missing parts or cracks	Pass
• For Rotary, Dc and Casing Slips: Visually checked for damage, deformations or cracks on the hinges brackets, slips segments with tail slot handles and hinge pin.	Pass
• Place a straight edge against the backs and inside face of the slips to check if they are bend or wear. A good slip back is straight, smooth, and well-greased.	Pass
• Perform MPI as Per Manufacture’s Recommendations of Hinged Connections Body (inside & Outside), Handles Guide Halves, Slips Top Cover Halves, Etc...	Pass
• Repaint the slip	Pass
• Prepare and submit the inspection report.	Pass

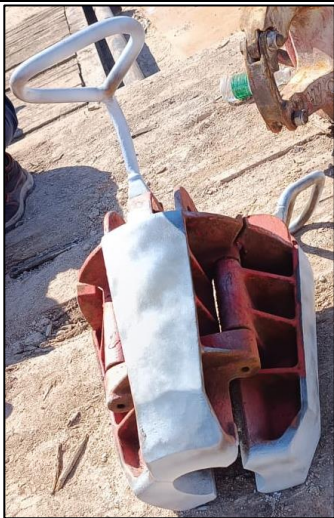
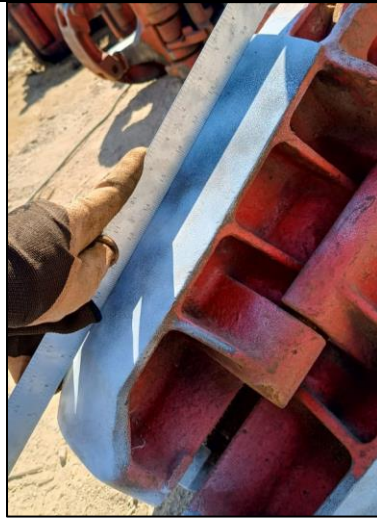
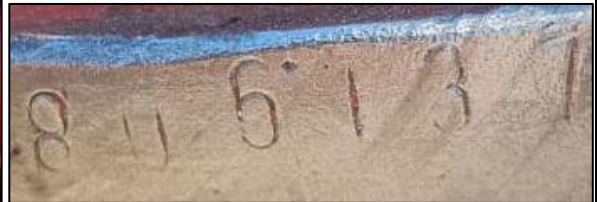
Serial Number	Description of the examined equipment	Result
806137	Hand Slip (Drill pipe slip), SDML 3 1/2 X 2 7/8	Pass
S/N:	806137

Visual and MPI carried out for the above description and found free of surface defects at the time of inspection

Identification of any part found to have a defect and a description of the defect: **None**

Particulars of any repair, renewal or alteration required to remedy the defect identified above: **None**
