Customer:	Hilong Oil Services & Engineering	Date Of Service:	01-03-2024
Type Of Inspection:	CAT IV INSPECTION	Report No:	ATS-02-24-2999-SC-003
Rig & Rig Number:	RIG-100	Specification:	API RP 8C

The Rig Was Equipped with JIANGSU RUTONG PETRO-MACHINERY CO. Safety Clamp, with The Following Specification:

Equipment:	Safety slip 2 7/8
Model/SN:	132296
Date of Manufacture:	-
Manufacturer:	JIANGSU RUTONG PETRO-MACHINERY
Reference Standard:	API RP 8C
Next Examination Date:	After 1 Year

Visual & Magnetic Particles Examination Report

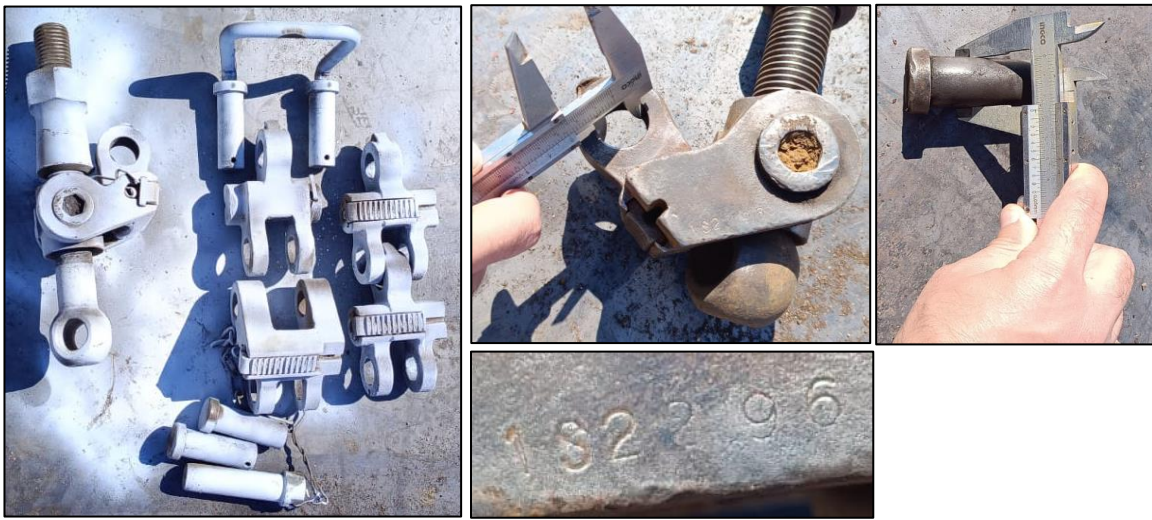
Serial Number	Description of the examined equipment	Result
132296	Safety slip , 2 7/8	Pass
S/N:	132296

Visual and MPI carried out for the above description and found free of surface defects at the time of inspection

Identification of any part found to have a defect and a description of the defect: **None**

Particulars of any repair, renewal or alteration required to remedy the defect identified above: **None**
