Customer:	Hilong Oil Services & Engineering	Date Of Service:	01-03-2024
Type Of Inspection:	CAT III INSPECTION	Report No:	ATS-02-24-2999-SJE-017
Rig & Rig Number:	RIG-100	Specification:	API RP 8C

Equipment:	Single Joint Elevator, SJ 4 ½ -5
SN:	414373009-14
Date of Manufacture:	-
Manufacturer/ Model:	JIANGSU RUTONG PETRO-MACHINERY CO.
Reference Standard:	API RP 8C
Next Examination Date:	After 6 Months

## Visual & Magnetic Particles Examination Report

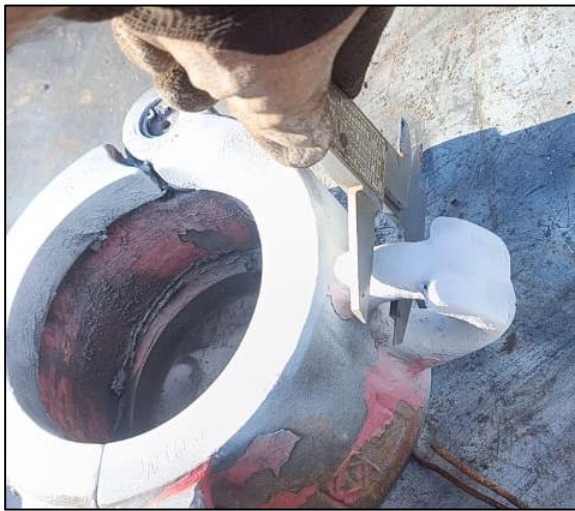
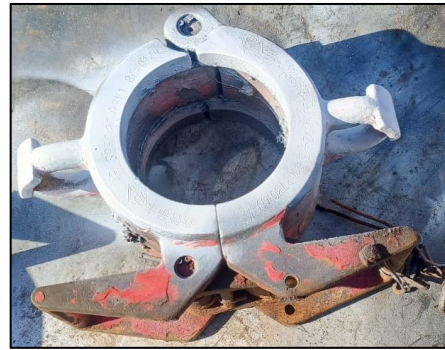
Serial Number	Description of the examined equipment	Result
414373009-14	Single Joint Elevator, SJ 4 1/2 -5	Pass
S/N:	414373009-14

Visual and MPI carried out for the above description and found free of surface defects at the time of inspection

Identification of any part found to have a defect and a description of the defect: **None**

Particulars of any repair, renewal or alteration required to remedy the defect identified above: **None**
