<b>Customer:</b>	<b>Hilong Oil Services &amp; Engineering</b>	<b>Date Of Service:</b>	<b>01-03-2024</b>
<b>Type Of Inspection:</b>	<b>CAT III INSPECTION</b>	<b>Report No:</b>	<b>ATS-02-24-2999-TEL-003</b>
<b>Rig &amp; Rig Number:</b>	<b>RIG-100</b>	<b>Specification:</b>	<b>API RP 8C</b>

The Rig Was Equipped with Jiangsu Rutong Petro-Machinery Co. Ltd. Square shoulder Elevator, with The Following Specification:

Equipment:	Square Shoulder elevator NU tubing, DD 2 7/8 , 150
Model/SN:	DD NU tubing
SN:	80830
Size:	2 7/8 ”
SWL:	150 tons
Date of Manufacture:	2018-08
Manufacturer:	Jiangsu Rutong Petro-Machinery Co. Ltd.
Reference Standard:	API RP 8C
Next Examination Date:	After 06 Months

## Visual & Magnetic Particles Examination Report

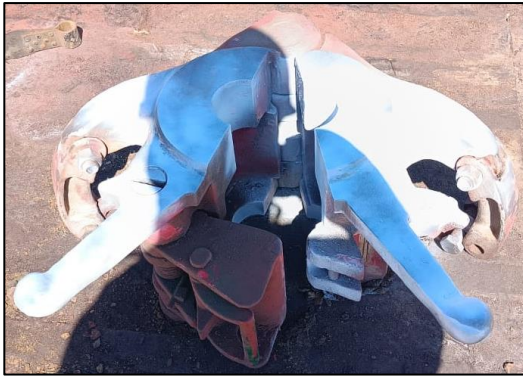
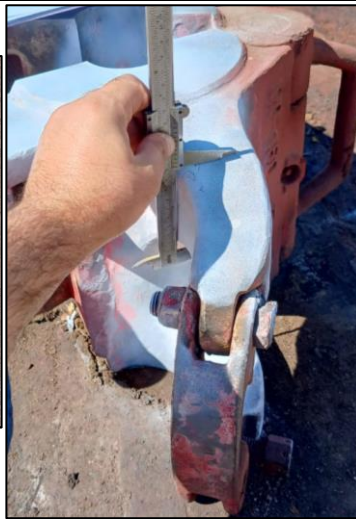
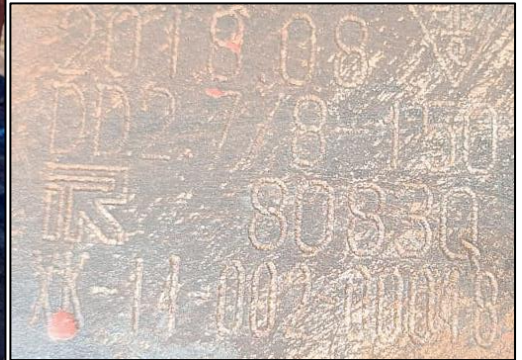
Serial Number	Description of the examined equipment	Result
80830	Square Shoulder elevator NU tubing, DD 2 7/8 , 150	Pass
S/N:	80830

Visual and MPI carried out for the above description and found free of surface defects at the time of inspection

Identification of any part found to have a defect and a description of the defect: **None**

Particulars of any repair, renewal or alteration required to remedy the defect identified above: **None**
