Customer:	Hilong Oil Services & Engineering	Date Of Service:	16-05-2024
Type Of Inspection:	CAT III INSPECTION	Report No:	ATS-05-24-3200-AS-001
Rig & Rig Number:	RIG-99	Specification:	API RP 8C

The Rig Was Equipped with JIANGSU RUTONG PETRO-MACHINERY CO. Pneumatic Slip, with The Following Specification:

Equipment:	Pneumatic Slip (Drill pipe slip) , 125TONS , CHD
SN:	0511
Date of Manufacture:	-
Manufacturer/Model:	JIANGSU RUTONG PETRO-MACHINERY CO / CHD
Reference Standard:	API RP 8C
Next Examination Date:	After 06 Months

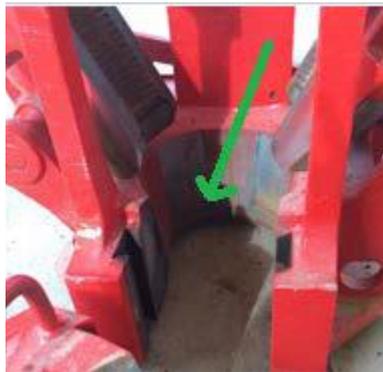
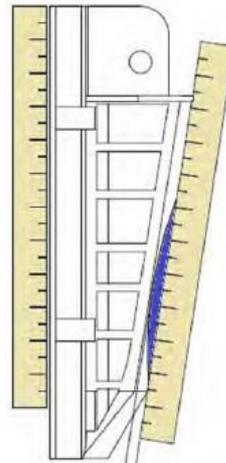
DESCRIPTION	VALUES	OEM VALUES	RESULT
The allowable Maximum wear on the outside surface of the slip and Inside Surface of the Spider	0.600	1.6	Accepted

** Visual And MPI Was Carried out on the critical areas and load bearing components of the slip and Found **Satisfactory for Further Use**.

** CAT III Inspection Was Carried Out on the slip and Found **Accepted**
At The Time of Inspection

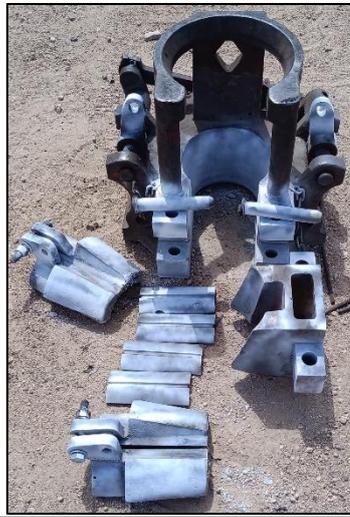
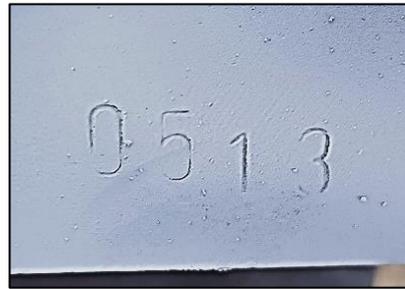
Visual and MPI carried out for the above description and found free of surface defects at the time of inspection

Identification of any part found to have a defect and a description of the defect: **None**

Particulars of any repair, renewal or alteration required to remedy the defect identified above: **None**
