Customer:	Hilong Oil Services & Engineering	Date Of Service:	15-05-2024
Type Of Inspection:	CAT III INSPECTION	Report No:	ATS-05-24-3200-DPEL-002
Rig & Rig Number:	RIG-99	Specification:	API RP 8C

Equipment:	Drill pipe elevator , DDZ 3 ½ EU-150
SN:	80444
Date of Manufacture:	-
Manufacturer/ Model:	JIANGSU RUTONG PTERO-MACHINERY CO
Reference Standard:	API RP 8C
Next Examination Date:	After 6 Months

## Visual & Magnetic Particles Examination Report

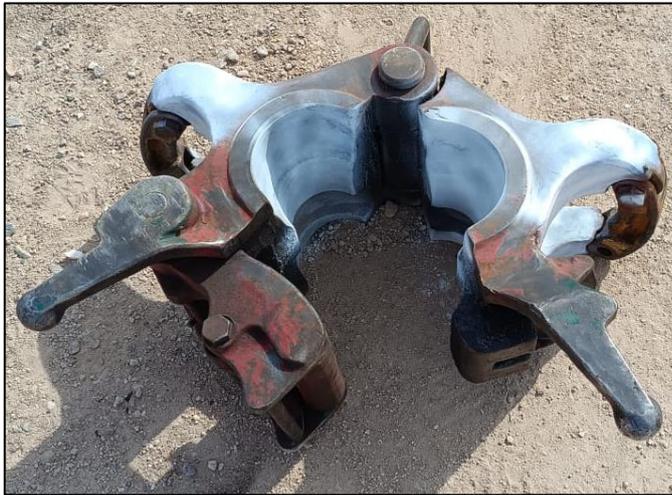
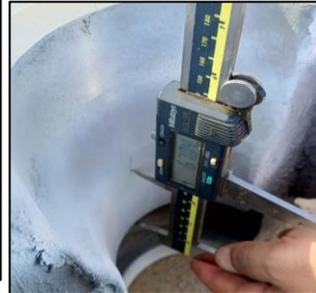
Serial Number	Description of the examined equipment	Result
80444	Drill pipe elevator , DDZ 3 1/2 EU-150	Pass
S/N:	80444

Visual and MPI carried out for the above description and found free of surface defects at the time of inspection

Identification of any part found to have a defect and a description of the defect: **None**

Particulars of any repair, renewal or alteration required to remedy the defect identified above: **None**
