Customer:	Hilong Oil Services & Engineering	Date Of Service:	15-05-2024
Type Of Inspection:	CAT III INSPECTION	Report No:	ATS-05-24-3200-HS-002
Rig & Rig Number:	RIG-99	Specification:	API RP 8C

The Rig Was Equipped with JIANGSU RUTONG PETRO-MACHINERY CO. Hand Slip, with The Following Specification:

Equipment:	Hand Slip (Drill collar slip), DCS.S 4 – 4 7/8
SN:	807086
Date of Manufacture:	-
Manufacturer/Model:	JIANGSU RUTONG PTERO-MACHINERY CO
Reference Standard:	API RP 8C
Next Examination Date:	After 06 Months

Visual & Magnetic Particles Examination Report

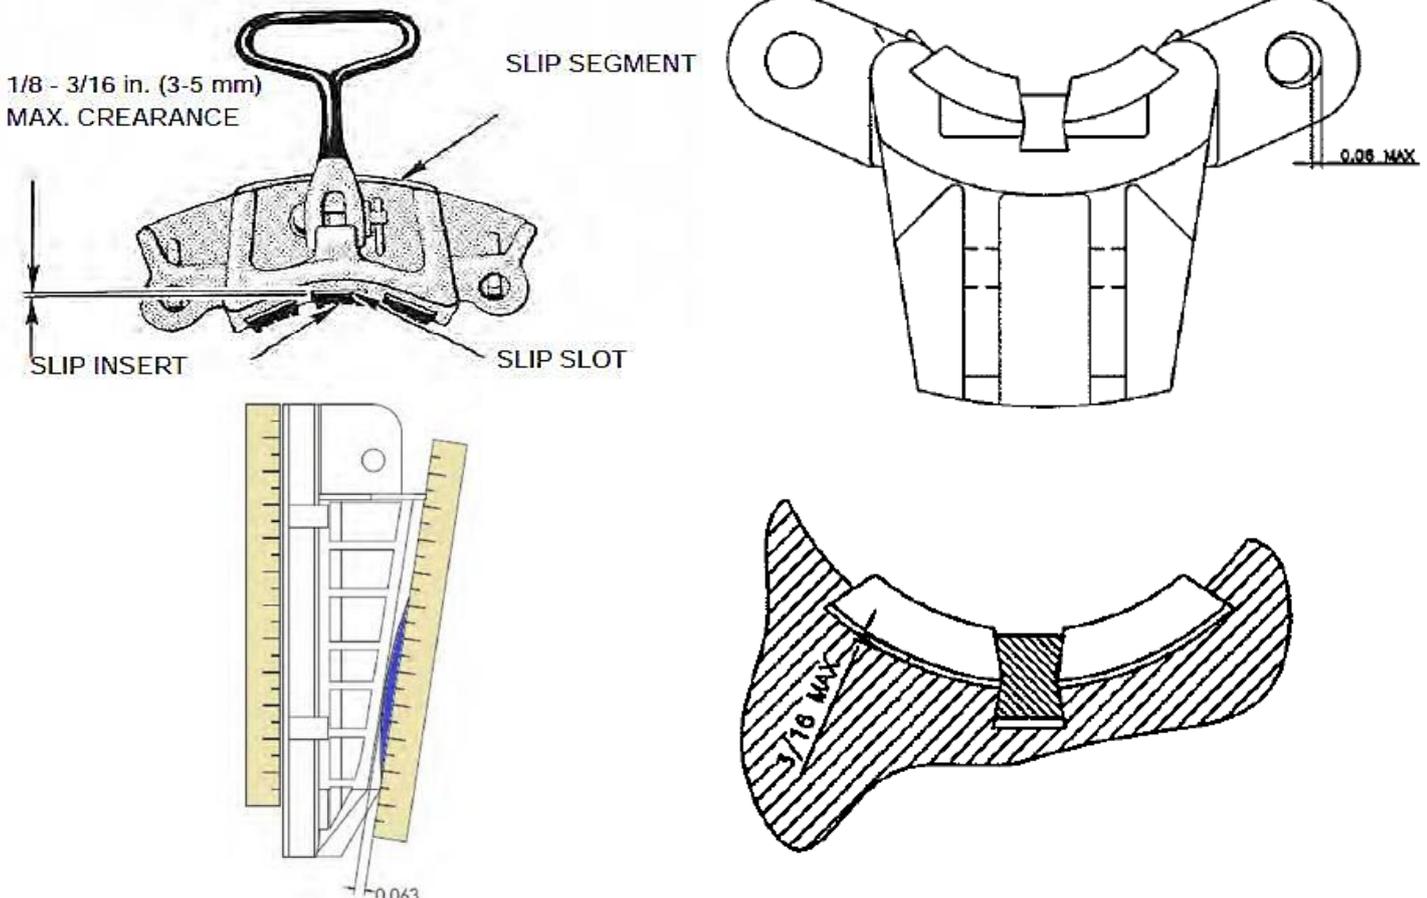
- The Drill collar Slip Has Been Inspected and Found Conformable to the Relevant Standard(s)
- The Rig was equipped with JIANGSU RUTONG PTERO-MACHINERY CO. LTD Drill collar Slip.
- Drill collar Slip Found Stripped Down for CAT III Inspection.

Action	Result
• Visually check for the serial number and Identification	Pass
• Prepare and clean the slip body and accessories to the extent necessary for inspection.	Pass
• Visually check for any damage, missing parts or cracks	Pass
• For Rotary, Dc and Casing Slips: Visually checked for damage, deformations or cracks on the hinges brackets, slips segments with tail slot handles and hinge pin.	Pass
• Place a straight edge against the backs and inside face of the slips to check if they are bend or wear. A good slip back is straight, smooth, and well-greased.	Pass
• Perform MPI as Per Manufacture’s Recommendations of Hinged Connections Body (inside & Outside), Handles Guide Halves, Slips Top Cover Halves, Etc...	Pass
• Repaint the slip	Pass
• Prepare and submit the inspection report.	Pass

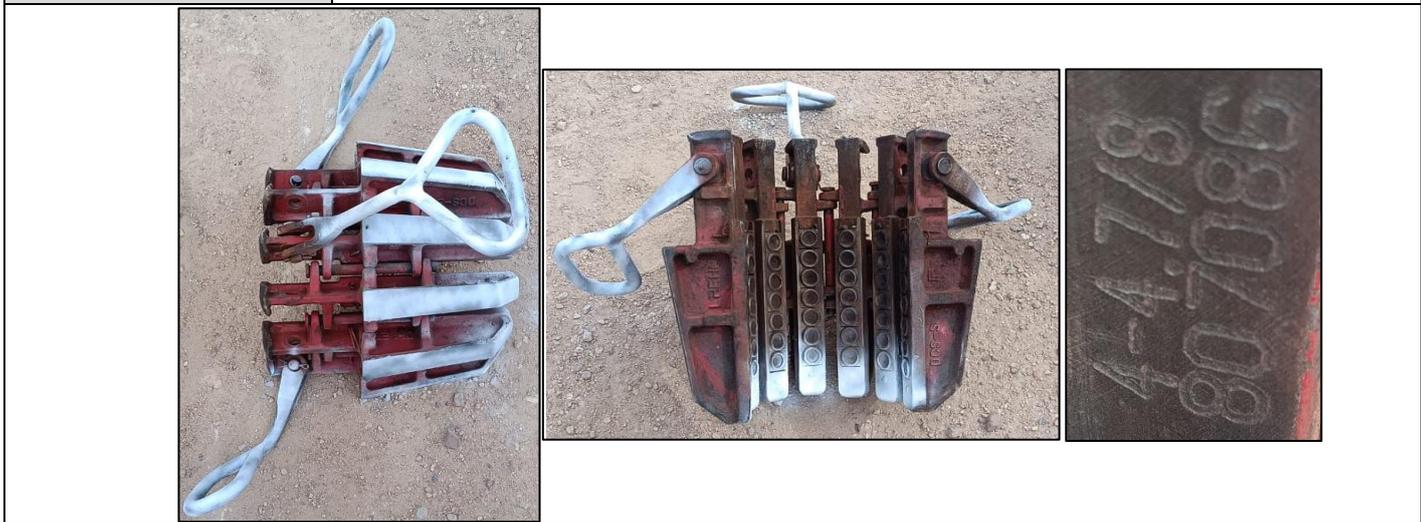
Serial Number	Description of the examined equipment	Result
807086	Hand Slip (Drill collar slip), DCS.S 4 – 4 7/8"	Pass
S/N:	807086

Visual and MPI carried out for the above description and found free of surface defects at the time of inspection

Identification of any part found to have a defect and a description of the defect: **None**

Particulars of any repair, renewal or alteration required to remedy the defect identified above: **None**
