| Type Of Inspection: | CAT III INSPECTION | Report No: | ATS-05-24-3200-HS-003 |
| Rig & Rig Number: | RIG-99 | Specification: | API RP 8C |

| Equipment: | Hand Slip (Drill pipe slip), SDML 3 ½ |

## Visual & Magnetic Particles Examination Report

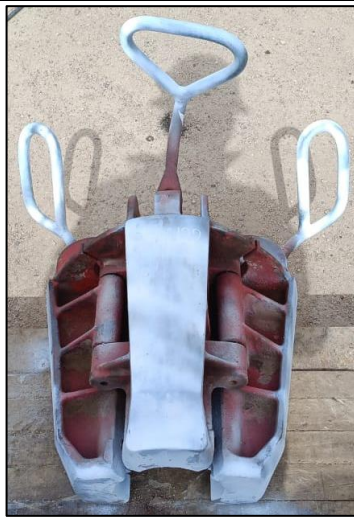
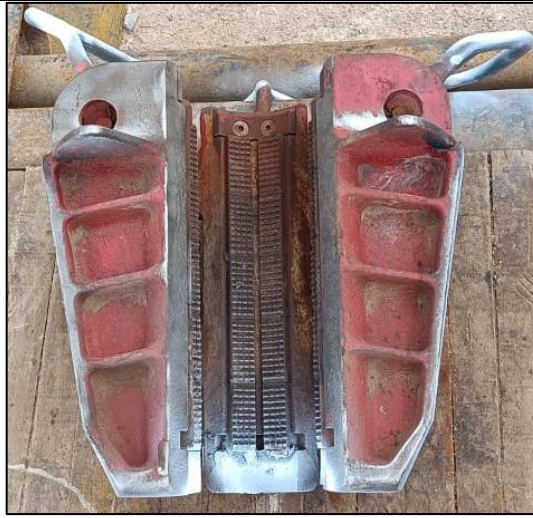
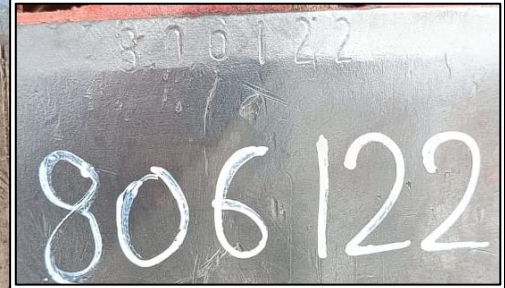
| Serial Number | Description of the examined equipment | Result |
|---|---|---|
| S/N: | 806122 | |

Visual and MPI carried out for the above description and found free of surface defects at the time of inspection

Identification of any part found to have a defect and a description of the defect: **None**

Particulars of any repair, renewal or alteration required to remedy the defect identified above: **None**
