## Certificate of Visual Thorough Examination and Magnetic Particle Inspection (MPI)

Client:	Hilong Oil Services & Engineering	Certificate Number:	ATS-05-24-3200- MPI-050
Rig Number:	HL99	Job No:	ATS-05-24-3200
Location:	Southern Rumila – RU-149	Page No:	01 of 01
Date of Inspection:	11-05-2024	Next Inspection Date:	10-11-2024
Type of Inspection	Visual inspection & MPI (Wet Visible Method)	Ref. Standards:	ASTM E709, ASTM E 1444

**Item Description: GENERATOR ROOM**

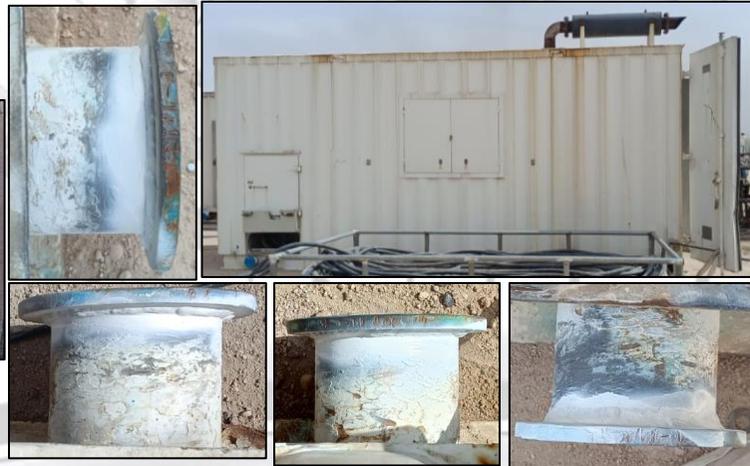
**PICTORIAL:**

发电机房  
Generator Room

(OUTLINE DIMENSIONS): 6058 x 2438 x 2900 mm

(WEIGHT): 11000 kg 出厂编号 (SERIAL NO.): 18640

SN	18640-01	18640-03
SN	18640-02	18640-04
SWL	50 KN

**Inspection Results:**  
MPI WAS CARRIED OUT ON THE CRITICAL AND WELDING AREAS OF LIFTING POINTS OF THE ABOVE-MENTIONED ITEM AND FOUND NO CRACKS OR RELEVANT INDICATIONS AT THE TIME OF INSPECTION..

**Remarks: ACCEPTED**
