| Customer: | Hilong Oil Services & Engineering | Date Of Service: | 16-05-2024 |
| Type Of Inspection: | CAT III INSPECTION | Report No: | ATS-05-24-3200-SC-001 |
| Rig & Rig Number: | RIG-99 | Specification: | API RP 8C |

| Equipment: | Safety Clamp |

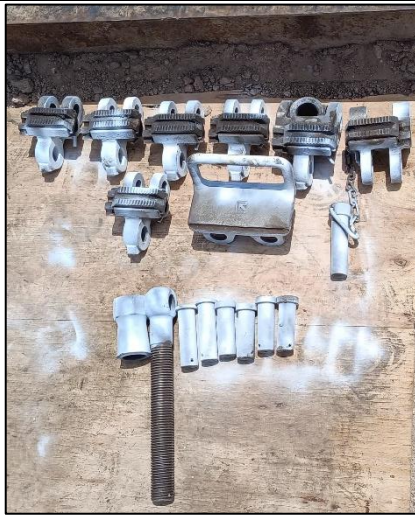
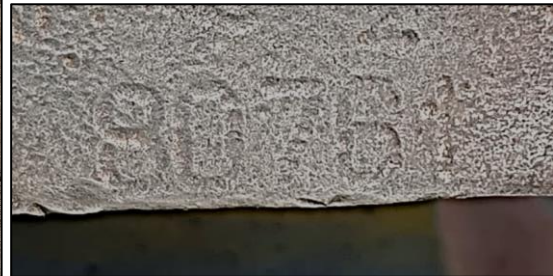
| Serial Number | Description of the examined equipment | Result |
|---|---|---|
| S/N: | 80761 | |

Visual and MPI carried out for the above description and found free of surface defects at the time of inspection

Identification of any part found to have a defect and a description of the defect: **None**

Particulars of any repair, renewal or alteration required to remedy the defect identified above: **None**
