Customer:	Hilong Oil Services & Engineering	Date Of Service:	16-05-2024
Type Of Inspection:	CAT III INSPECTION	Report No:	ATS-05-24-3200-SC-002
Rig & Rig Number:	RIG-099	Specification:	API RP 8C

The Rig Was Equipped with JIANGSU RUTONG PETRO-MACHINERY CO. Safety Clamp, with The Following Specification:

Equipment:	Safety Clamp
Model/SN:	80740
Date of Manufacture:	-
Manufacturer:	JIANGSU RUTONG PETRO-MACHINERY
Reference Standard:	API RP 8C
Next Examination Date:	After 6 months

Visual & Magnetic Particles Examination Report

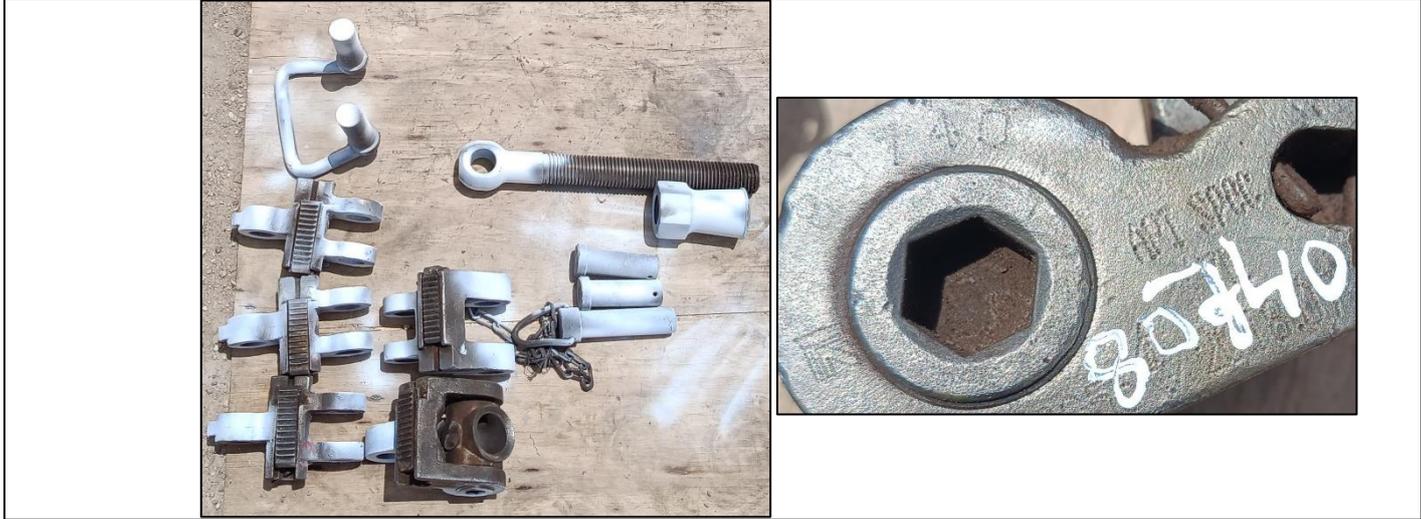
Serial Number	Description of the examined equipment	Result
80740	Safety Clamp	Pass
S/N:	80740

Visual and MPI carried out for the above description and found free of surface defects at the time of inspection

Identification of any part found to have a defect and a description of the defect: **None**

Particulars of any repair, renewal or alteration required to remedy the defect identified above: **None**
