Customer:	Hilong Oil Services & Engineering	Date Of Service:	16-05-2024
Type Of Inspection:	CAT III INSPECTION	Report No:	ATS-05-24-3200-SC-003
Rig & Rig Number:	RIG-099	Specification:	API RP 8C

The Rig Was Equipped with JIANGSU RUTONG PETRO-MACHINERY CO. Safety Clamp, with The Following Specification:

Equipment:	Safety Clamp – 61/2” - 7 5/8”
Model/SN:	80762
Date of Manufacture:	-
Manufacturer:	JIANGSU RUTONG PETRO-MACHINERY
Reference Standard:	API RP 8C
Next Examination Date:	After 6 months

## Visual & Magnetic Particles Examination Report

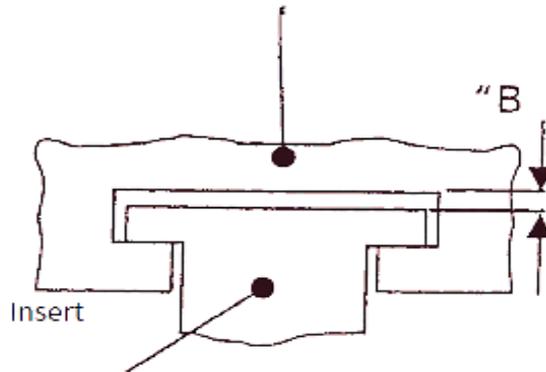
Measurement	Nominal	Tolerance	Actual Reading	Result
Insert Carrier - Insert Clearance No. 01 B	-	1.6	0.645	Accepted
Insert Carrier - Insert Clearance No. 02 B	-	1.6	0.630	Accepted
Insert Carrier - Insert Clearance No. 03 B	-	1.6	0.633	Accepted
Insert Carrier - Insert Clearance No. 04 B	-	1.6	0.630	Accepted
Insert Carrier - Insert Clearance No. 05 B	-	1.6	0.634	Accepted
Insert Carrier - Insert Clearance No. 06 B	-	1.6	0.639	Accepted
Insert Carrier - Insert Clearance No. 07 B	-	1.6	0.630	Accepted

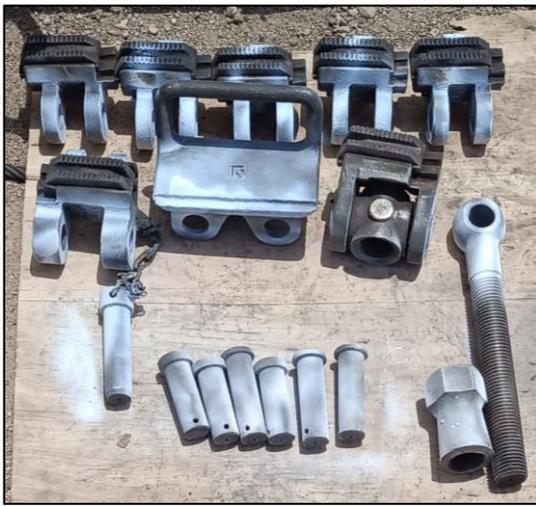
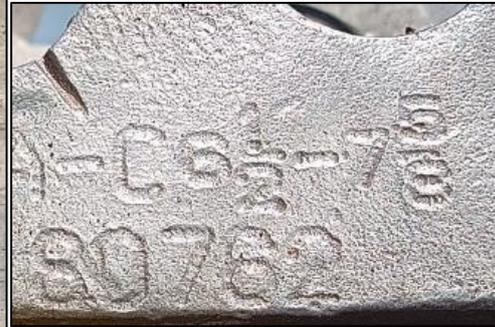
Serial Number	Description of the examined equipment	Result
80762	Safety Clamp – 61/2” – 7 5/8”	Pass
S/N:	80762

Visual and MPI carried out for the above description and found free of surface defects at the time of inspection

Identification of any part found to have a defect and a description of the defect: **None**

Particulars of any repair, renewal or alteration required to remedy the defect identified above: **None**
