| Type Of Inspection: | CAT III INSPECTION | Report No: | ATS-05-24-3200-STE-001 |
| Rig & Rig Number: | RIG-99 | Specification: | API RP 8C |

| Equipment: | Slip Type Elevator, 3 1/2 YT-75 |

## Visual & Magnetic Particles Examination Report

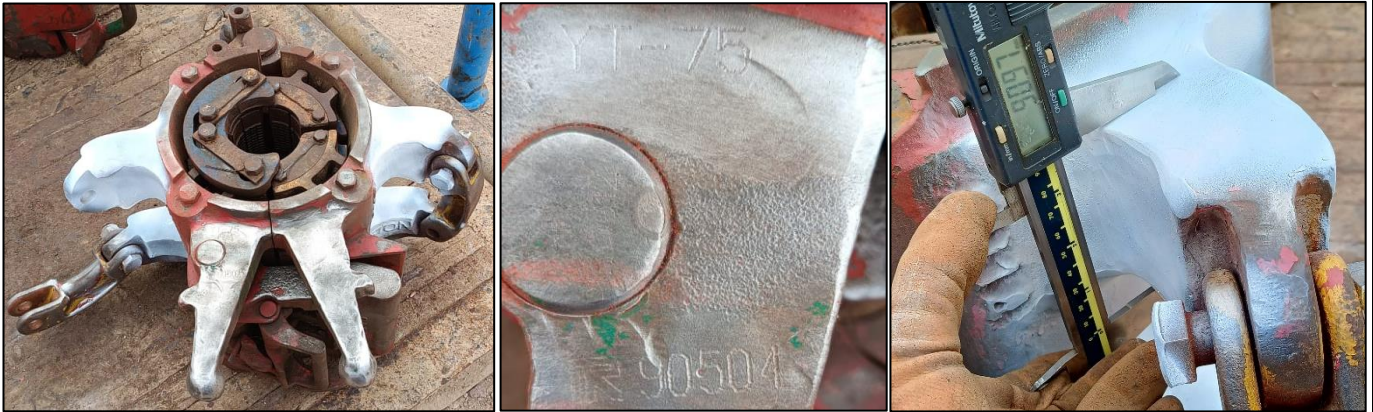
| Serial Number | Description of the examined equipment | Result |
|---|---|---|
| S/N: | 90504 | |

Visual and MPI carried out for the above description and found free of surface defects at the time of inspection

Identification of any part found to have a defect and a description of the defect: **None**

Particulars of any repair, renewal or alteration required to remedy the defect identified above: **None**
