Customer:	Hilong Oil Services & Engineering	Date Of Service:	15-05-2024
Type Of Inspection:	CAT III INSPECTION	Report No:	ATS-05-24-3200-STE-002
Rig & Rig Number:	RIG-99	Specification:	API RP 8C

Equipment:	Slip Type Elevator, 3 1/2 YT-75
SN:	90501
Date of Manufacture:	-
Manufacturer/ Model:	JIANGSU RUTONG PETRO-MACHINERY
Reference Standard:	API RP 8C
Next Examination Date:	After 6 Months

## Visual & Magnetic Particles Examination Report

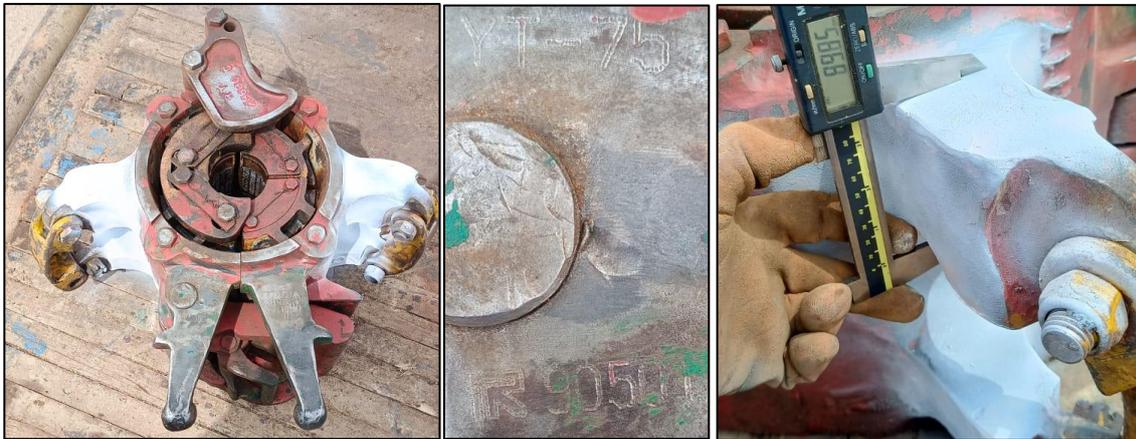
Serial Number	Description of the examined equipment	Result
90501	Slip Type Elevator, 3 1/2 , YT-75	Pass
S/N:	90501

Visual and MPI carried out for the above description and found free of surface defects at the time of inspection

Identification of any part found to have a defect and a description of the defect: **None**
