Customer:	Hilong Oil Services & Engineering	Date Of Service:	15-05-2024
Type Of Inspection:	CAT III INSPECTION	Report No:	ATS-05-24-3200-STE-003
Rig & Rig Number:	RIG-99	Specification:	API RP 8C

The Rig Was Equipped with JIANGSU RUTONG PETRO-MACHINERY CO. Slip Type Elevator, with The Following Specification:

Equipment:	Slip Type Elevator, 200 tons, 4 ½ , HYC-200
SN:	41903001-19
Date of Manufacture:	01-19
Manufacturer/ Model:	JIANGSU RUTONG PETRO-MACHINERY
Reference Standard:	API RP 8C
Next Examination Date:	After 6 Months

## Visual & Magnetic Particles Examination Report

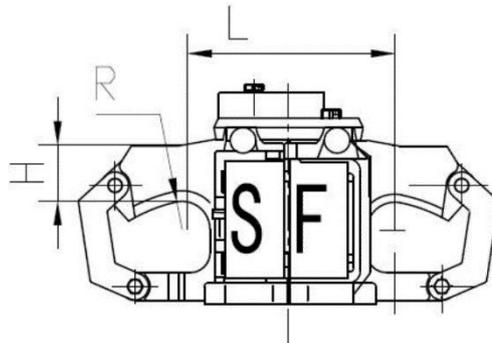
OREINTATION	DESCRIPTION	VALUES	OEM VALUES	RESULT
RIGHT	The maximum allowable wear tolerance of (D)	104 mm	99 mm	Accepted
	The center distance "L" between the arms	562 mm	562 mm	Accepted
	The designed value for radius "R" at the force point	55 mm	55 mm	Accepted
LEFT	The maximum allowable wear tolerance of (D)	104 mm	99 mm	Accepted
	The center distance "L" between the arms	562 mm	562 mm	Accepted
	The designed value for radius "R" at the force point	55 mm	55 mm	Accepted

\*\* Visual And MPI Was Carried out on the critical areas and load bearing components of the elevator and Found **Satisfactory for Further Use**.

\*\* CAT III Inspection Was Carried Out on the Elevator and Found **Accepted** At The Time of Inspection

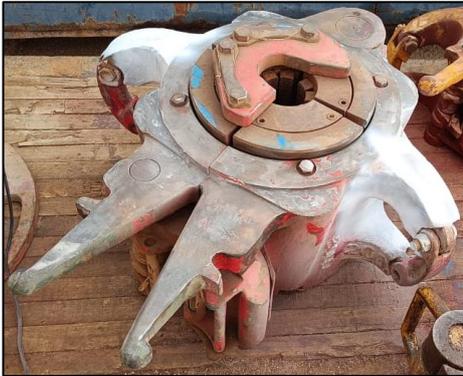
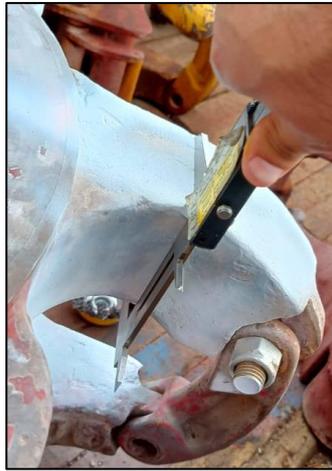
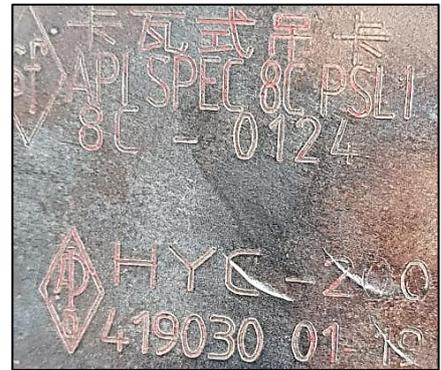
Description of the examined equipment	Result
41903001-19	Slip Type Elevator, 4 1/2, HYC-200	Pass
S/N:	41903001-19

Visual and MPI carried out for the above description and found free of surface defects at the time of inspection

Identification of any part found to have a defect and a description of the defect: **None**

Particulars of any repair, renewal or alteration required to remedy the defect identified above: **None**
