Customer:	Hilong Oil Services & Engineering	Date Of Service:	23-06-2024
Type Of Inspection:	CAT III INSPECTION	Report No:	ATS-06-24-3466-TB-001
Rig & Rig Number:	RIG-100	Specification:	API RP 8B

The Rig Was Equipped with SJ PETRO-MACHINERY GROUP CO.LTD Travelling Block, with The Following Specification:

Equipment:	Travelling Block
Model:	YC180
S/N:	180702
Marker & Date of Manufacture:	07-2018
Ref Standard:	API RP 8B
Inspection Frequency:	Every 06 Months

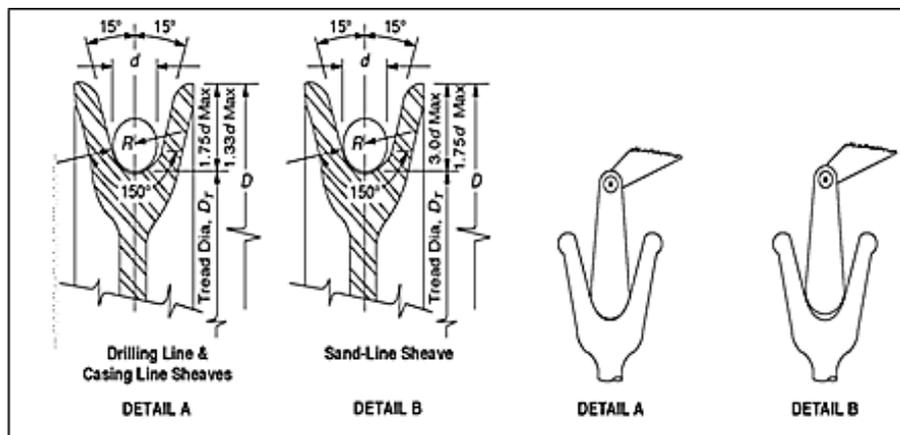
***Travelling block Sheaves - Groove Depth Measurements**

Sheaves No:	Nominal Wire Rope Dim:	Actual Depth:	Max Allowable Groove Depth =1.75 d	Min Allowable Groove Depth =1.33 d	Remarks/Results
1	29	45.50	50.75	38.57	Accepted
2	29	45.60	50.75	38.57	Accepted
3	29	45.55	50.75	38.57	Accepted
4	29	45.65	50.75	38.57	Accepted
5	29	45.60	50.75	38.57	Accepted

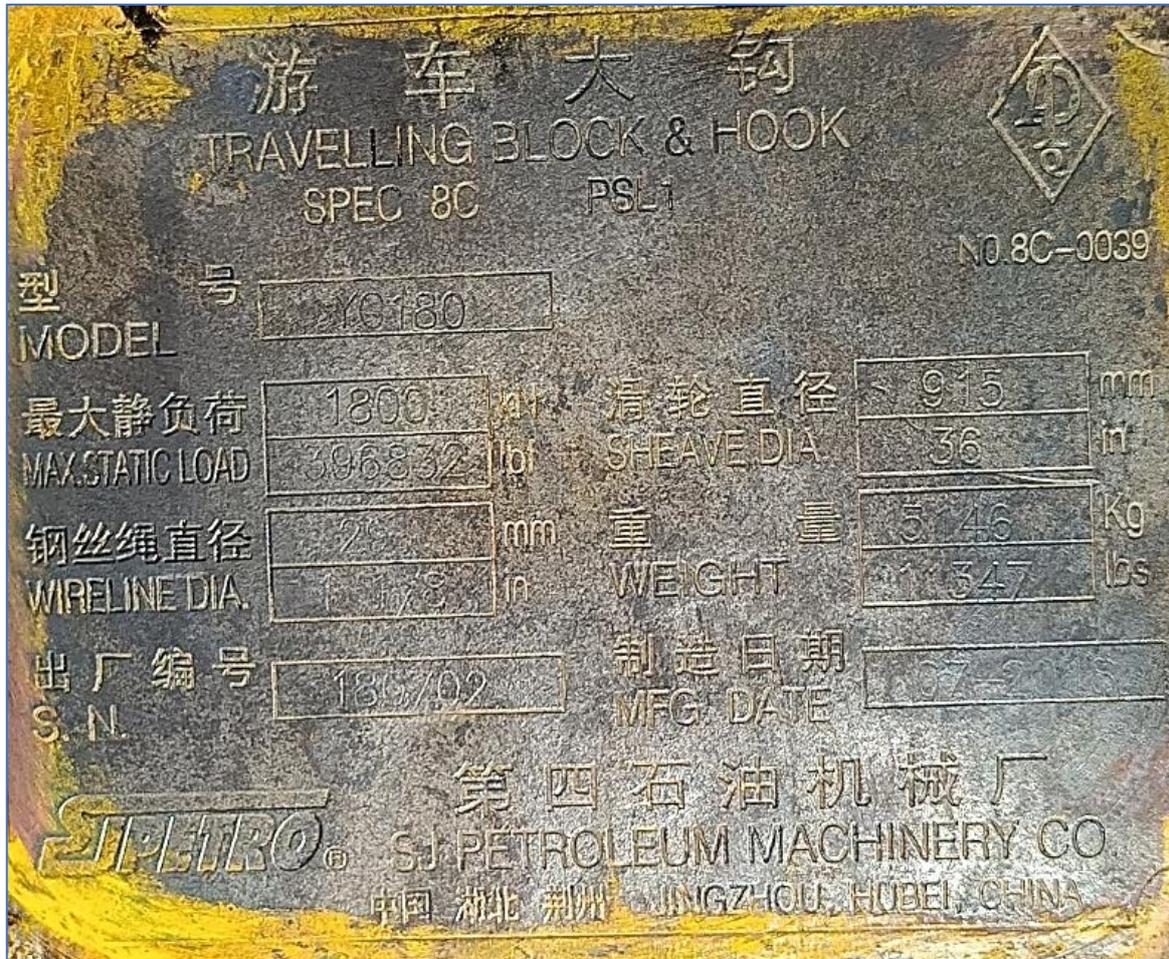
PICTORIAL

** Visual and MPI Was Carried Out on the Available Critical & Welding Areas of the Travelling Block and Found **Satisfactory for Further Use.**

** CAT III Inspection Was Carried Out on Travelling Block and Found **Accepted** at The Time of Inspection.

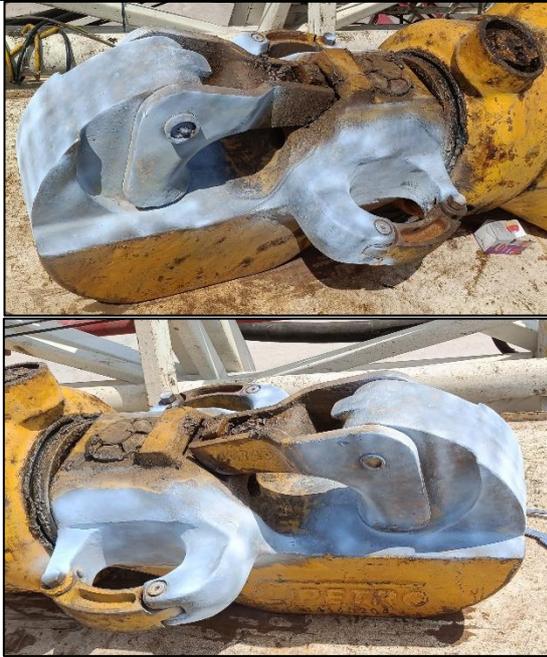
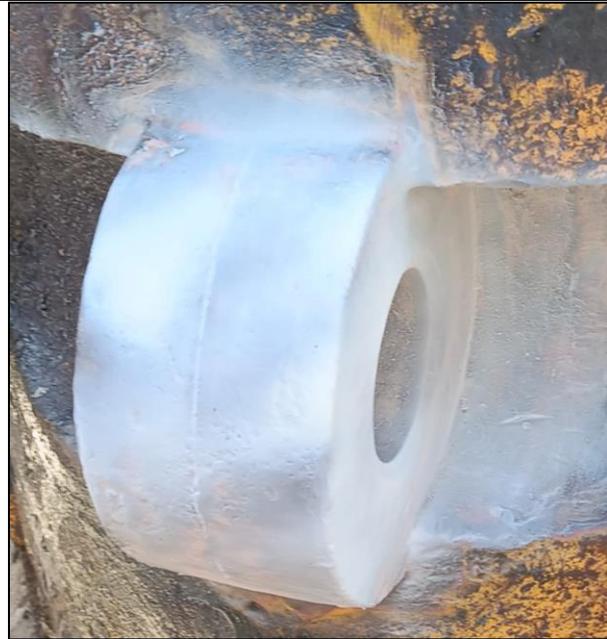
Serial Number	Description of the examined equipment	Result
180702	Travelling block	Pass
S/N:	-

Visual and MPI carried out for the above-mentioned items and found free of surface defects at the time of inspection

Identification of any part found to have a defect and a description of the defect: **None**

Particulars of any repair, renewal or alteration required to remedy the defect identified above: **None**
