Customer:	Hilong Oil Services & Engineering	Date Of Service:	16-July-2024
Type Of Inspection:	CAT III INSPECTION	Report No:	ATS-07-24-4007-008
Rig & Rig Number:	RIG-99	Specification:	API spec 7K

Equipment:	Master Bushing
Model/SN:	ZP275 / BL180803
Date of Manufacture:	-
Manufacturer:	Zhengzhou Baolai Machinery Manufacturing CO
Reference Standard:	API RP 7K

## Visual & Magnetic Particles Examination Report

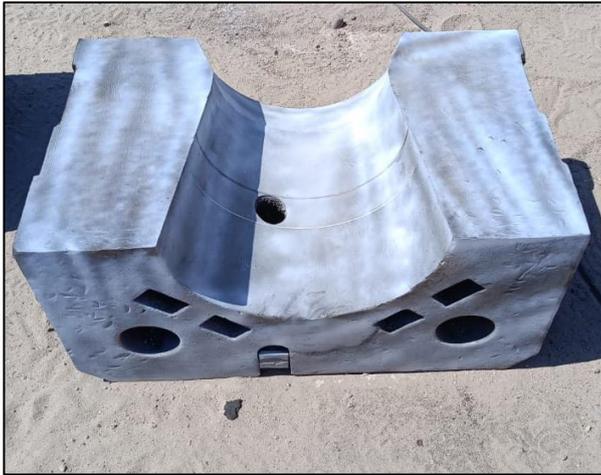
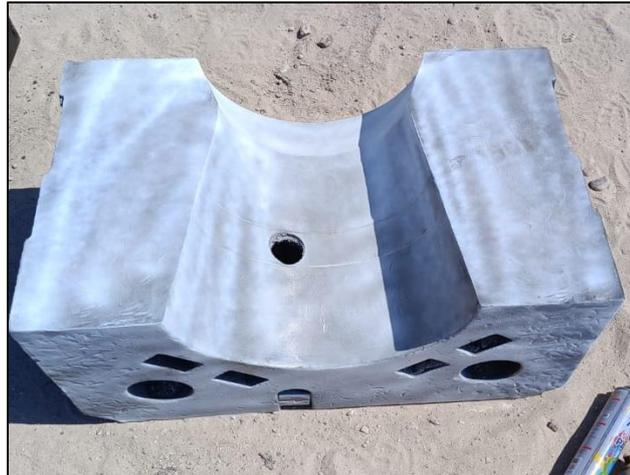
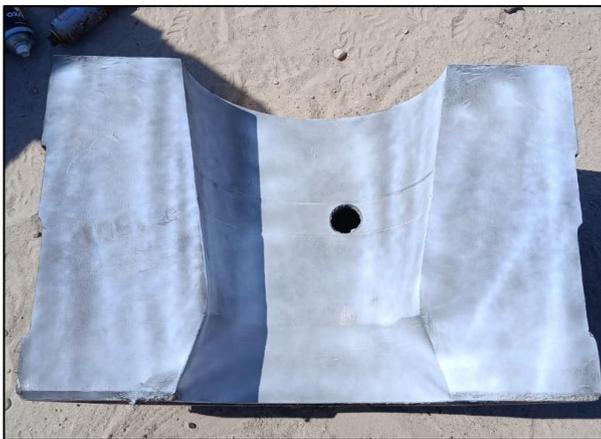
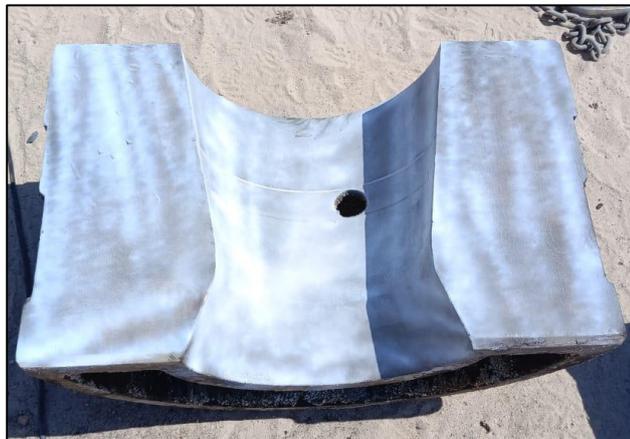
PICTORIAL:

\*\* Visual And MPI Was Carried out on The Critical Areas Of The master bushing and Found **Satisfactory for Further Use.**

\*\* CAT III Inspection Was Carried Out on the master bushing and Found **Accepted** At The Time of Inspection.

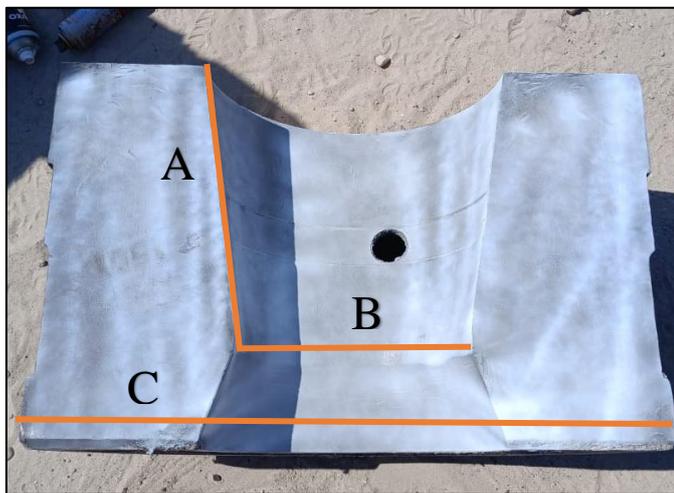
Description:	OEM	Actual Value (mm)	Result
Length of taper (A):	324 new (15mm tolerance)	319	accept
Inside diameter of throat(B):	257.18 new (5mm tolerance)	260	accept
Outside diameter(C):	New 696.913 (5mm tolerance)	695	accept
