# ABERDEEN TECHNICAL SERVICES AND GENERAL TRANSPORTATION

## PNEUMATIC SLIP- CAT IV INSPECTION REPORT

| Type Of Inspection: | CAT IV INSPECTION | Report No: | ATS-08-24-4132-PS-014 |

| Equipment: | Pneumatic air Slip (spider), 125 TONS , CHD |

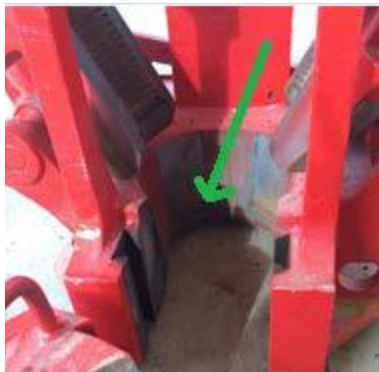
| DESCRIPTION | VALUES | OEM VALUES | RESULT |
| The allowable Maximum wear on the taper of both the inner cone and the outer cone | 0.00 | 1.6 | Accepted |

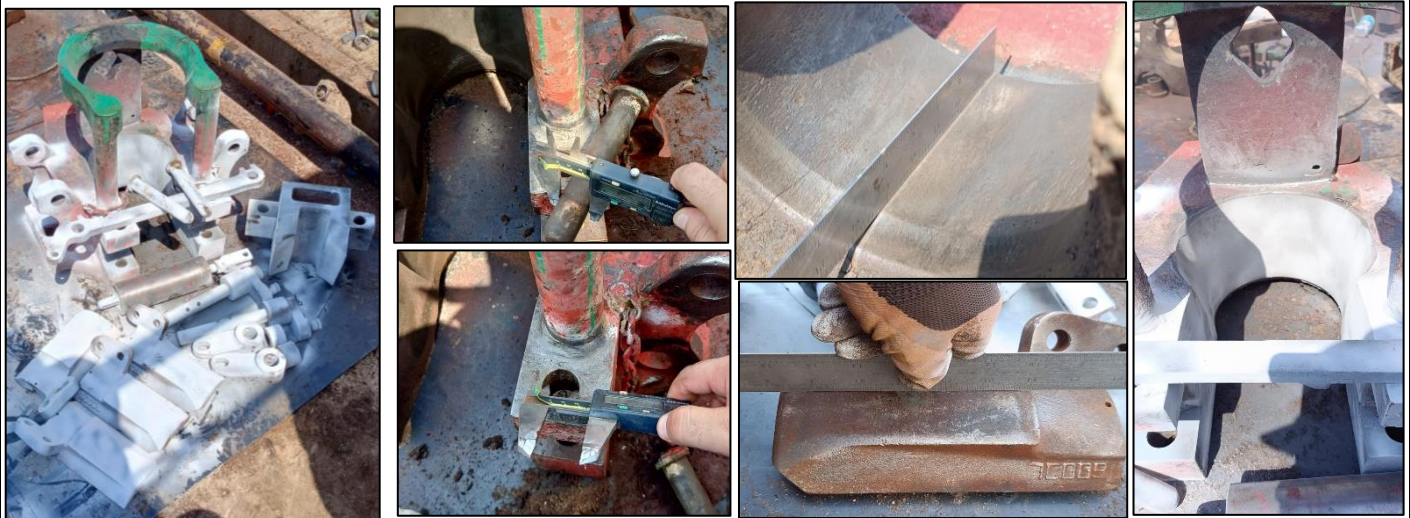
Visual and MPI carried out for the above description and found free of surface defects at the time of inspection

Identification of any part found to have a defect and a description of the defect: **None**

Particulars of any repair, renewal or alteration required to remedy the defect identified above: **None**

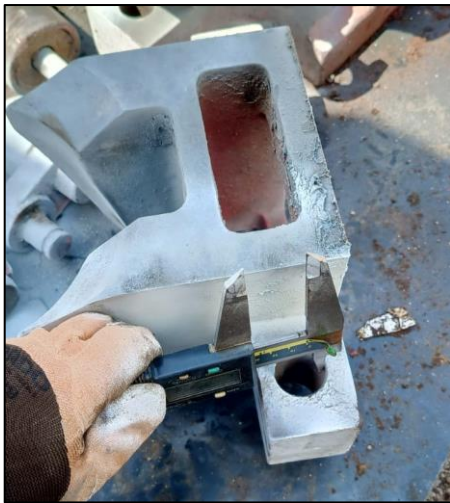
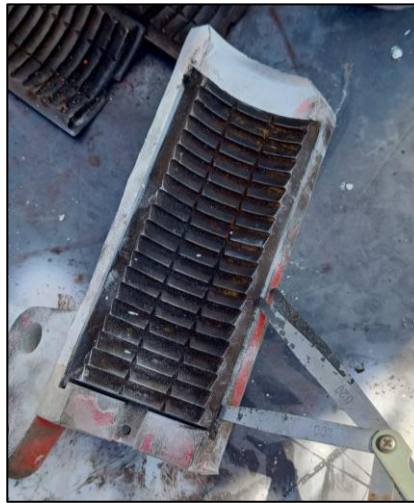
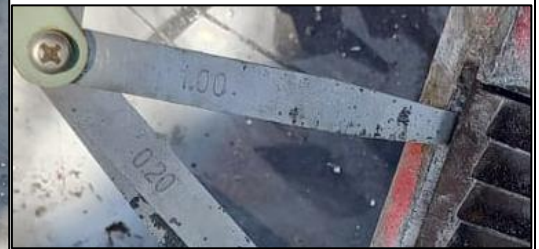
Visual and MPI carried out for the above description and found free of surface defects at the time of inspection

Identification of any part found to have a defect and a description of the defect: **None**

Particulars of any repair, renewal or alteration required to remedy the defect identified above: **None**
