Customer:	Hilong Oil Services & Engineering	Date Of Service:	07-08-2024
Type Of Inspection:	CAT IV INSPECTION	Report No:	ATS-08-24-4132-PS-015
Rig & Rig Number:	RIG-100	Specification:	API RP 8B

The Rig Was Equipped with JIANGSU RUTONG PETRO-MACHINERY CO. Pneumatic Slip, with The Following Specification:

Equipment:	Pneumatic air Slip (spider), 125 TONS , CHD
SN:	80801
Date of Manufacture:	-
Manufacturer/Model:	JIANGSU RUTONG PETRO-MACHINERY CO / CHD
Reference Standard:	API RP 8B
Next Examination Date:	After 01 Year

## Visual & Magnetic Particles Examination Report

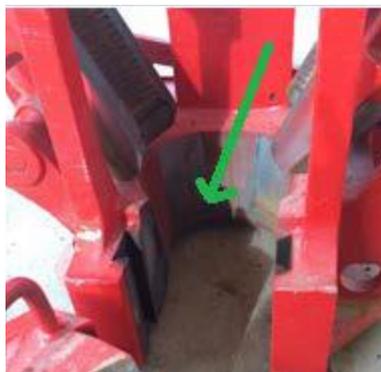
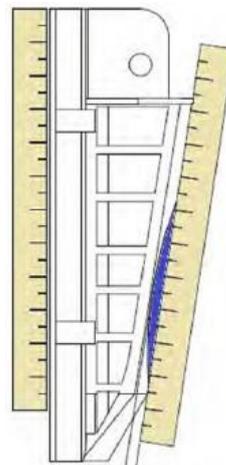
DESCRIPTION	VALUES	OEM VALUES	RESULT
The allowable Maximum wear on the taper of both the inner cone and the outer cone	<b>0.00</b>	<b>1.6</b>	<b>Accepted</b>

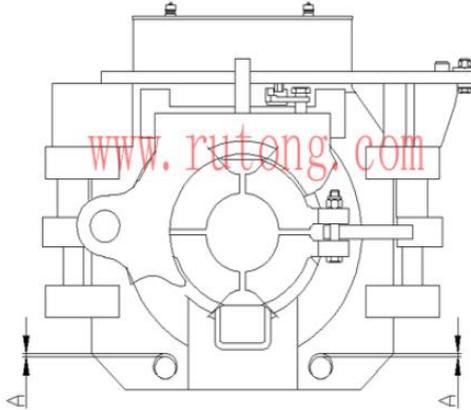
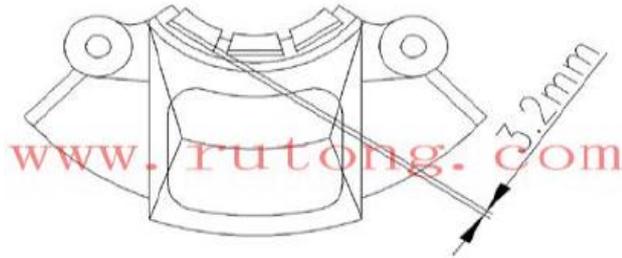
Measurement	Nominal	Tolerance	Actual Reading	Result
Pin OD No. 01	28	1.14	27.50	Accepted
Hole ID No. 01	28.09		28.40	
Clearance A: No. 01	0.09		0.9	
Pin OD No. 02	28	1.14	27.25	Accepted
Hole ID No. 02	28.09		28.15	
Clearance A: No. 02	0.09		0.9

Measurement	Tolerance	Actual Reading	Result
(Insert Groove 1 - Insert) Clearance No. 01	3.2	1.00	Accepted
(Insert Groove 2 - Insert) Clearance No. 01	3.2	1.00	Accepted
(Insert Groove 3 - Insert) Clearance No. 01	3.2	1.00	Accepted
(Insert Groove 1 - Insert) Clearance No. 02	3.2	1.00	Accepted
(Insert Groove 2 - Insert) Clearance No. 02	3.2	1.00	Accepted
(Insert Groove 3 - Insert) Clearance No. 02	3.2	1.00	Accepted
(Insert Groove 1 - Insert) Clearance No. 03	3.2	1.00	Accepted
(Insert Groove 2 - Insert) Clearance No. 03	3.2	1.00	Accepted
(Insert Groove 3 - Insert) Clearance No. 03	3.2	1.00	Accepted
(Insert Groove 1 - Insert) Clearance No. 04	3.2	1.00	Accepted
(Insert Groove 2 - Insert) Clearance No. 04	3.2	1.00	Accepted
(Insert Groove 3 - Insert) Clearance No. 04	3.2	1.00	Accepted

\*\* Visual And MPI Was Carried out on the critical areas and load bearing components of the slip and Found **Satisfactory for Further Use**.

\*\* CAT IV Inspection Was Carried Out on the slip and Found **Accepted**

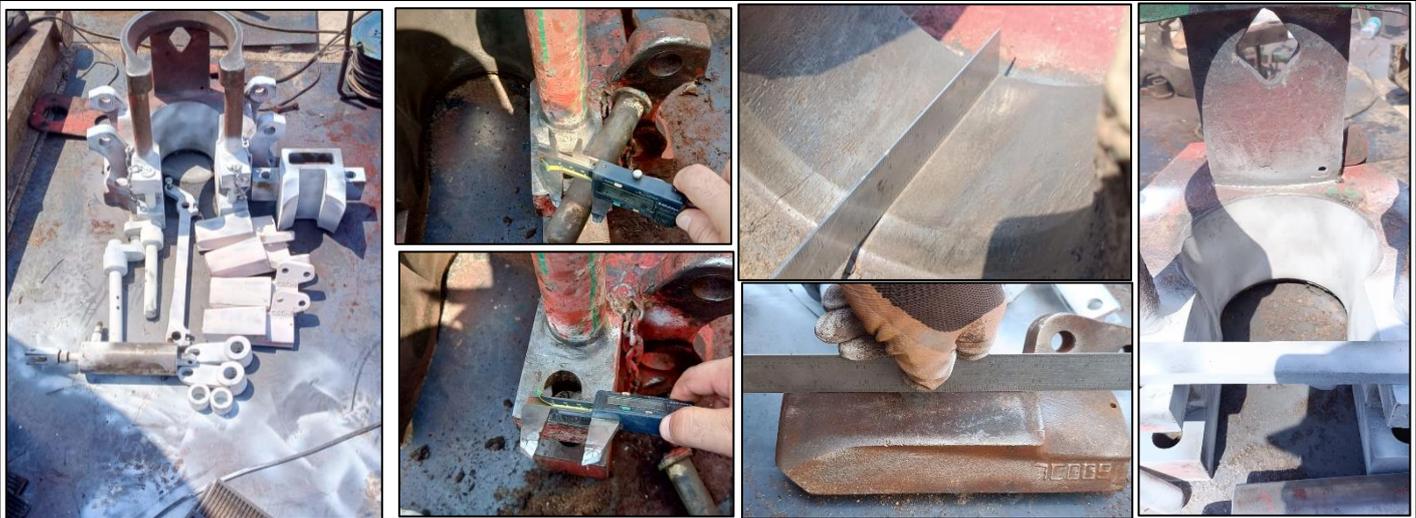
Visual and MPI carried out for the above description and found free of surface defects at the time of inspection

Identification of any part found to have a defect and a description of the defect: **None**

Particulars of any repair, renewal or alteration required to remedy the defect identified above: **None**

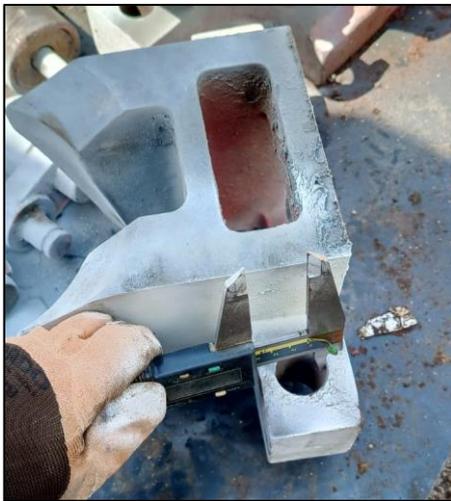
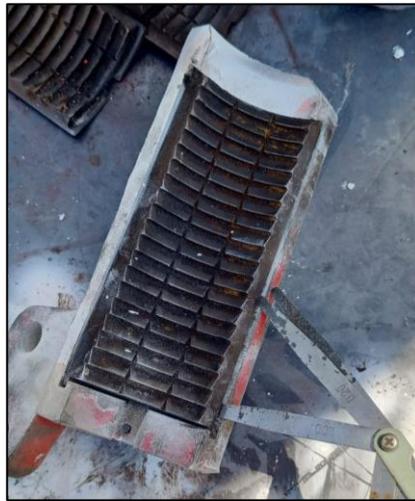
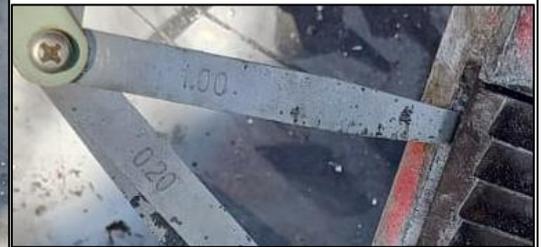
Visual and MPI carried out for the above description and found free of surface defects at the time of inspection

Identification of any part found to have a defect and a description of the defect: **None**

Particulars of any repair, renewal or alteration required to remedy the defect identified above: **None**
