| Type Of Inspection: | CAT IV INSPECTION | Report No: | ATS-08-24-4132-SL-034 |
| Rig & Rig Number: | HL - 100 | Specification: | API RP 7L |

| Equipment: | Hand Slip (Drill pipe) SDML |

## Visual & Magnetic Particles Examination Report

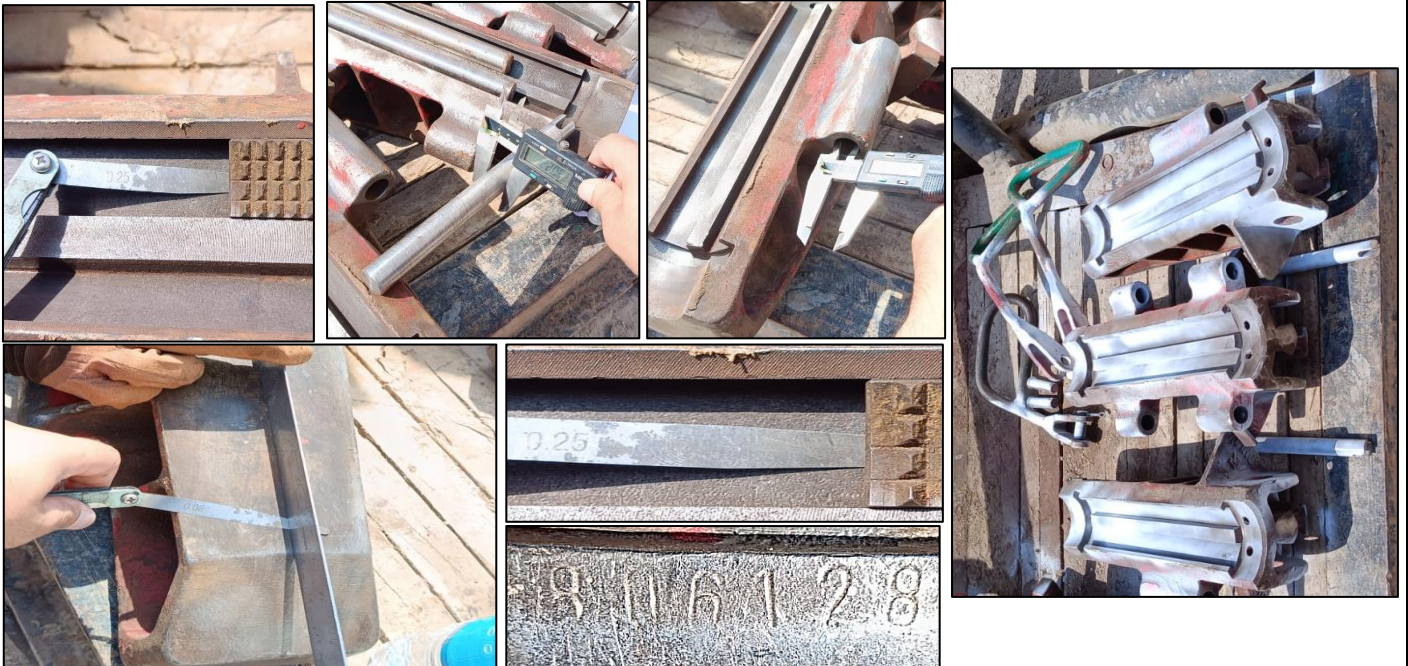
| Serial Number | Description of the examined equipment | Result |
|---|---|---|
| 806128 | Hand Slip (Drill pipe) SDML | Pass |

Visual and MPI carried out for the above description and found free of surface defects at the time of inspection

Identification of any part found to have a defect and a description of the defect: **None**

Particulars of any repair, renewal or alteration required to remedy the defect identified above: **None**
