| Type Of Inspection: | CAT IV INSPECTION | Report No: | ATS-08-24-4132-SL-035 |
| Rig & Rig Number: | HL - 100 | Specification: | API RP 7L |

| Equipment: | Hand Slip (Drill pipe) SDML |
| Model/SN: | 806137 |

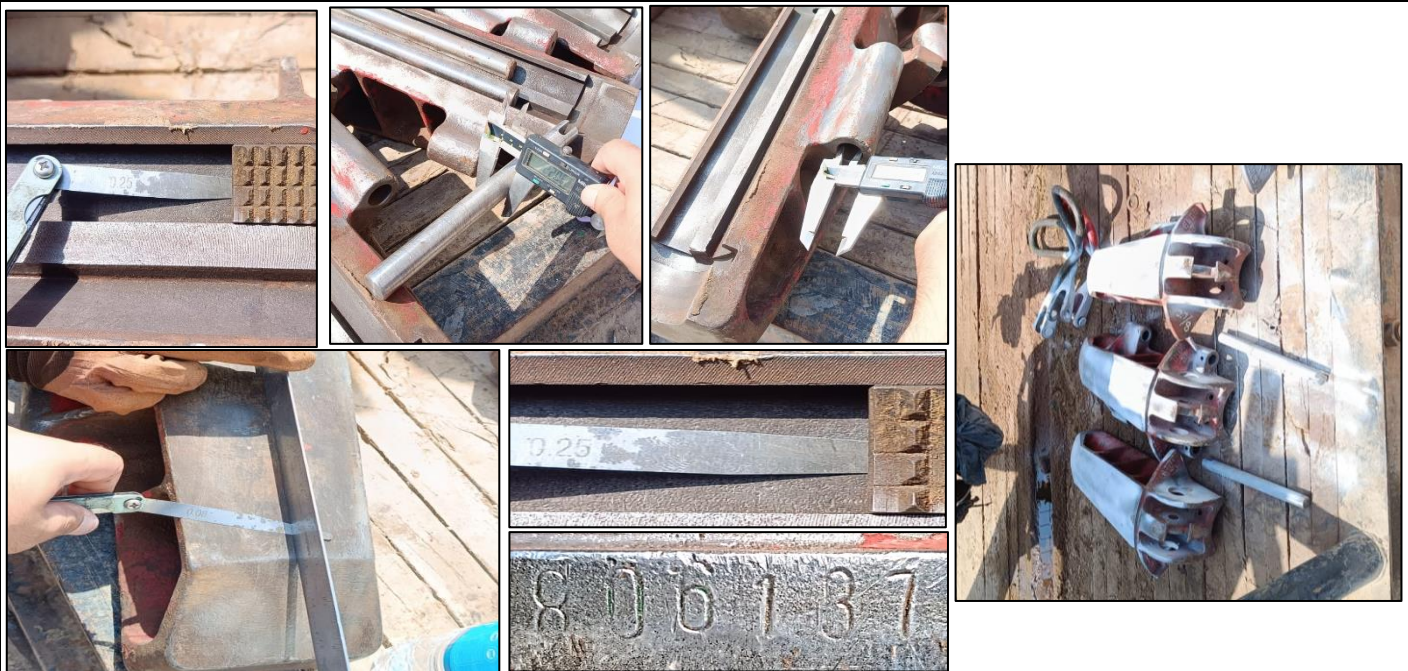
Visual and MPI carried out for the above description and found free of surface defects at the time of inspection

Identification of any part found to have a defect and a description of the defect: **None**

Particulars of any repair, renewal or alteration required to remedy the defect identified above: **None**
