| Type Of Inspection: | CAT IV INSPECTION | Report No: | ATS-08-24-4132-SL-036 |
| Rig & Rig Number: | HL - 100 | Specification: | API RP 7L |

| Equipment: | Hand Slip (Drill pipe) SDML |

## Visual & Magnetic Particles Examination Report

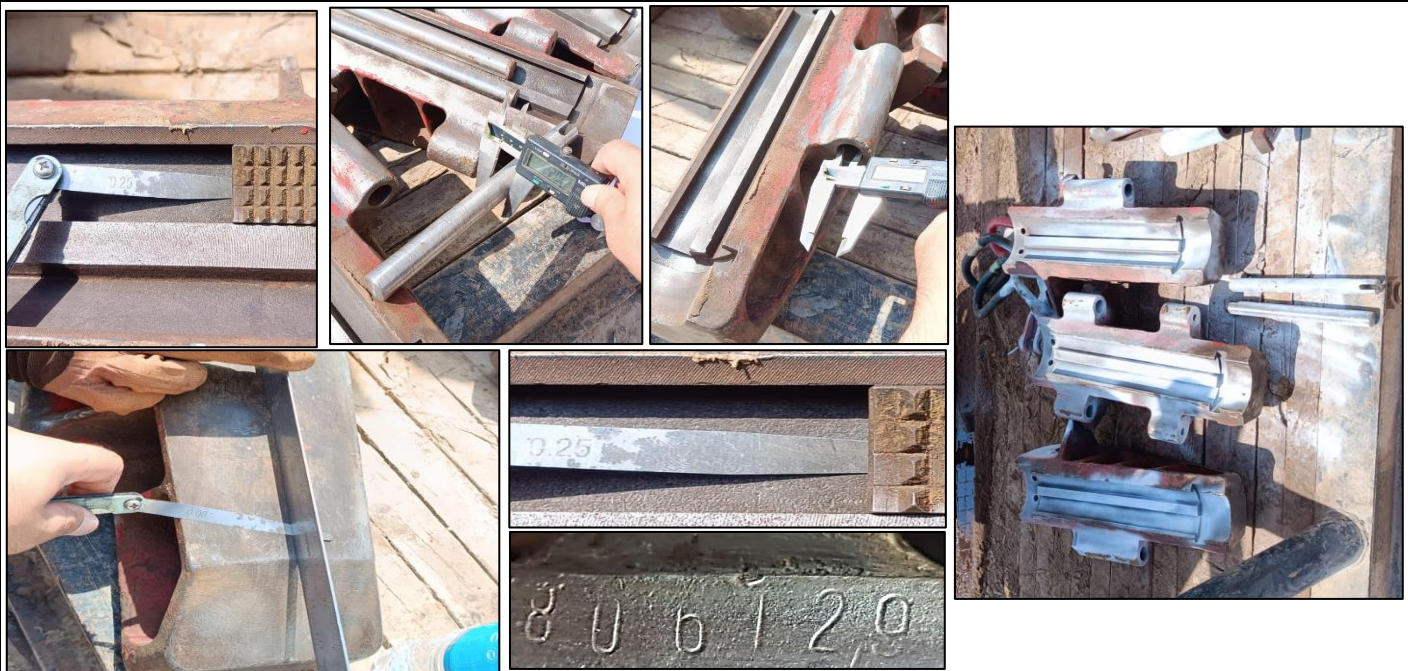
Visual and MPI carried out for the above description and found free of surface defects at the time of inspection

Identification of any part found to have a defect and a description of the defect: **None**

Particulars of any repair, renewal or alteration required to remedy the defect identified above: **None**
