| Type Of Inspection: | CAT IV INSPECTION | Report No: | ATS-08-24-4132-SL-037 |
| Rig & Rig Number: | HL - 100 | Specification: | API RP 7L |

| Equipment: | Hand Slip (Drill pipe) SDML |

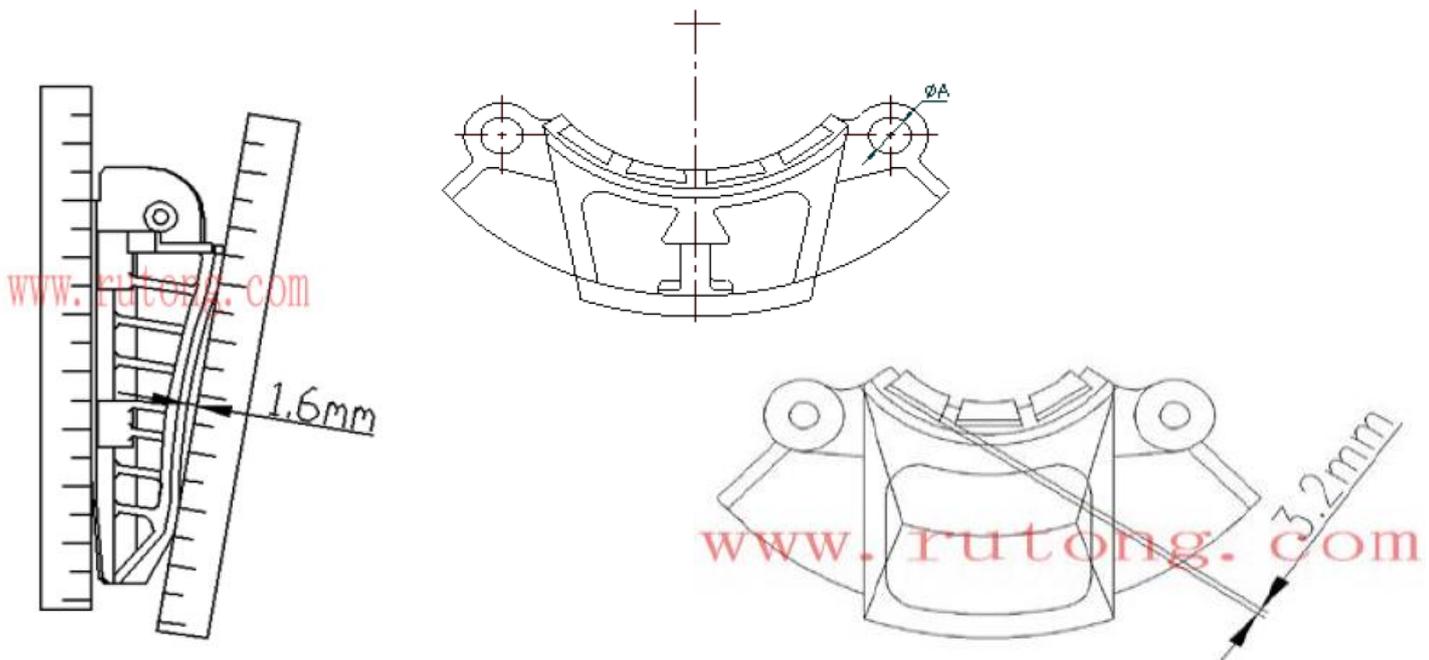
- The Slip Has Been Inspected and Found Conformable to the Relevant Standard(s)
- The Rig was equipped with ZHEJIANG ZHONGHENG INSTRUMENT AND GAUGE CO. LTD Slip.
- Slip Found Stripped Down /Dismantling Condition for CAT IV Inspection.

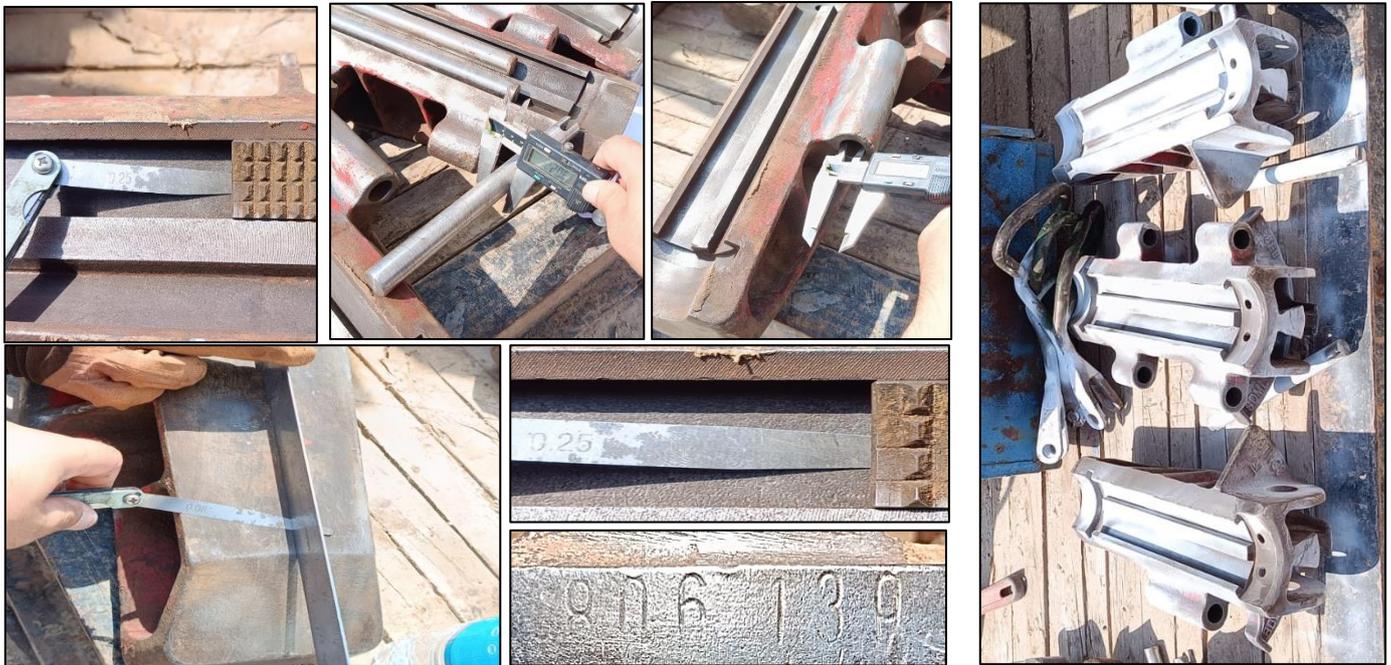
Visual and MPI carried out for the above description and found free of surface defects at the time of inspection

Identification of any part found to have a defect and a description of the defect: **None**

Particulars of any repair, renewal or alteration required to remedy the defect identified above: **None**
