Customer:	Hilong Oil Services & Engineering	Date Of Service:	10-08-2024
Type Of Inspection:	CAT IV INSPECTION	Report No:	ATS-08-24-4132-SL-038
Rig & Rig Number:	HL - 100	Specification:	API RP 7L

The Rig Was Equipped with SJ PETROUM MACHINERY CO. Hand Slip, with The Following Specification:

Equipment:	Hand Slip (Drill pipe) SDML
Model/SN:	806130
Date of Manufacture:	-
Manufacturer:	JIANGSU RUTONG PTERO-MACHINERY CO
Reference Standard:	API RP 7L
Next Examination Date:	After 1 Year

Visual & Magnetic Particles Examination Report

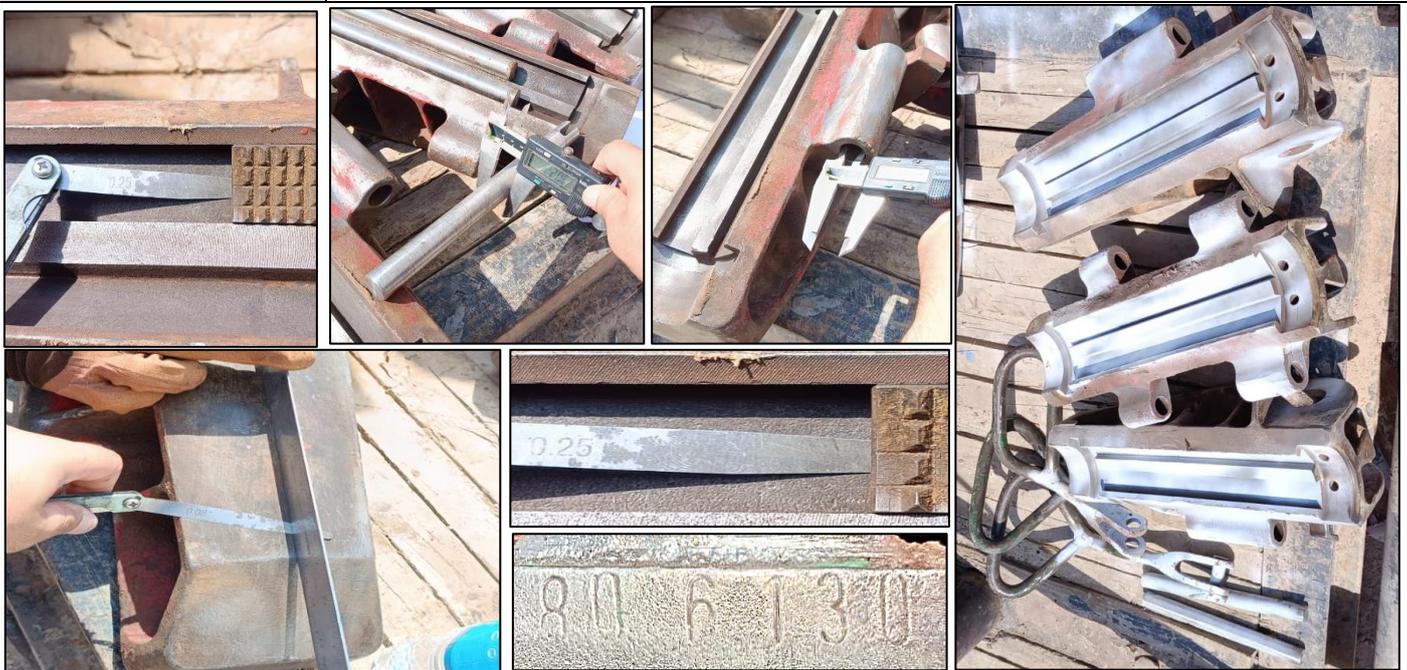
Serial Number	Description of the examined equipment	Result
806130	Hand Slip (Drill pipe) SDML	Pass
S/N:	-

Visual and MPI carried out for the above description and found free of surface defects at the time of inspection

Identification of any part found to have a defect and a description of the defect: **None**

Particulars of any repair, renewal or alteration required to remedy the defect identified above: **None**
