Customer:	Hilong Oil Services & Engineering	Date Of Service:	14-08-2024
Type Of Inspection:	CAT IV INSPECTION	Report No:	ATS-08-24-4195-SL-001
Rig & Rig Number:	HL - 99	Specification:	API RP 7L

Equipment:	Hand Slip (Drill collar) DCS-S
Model/SN:	807086
Date of Manufacture:	-
Manufacturer:	JIANGSU RUTONG PTERO-MACHINERY CO
Reference Standard:	API RP 7L
Next Examination Date:	After 1 Year

Visual & Magnetic Particles Examination Report

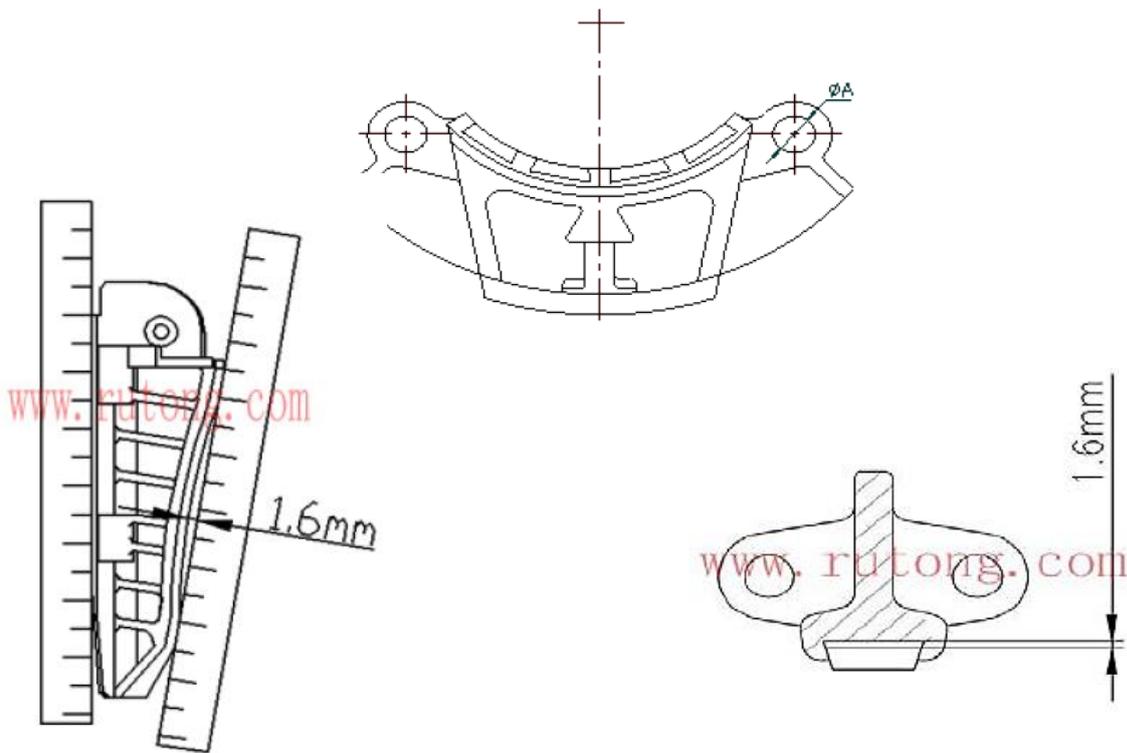
- The Slip Has Been Inspected and Found Conformable to the Relevant Standard(s)
- The Rig was equipped with ZHEJIANG ZHONGHENG INSTRUMENT AND GAUGE CO. LTD Slip.
- Slip Found Stripped Down /Dismantling Condition for CAT IV Inspection.

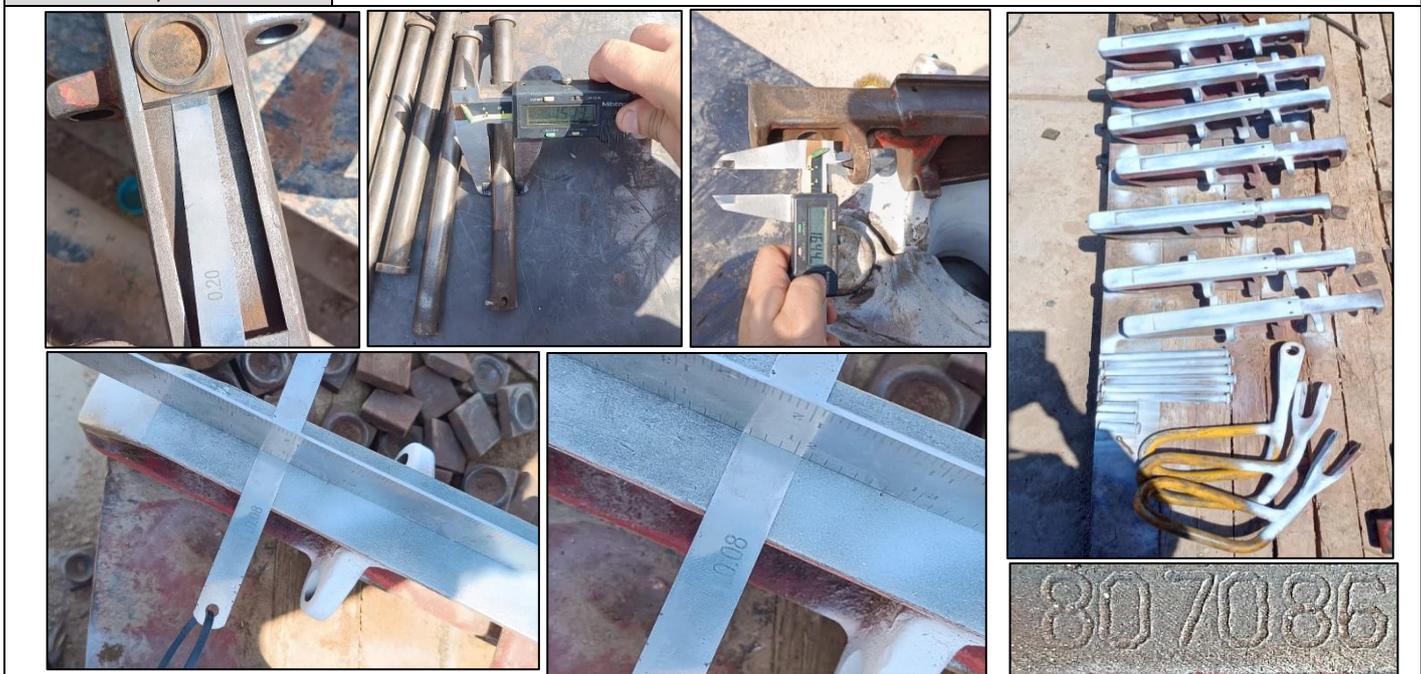
Serial Number	Description of the examined equipment	Result
807086	Hand Slip (Drill collar) DCS-S	Pass
S/N:	-

Visual and MPI carried out for the above description and found free of surface defects at the time of inspection
