Customer:	Hilong Oil Services & Engineering	Date Of Service:	14-08-2024
Type Of Inspection:	CAT IV INSPECTION	Report No:	ATS-08-24-4195-SL-002
Rig & Rig Number:	HL - 99	Specification:	API RP 7L

The Rig Was Equipped with SJ PETROUM MACHINERY CO. Hand Slip, with The Following Specification:

Equipment:	Hand Slip (Drill collar) DCS-S
Model/SN:	807085
Date of Manufacture:	-
Manufacturer:	JIANGSU RUTONG PTERO-MACHINERY CO
Reference Standard:	API RP 7L
Next Examination Date:	After 1 Year

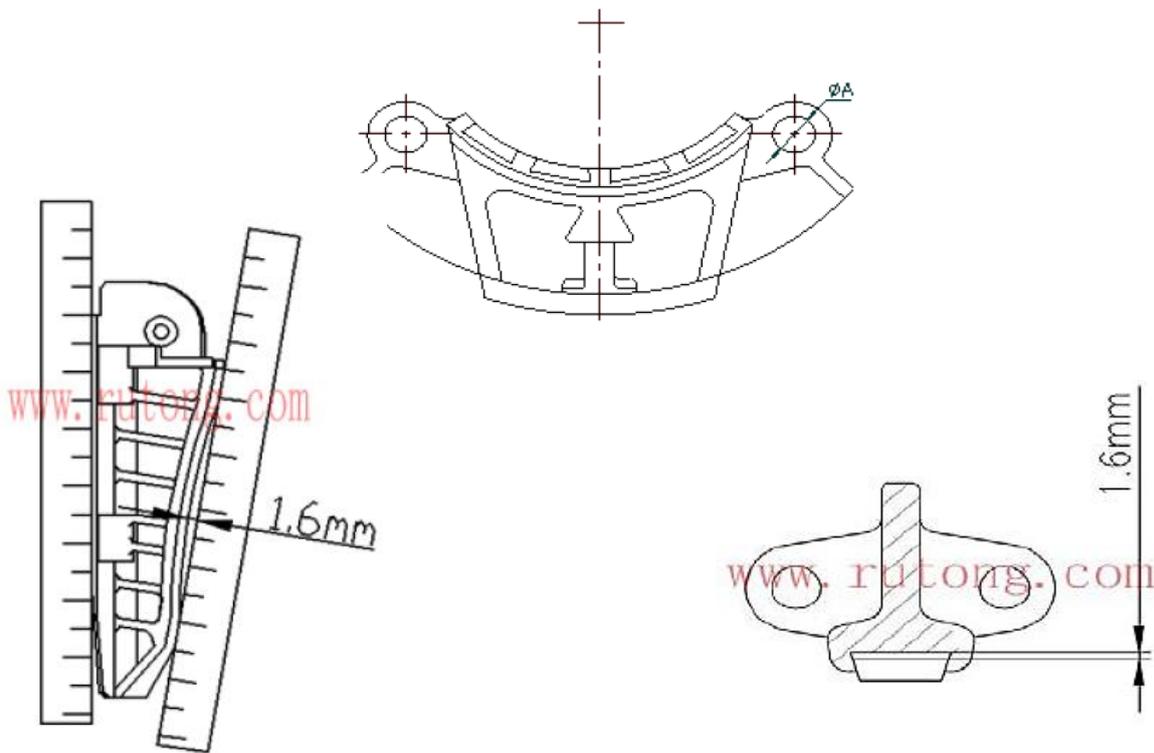
• Visually check after Reassembly	Pass
• Repaint the slip	Pass
• Prepare and submit the inspection report.	Pass

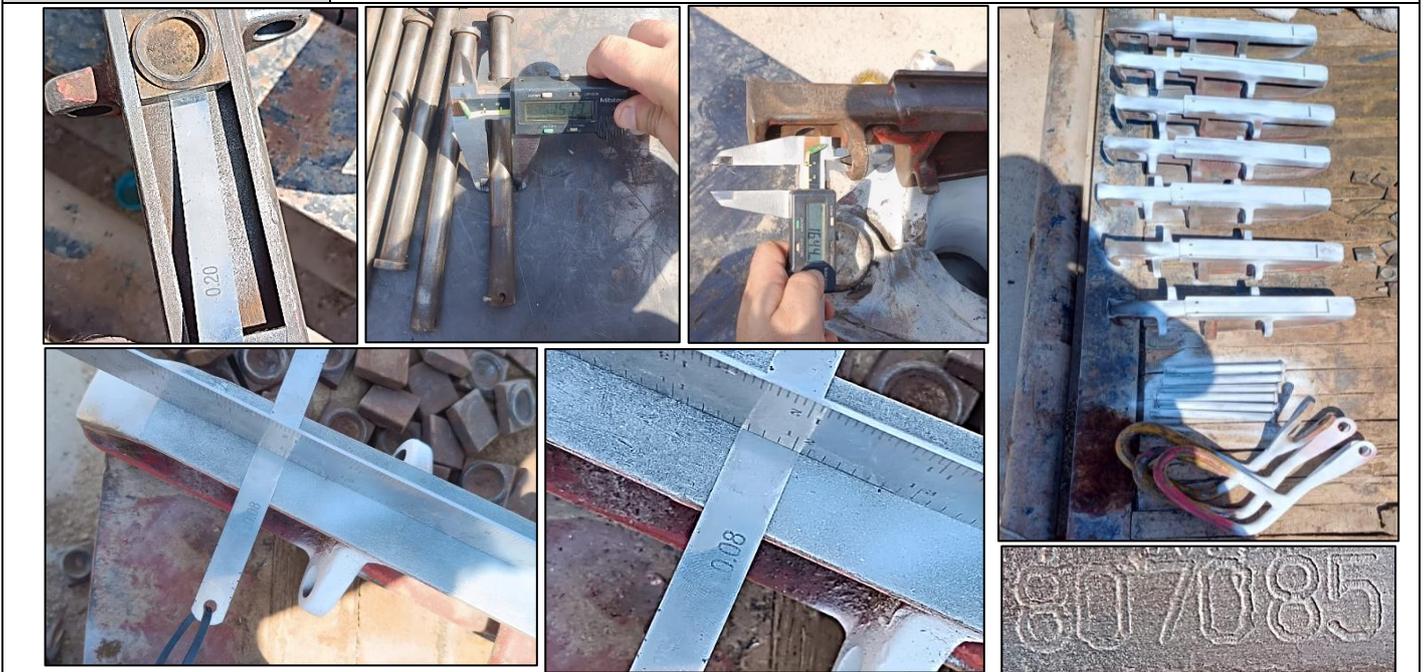
Serial Number	Description of the examined equipment	Result
807085	Hand Slip (Drill collar) DCS-S	Pass
S/N:	-	-

Visual and MPI carried out for the above description and found free of surface defects at the time of inspection

Identification of any part found to have a defect and a description of the defect: **None**

Particulars of any repair, renewal or alteration required to remedy the defect identified above: **None**
