Customer:	Hilong Oil Services & Engineering	Date Of Service:	14-08-2024
Type Of Inspection:	CAT IV INSPECTION	Report No:	ATS-08-24-4195-SL-005
Rig & Rig Number:	HL - 99	Specification:	API RP 7L

The Rig Was Equipped with SJ PETROUM MACHINERY CO. Hand Slip, with The Following Specification:

Equipment:	Hand Slip (Drill pipe) SDML
Model/SN:	808062
Date of Manufacture:	-
Manufacturer:	JIANGSU RUTONG PTERO-MACHINERY CO
Reference Standard:	API RP 7L
Next Examination Date:	After 1 Year

Visual & Magnetic Particles Examination Report

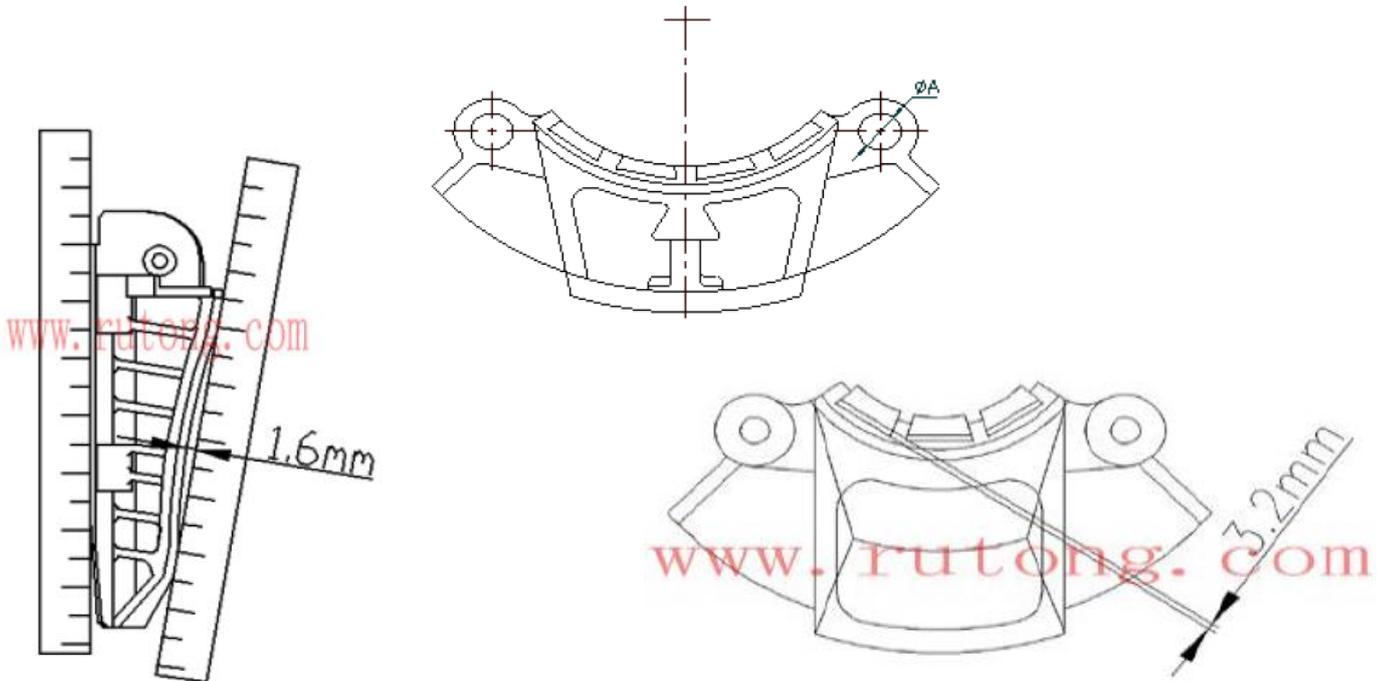
- The Slip Has Been Inspected and Found Conformable to the Relevant Standard(s)
- The Rig was equipped with ZHEJIANG ZHONGHENG INSTRUMENT AND GAUGE CO. LTD Slip.
- Slip Found Stripped Down /Dismantling Condition for CAT IV Inspection.

• Visually check after Reassembly	Pass
• Repaint the slip	Pass
• Prepare and submit the inspection report.	Pass

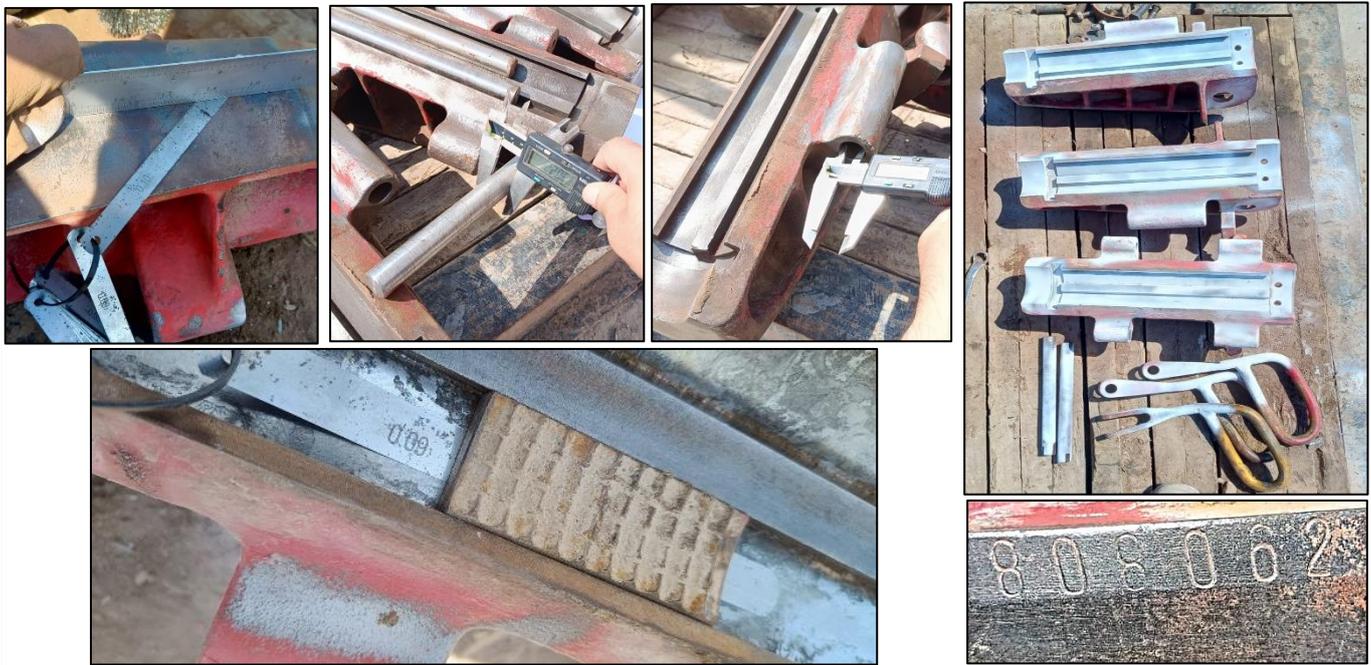
Serial Number	Description of the examined equipment	Result
808062	Hand Slip (Drill pipe) SDML	Pass
S/N:	-

Visual and MPI carried out for the above description and found free of surface defects at the time of inspection

Identification of any part found to have a defect and a description of the defect: **None**

Particulars of any repair, renewal or alteration required to remedy the defect identified above: **None**
