Customer:	Hilong Oil Services & Engineering	Date Of Service:	22-09-2024
Type Of Inspection:	CAT III INSPECTION	Report No:	ATS-09-24-4307-DWB-001
Location & Rig Number:	R026 / RIG: HL-100	Specification:	API RP 7L

The Rig Was Equipped with “BEIJING GOLD BASIN PETROLEUM TECHNOLOGY CO., LTD” Drawworks Brake System, with The Following Specification:

Equipment:	Drawworks (brake system)
Model/SN:	18-01
Date of Manufacture:	2018
Manufacturer:	BEIJING GOLD BASIN PETROLEUM TECHNOLOGY CO., LTD
Reference Standard:	API RP 7L
Next Examination Date:	After 6 Months

Visual & Magnetic Particles Examination Report

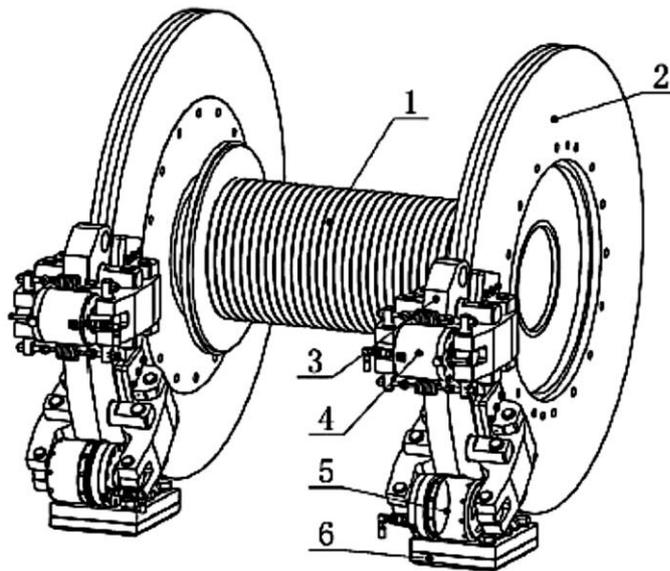
Figure 1 Braking Actuating Mechanism

1. drum 2. friction disc 3. caliper frame 4. service caliper 5. safety caliper 6. base

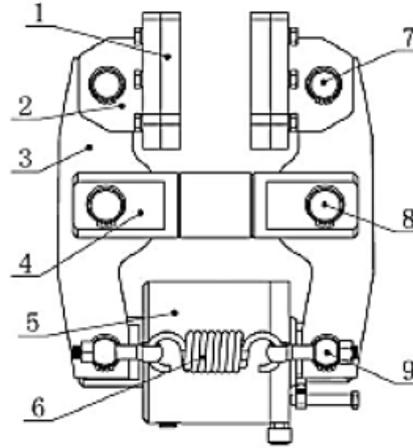
Figure 2 Service Caliper

1. brake pad
2. steel backing
3. lever
4. support lever
5. service caliper cylinder
6. reset extension spring
7. shaft pin I
8. shaft pin II
9. shaft pin III

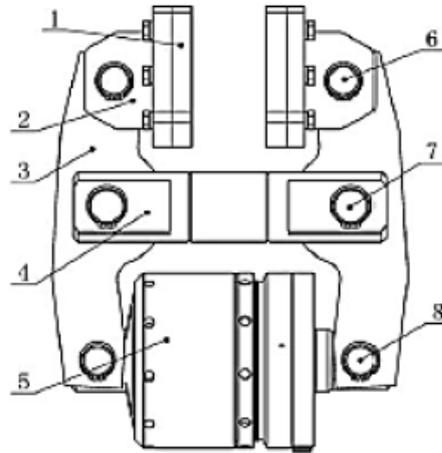
Figure 3 Safety Caliper

1. brake pad
2. steel backing
3. lever
4. support lever
5. safety caliper cylinder
6. shaft pin I
7. shaft pin II
8. shaft pin IV

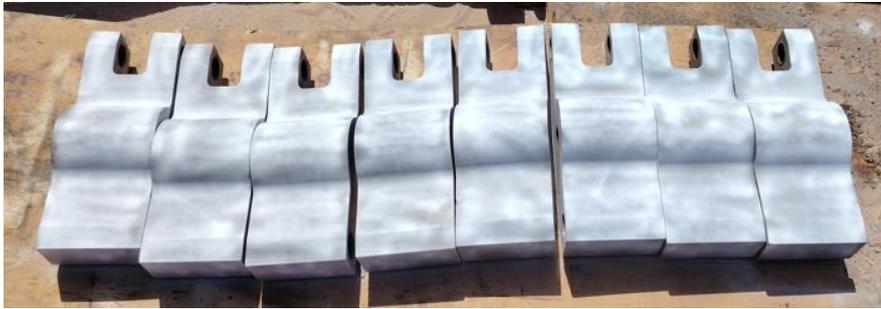
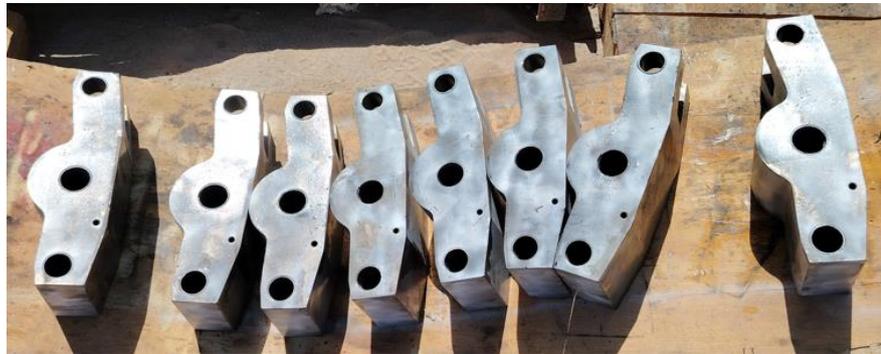
Serial Number	Description of the examined equipment	Result
18-01	Levers	Pass
S/N:	23+24+25+26+27+28+29+30

Visual and MPI carried out for the above described-items and found free of surface defects at the time of inspection

Identification of any part found to have a defect and a description of the defect: **None**

Particulars of any repair, renewal or alteration required to remedy the defect identified above: **None**

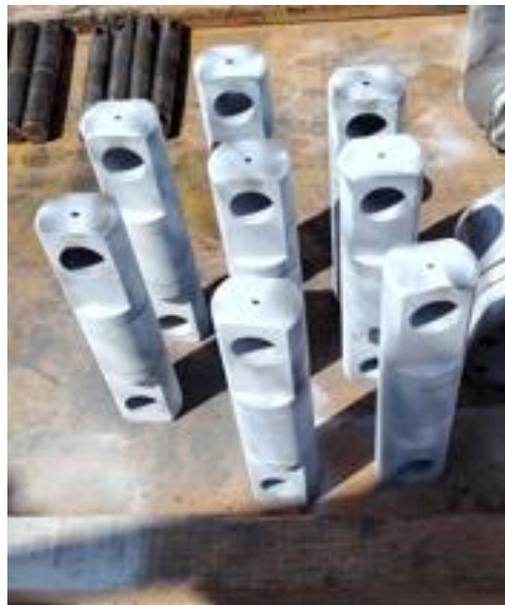
Serial Number	Description of the examined equipment	Result
18-01	Supporting arms	Pass
S/N:	5 + 6 + 7 + 8 + 9 + 12 + 13 + 14

Visual and MPI carried out for the above described-items n and found free of surface defects at the time of inspection

Identification of any part found to have a defect and a description of the defect: **None**

Particulars of any repair, renewal or alteration required to remedy the defect identified above: **None**

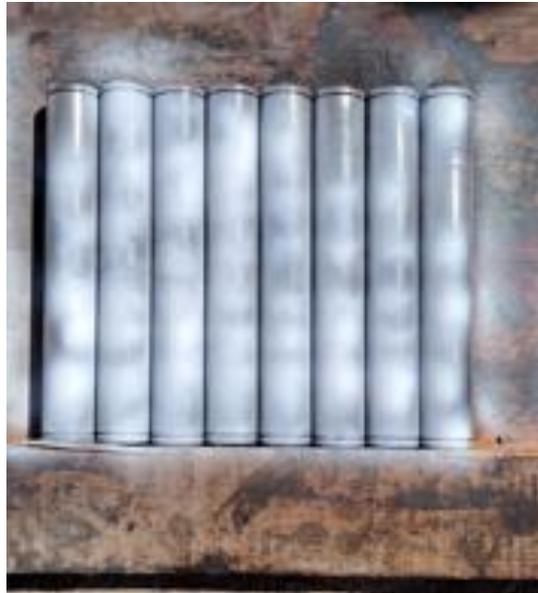
Serial Number	Description of the examined equipment	Result
18-01	pins	Pass
S/N:	31+32+33+34+35+36+37+38

Visual and MPI carried out for the above described-items and found free of surface defects at the time of inspection

Identification of any part found to have a defect and a description of the defect: **None**

Particulars of any repair, renewal or alteration required to remedy the defect identified above: **None**

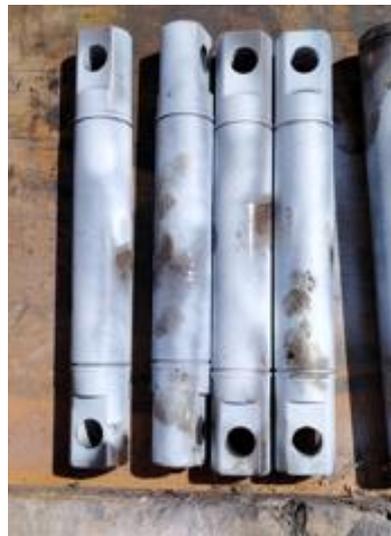
Serial Number	Description of the examined equipment	Result
18-01	pins	Pass
S/N:	39+40+41+42

Visual and MPI carried out for the above described-items and found free of surface defects at the time of inspection

Identification of any part found to have a defect and a description of the defect: **None**

Particulars of any repair, renewal or alteration required to remedy the defect identified above: **None**

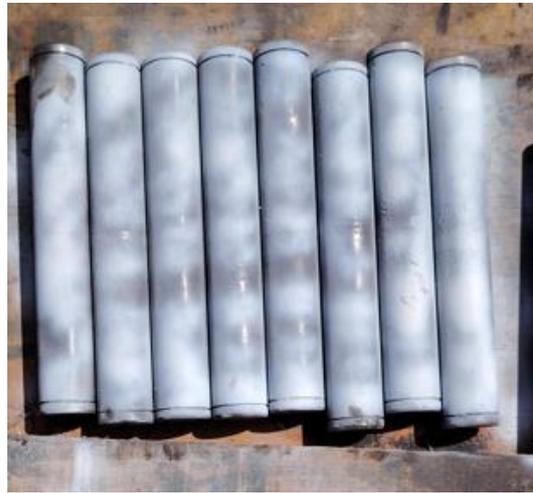
Serial Number	Description of the examined equipment	Result
18-01	pins	Pass
S/N:	43+44+45+46+47+48+49+50

Visual and MPI carried out for the above described-items and found free of surface defects at the time of inspection

Identification of any part found to have a defect and a description of the defect: **None**

Particulars of any repair, renewal or alteration required to remedy the defect identified above: **None**

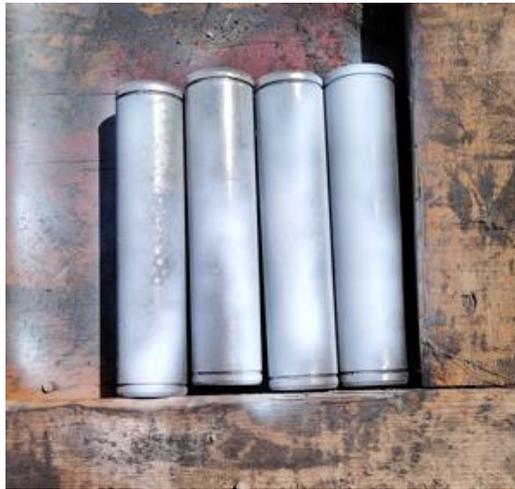
Serial Number	Description of the examined equipment	Result
18-01	pins	Pass
S/N:	51+52+53+54

Visual and MPI carried out for the above described-items and found free of surface defects at the time of inspection

Identification of any part found to have a defect and a description of the defect: **None**

Particulars of any repair, renewal or alteration required to remedy the defect identified above: **None**

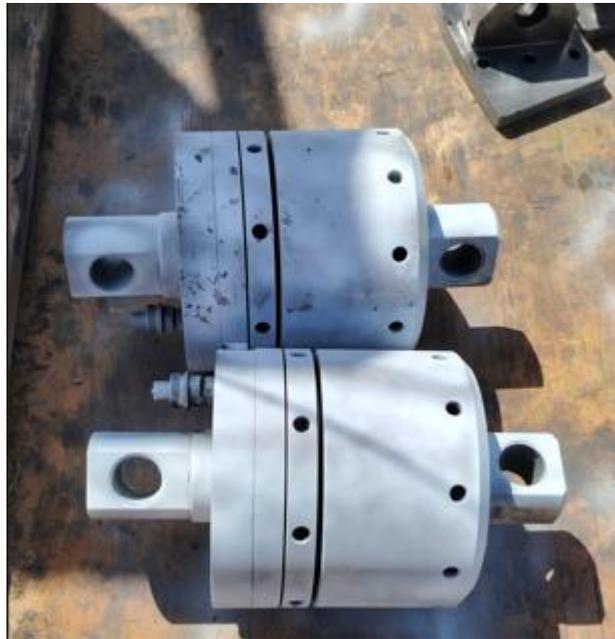
Serial Number	Description of the examined equipment	Result
18-01	Safety caliper cylinders	Pass
S/N:	3 + 4

Visual and MPI carried out for the above described-items and found free of surface defects at the time of inspection

Identification of any part found to have a defect and a description of the defect: **None**

Particulars of any repair, renewal or alteration required to remedy the defect identified above: **None**

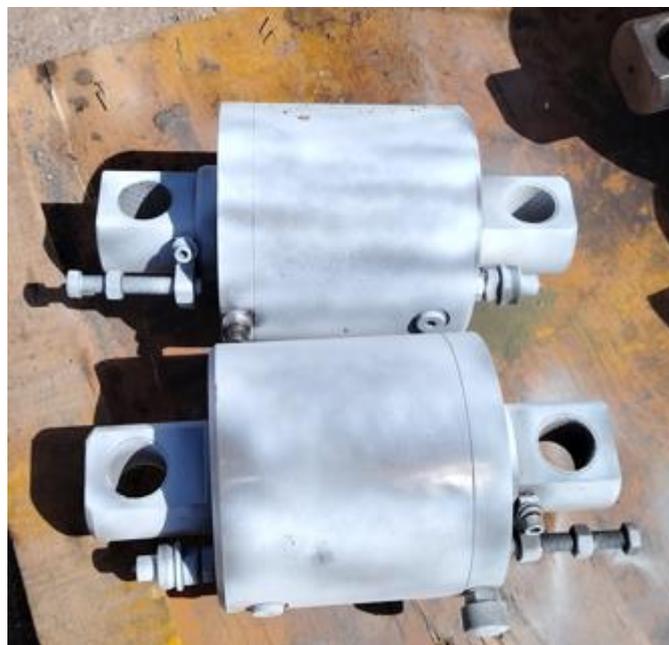
Serial Number	Description of the examined equipment	Result
18-01	Service caliper cylinders	Pass
S/N:	1 + 2

Visual and MPI carried out for the above described-items and found free of surface defects at the time of inspection

Identification of any part found to have a defect and a description of the defect: **None**

Particulars of any repair, renewal or alteration required to remedy the defect identified above: **None**

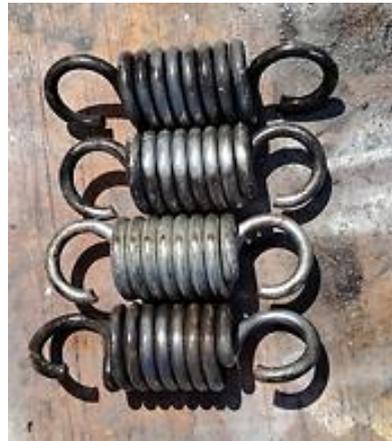
Serial Number	Description of the examined equipment	Result
18-01	Springs (6-Months old)	Pass
S/N:	-

Visual inspection & MPI by Fluorescent particles were carried out for the above described-items and found free of surface defects at the time of inspection

Identification of any part found to have a defect and a description of the defect: **None**

Particulars of any repair, renewal or alteration required to remedy the defect identified above: **None**

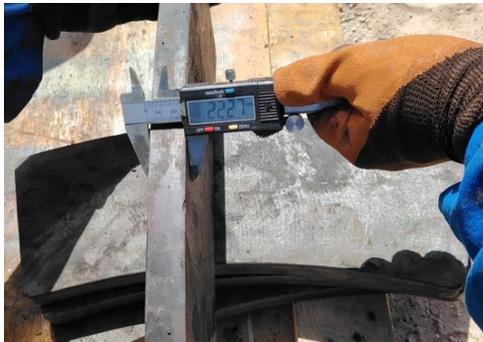
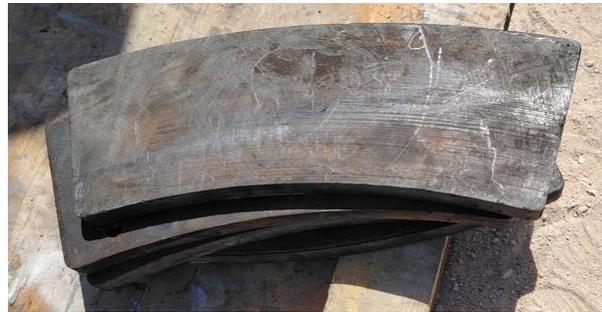
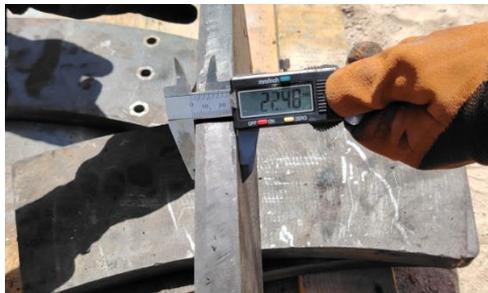
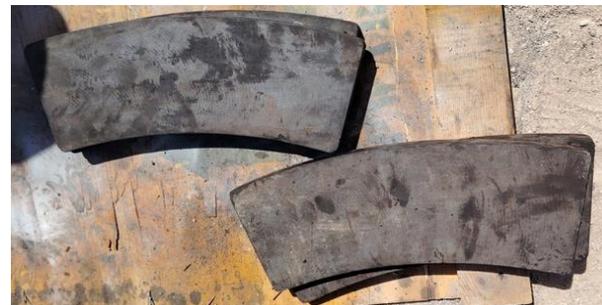
Serial Number	Description of the examined equipment	Result
18-01	Brake pads	Pass
S/N:	-

DESCRIPTION	MEASURED VALUES	OEM VALUES	RESULT
The thickness of brake pad No.1	22.27 mm	12 mm min	Accepted
The thickness of brake pad No.2	22.48 mm	12 mm min	Accepted
The thickness of brake pad No.3	22.36 mm	12 mm min	Accepted
The thickness of brake pad No.4	22.25 mm	12 mm min	Accepted
The thickness of brake pad No.5	22.21 mm	12 mm min	Accepted
The thickness of brake pad No.6	22.29 mm	12 mm min	Accepted
The thickness of brake pad No.7	22.33 mm	12 mm min	Accepted
The thickness of brake pad No.8	22.27 mm	12 mm min	Accepted
Check that all the disk springs have been replaced annually by original ones			Accepted

Visual check and Dimensional measurements were carried out for the above described-items and found free of surface defects, and within OEM dimensional tolerances at the time of inspection

Identification of any part found to have a defect and a description of the defect: **None**

Particulars of any repair, renewal or alteration required to remedy the defect identified above: **None**

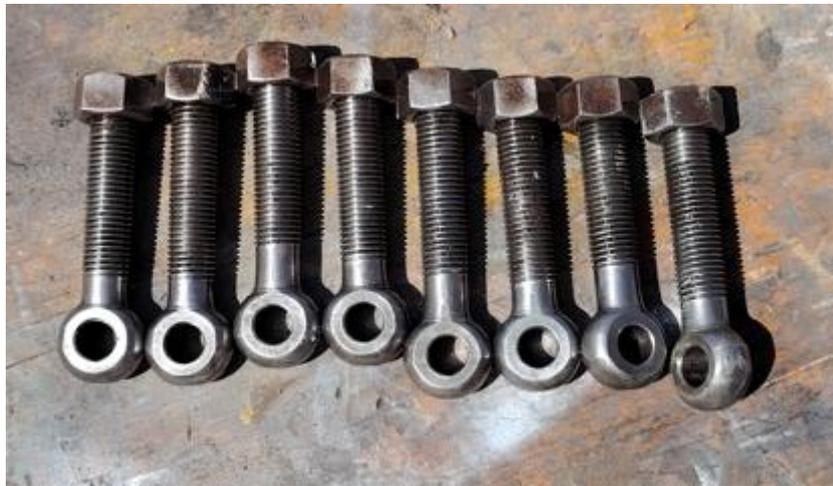
Serial Number	Description of the examined equipment	Result
18-01	Adjusting screws	Pass
S/N:	-

Visual inspection & MPI by Fluorescent particles were carried out for the above described-items and found free of surface defects at the time of inspection

Identification of any part found to have a defect and a description of the defect: **None**

Particulars of any repair, renewal or alteration required to remedy the defect identified above: **None**

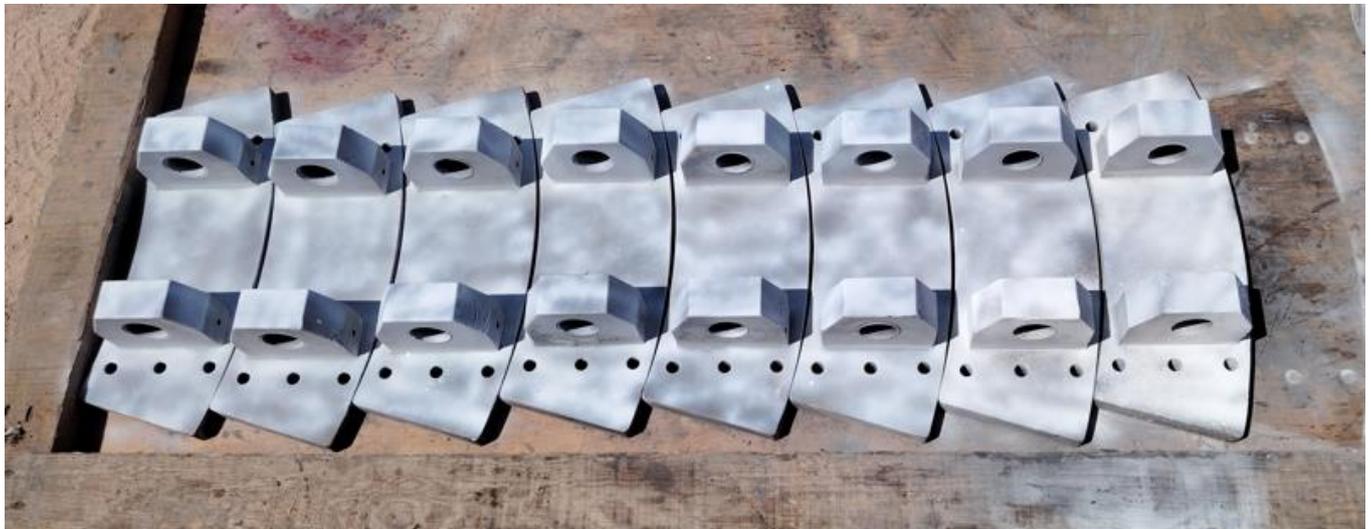
Serial Number	Description of the examined equipment	Result
18-01	Steel brake shoes	Pass
S/N:	15+16+17+18+19+20+21+22

Visual and MPI carried out for the above described-items and found free of surface defects at the time of inspection

Identification of any part found to have a defect and a description of the defect: **None**

Particulars of any repair, renewal or alteration required to remedy the defect identified above: **None**

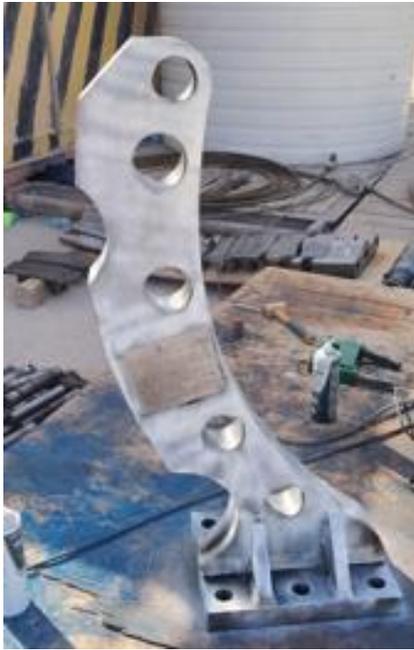
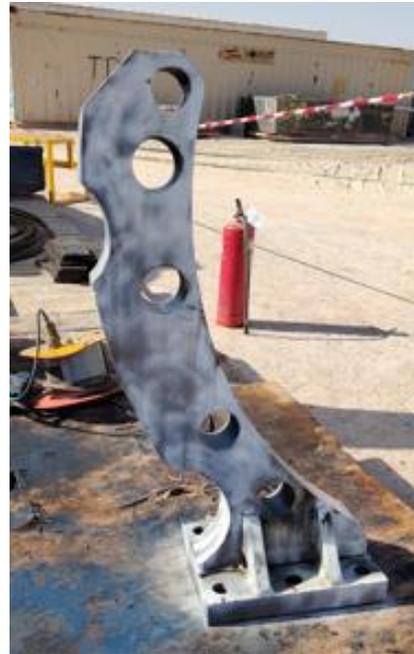
Serial Number	Description of the examined equipment	Result
18-01	Caliper frames	Pass
S/N:	10 + 11

Visual and MPI carried out for the above described-items and found free of surface defects at the time of inspection

Identification of any part found to have a defect and a description of the defect: **None**

Particulars of any repair, renewal or alteration required to remedy the defect identified above: **None**

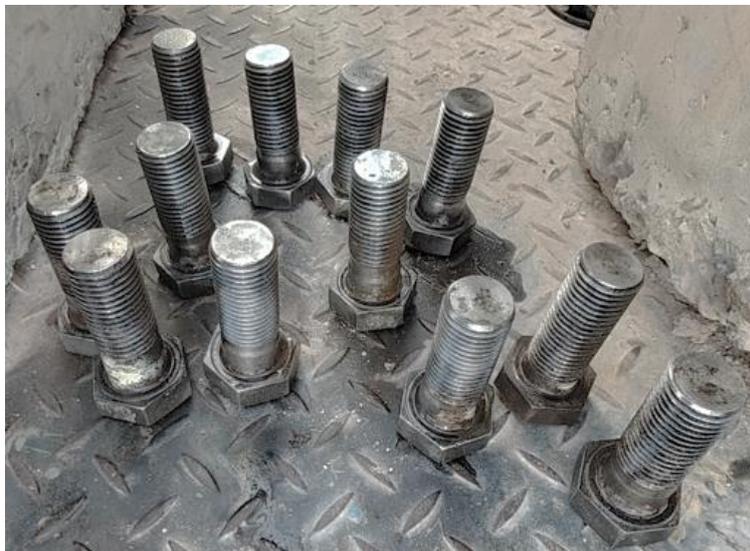
Serial Number	Description of the examined equipment	Result
18-01	Bolts (connecting caliper frame to its base on carrier)	Pass
S/N:	-

Visual inspection & MPI by Fluorescent particles were carried out for the above described-items and found free of surface defects at the time of inspection

Identification of any part found to have a defect and a description of the defect: **None**

Particulars of any repair, renewal or alteration required to remedy the defect identified above: **None**

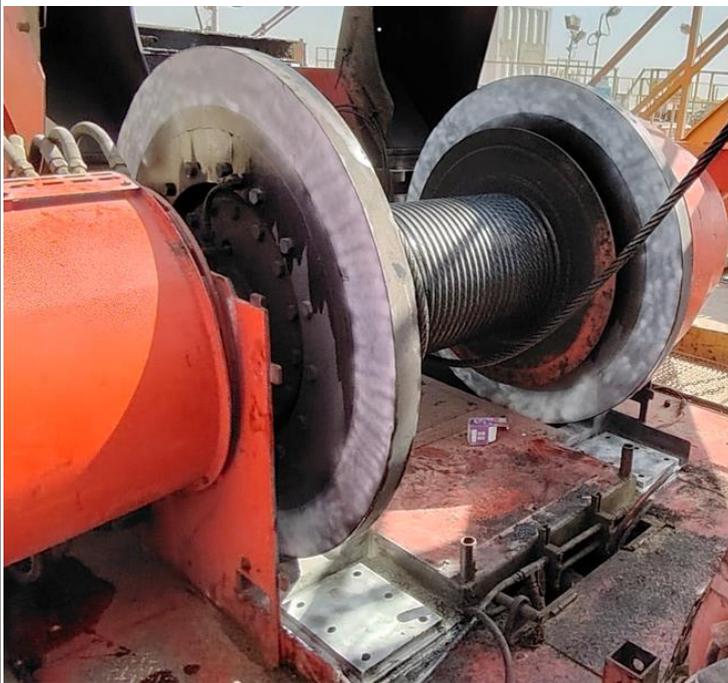
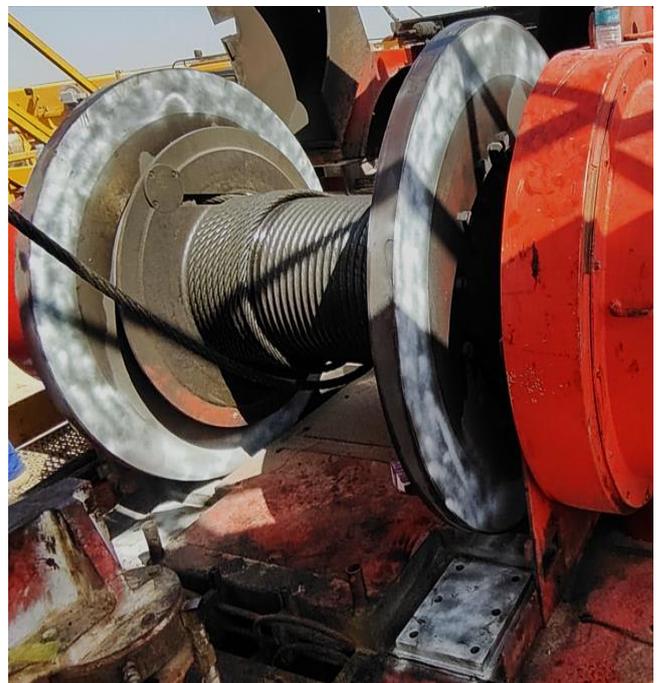
Serial Number	Description of the examined equipment	Result
18-01	Friction disk and caliper frame base	Pass
S/N:	-

Visual and MPI carried out for the above described-items and found free of surface defects at the time of inspection

Identification of any part found to have a defect and a description of the defect: **None**

Particulars of any repair, renewal or alteration required to remedy the defect identified above: **None**

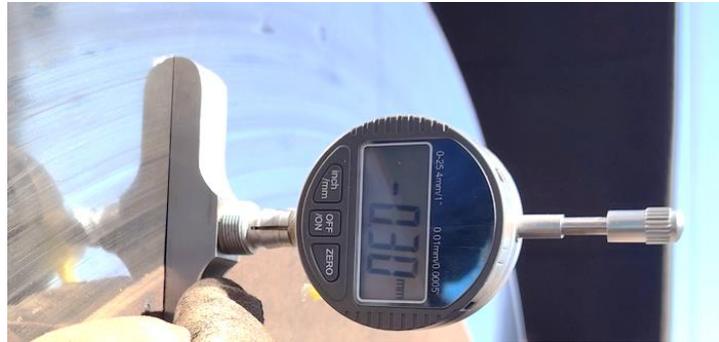
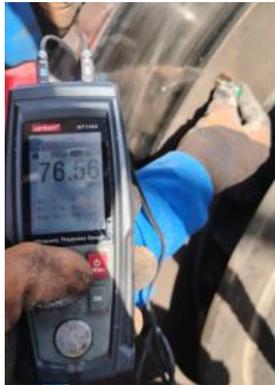
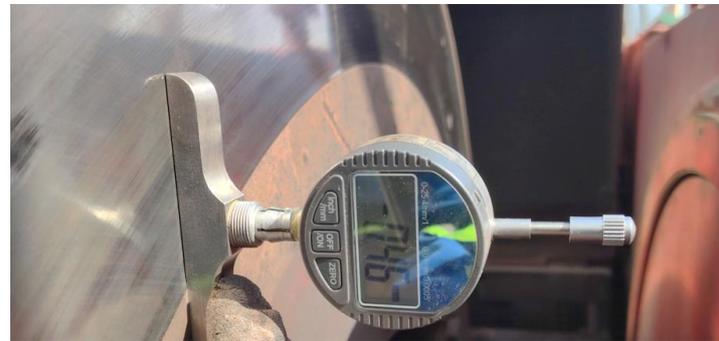
Serial Number	Description of the examined equipment	Result
18-01	Friction disk (thickness and wear)	Pass
S/N:	-

DESCRIPTION	MEASURED VALUES	OEM VALUES	RESULT
Wear of right friction disk	0.46 mm/each side	10 mm max.	Accepted
Wear of left friction disk	0.30 mm/each side	10 mm max.	Accepted

Wear & Thickness Measurements were carried out for the above described-items and found within OEM Tolerances

Identification of any part found to have a defect and a description of the defect: **None**

Particulars of any repair, renewal or alteration required to remedy the defect identified above: **None**
