Customer:	Hilong Oil Services & Engineering	Date Of Service:	05/12/2024
Type Of Inspection:	CAT IV INSPECTION	Report No:	ATS-12-24-4682-VD-001
Rig & Rig Number:	RIG-22	Specification:	API STD 53

The Rig Was Equipped with “BOHAI EQUIPMENT ZHONGCHENG EQUIPMENT” Vacuum Degasser, with The Following Specification:

Equipment:	Vacuum Degasser
Model:	ZSCQ300
SN:	2014-01
Date of Manufacture:	04-08-2014
Manufacturer:	BOHAI EQUIPMENT ZHONGCHENG EQUIPMENT
Reference Standard:	API STD 53
Next Examination Date:	After 5 Years

Visual & Magnetic Particles Examination Report

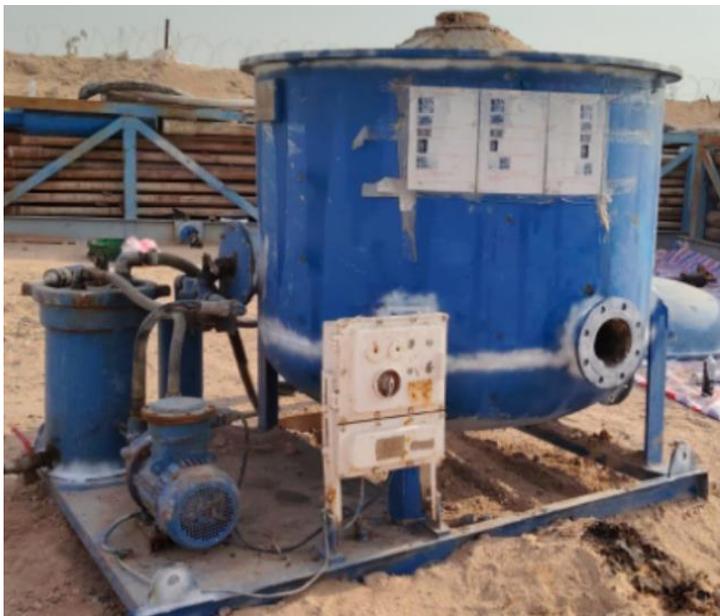
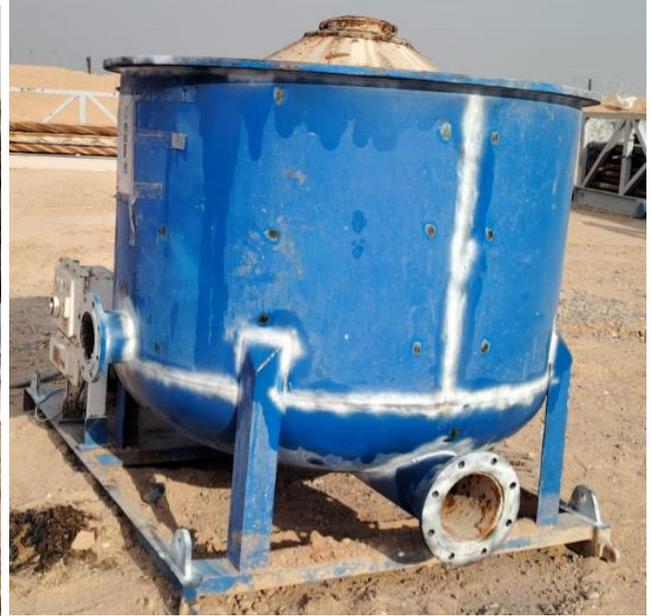
Serial Number	Description of the examined equipment	Result
2014-01	Vacuum Degasser - Vessel	Pass
S/N:	2014-01

Visual and MPI carried out for the above description and found free of surface defects at the time of inspection

Identification of any part found to have a defect and a description of the defect: **None**

Particulars of any repair, renewal or alteration required to remedy the defect identified above: **None**

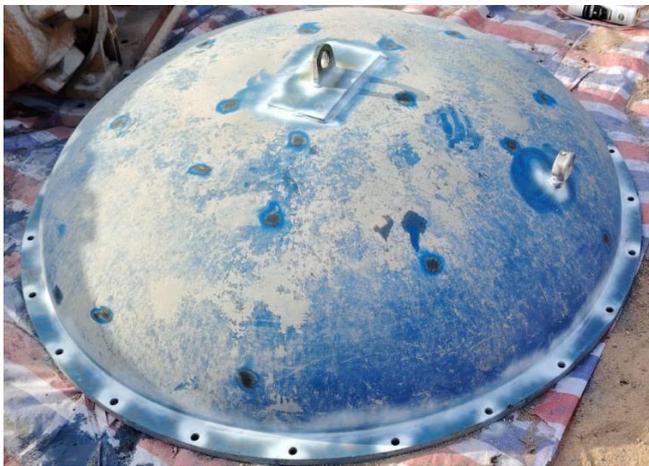
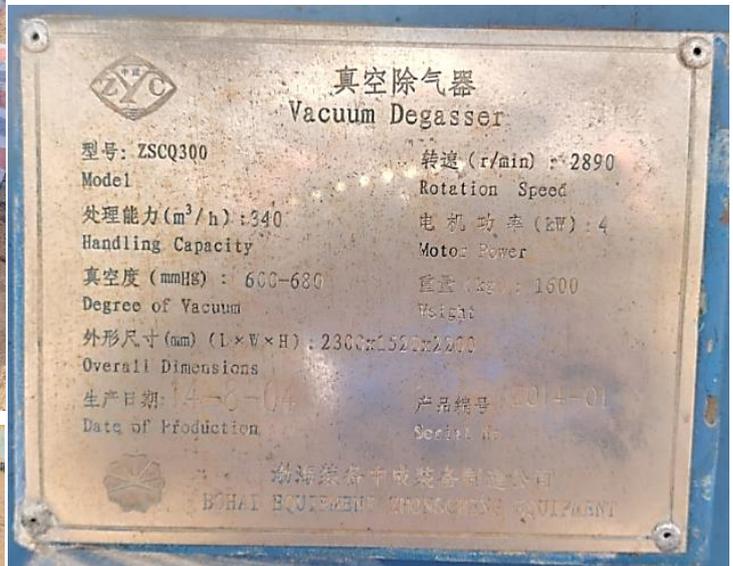
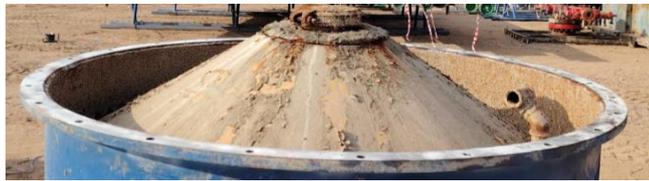
Serial Number	Description of the examined equipment	Result
2014-01	Vacuum Degasser – Head flanges	Pass
S/N:	2014-01

Visual and MPI carried out for the above description and found free of surface defects at the time of inspection

Identification of any part found to have a defect and a description of the defect: **None**

Particulars of any repair, renewal or alteration required to remedy the defect identified above: **None**

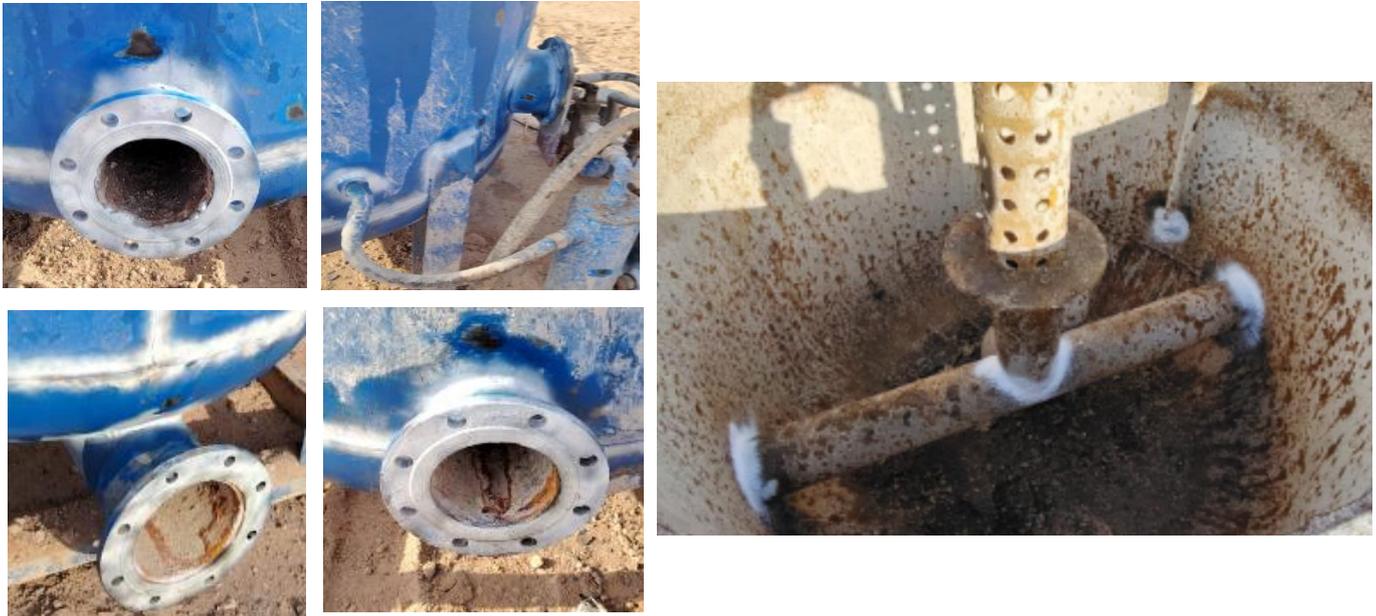
Serial Number	Description of the examined equipment	Result
2014-01	Vacuum Degasser – Internal Pipes and Nozzles	Pass
S/N:	2014-01

Visual and MPI carried out for the above description and found free of surface defects at the time of inspection

Identification of any part found to have a defect and a description of the defect: **None**

Particulars of any repair, renewal or alteration required to remedy the defect identified above: **None**
