ABERDEEN TECHNICAL SERVICES AND GENERAL TRANSPORTATION
TRAVELLING BLOCK SHEAVES & CRITICAL AREAS - CAT III INSPECTION REPORT

Customer:	Hilong Oil Services & Engineering	Date Of Service:	14-Dec-2024
Type Of Inspection:	CAT III INSPECTION	Report No:	ATS-12-24-4705-TB-01
Rig Number:	HL-16	Specification:	API RP 8B, API RP 9B

Equipment:	Travelling Block
Model:	YC-450
S/N:	YS15026
Marker & Date of Manufacture:	BAOJI OILFIELD MACHINERY CO., LTD / 07-2015
Inspection, Ref. Standard:	API RP 9B, API RP 8B
Inspection Frequency:	Every 06 Months

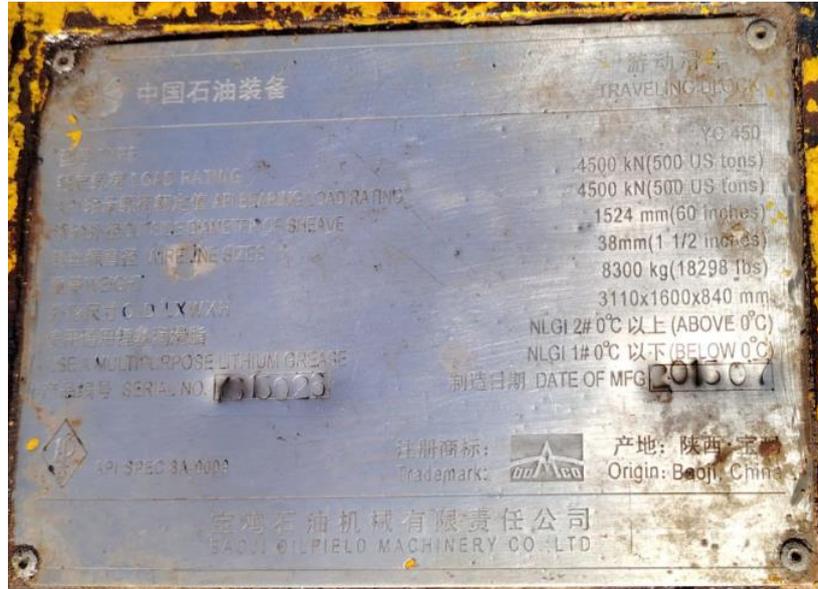
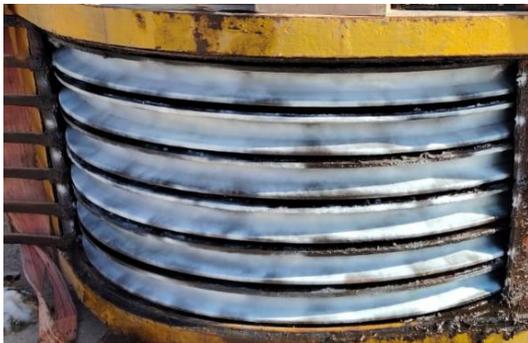
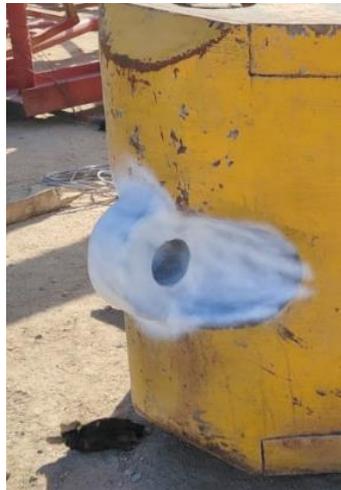
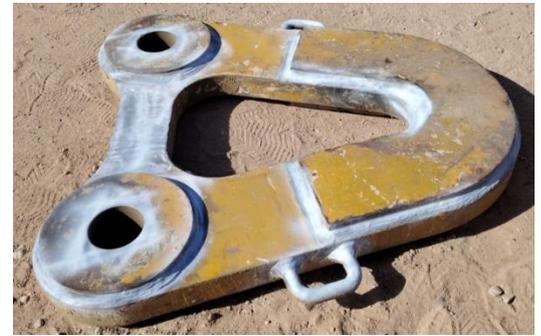
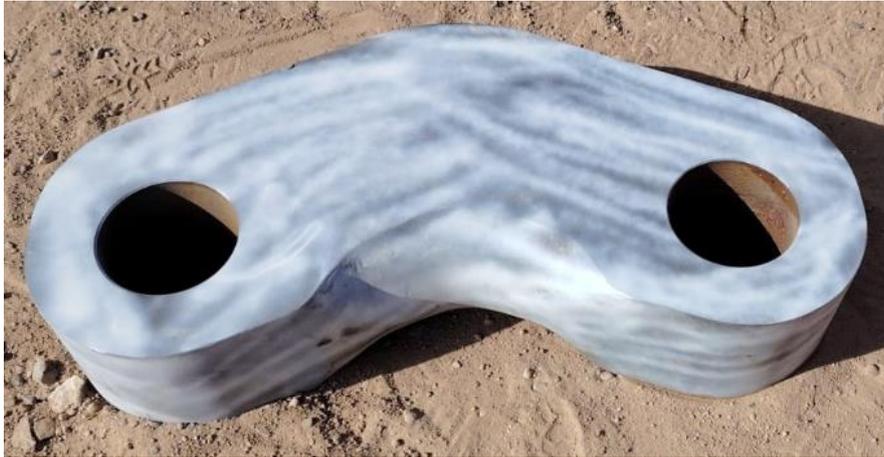
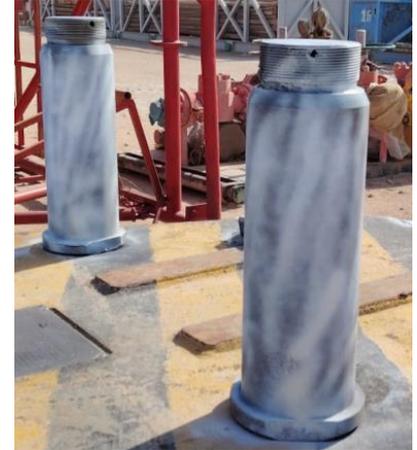
PICTORIAL

** Visual, MPI, and Dimensional Checks Were Carried Out on the Sheave Grooves and Critical Areas of the Travelling Block and Found **Satisfactory for Further Use**.

** CAT III Inspection Was Carried Out on Travelling Block Sheaves and Critical Areas and Found **Accepted** at The Time of Inspection.

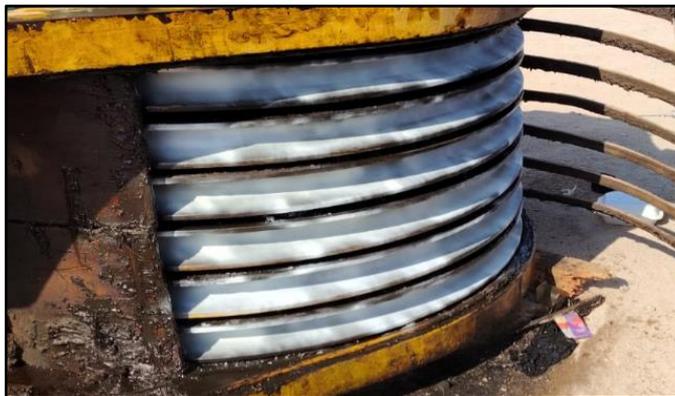
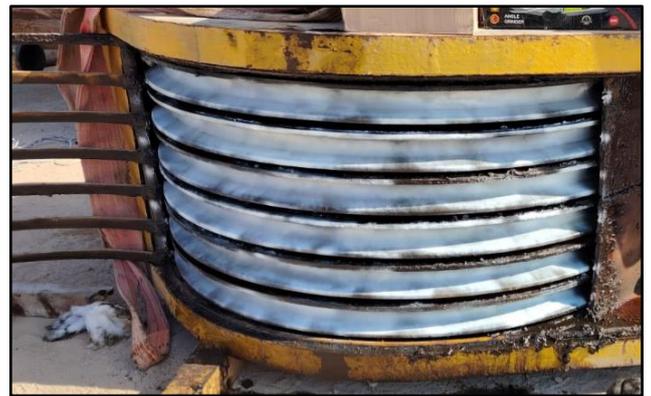
Serial Number	Description of the examined equipment	Result
YS15026	Travelling Block - Sheave Grooves	Pass
S/N:	Cluster Sheaves

Visual and MPI carried out for the above-mentioned items and found free of surface defects at the time of inspection

Identification of any part found to have a defect and a description of the defect: **None**

Particulars of any repair, renewal or alteration required to remedy the defect identified above: **None**

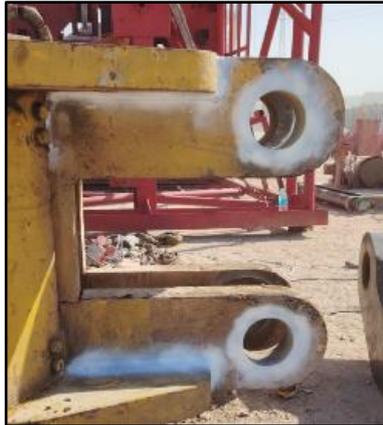
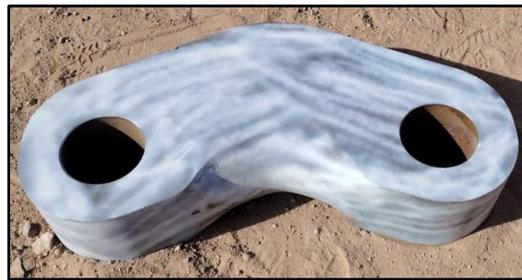
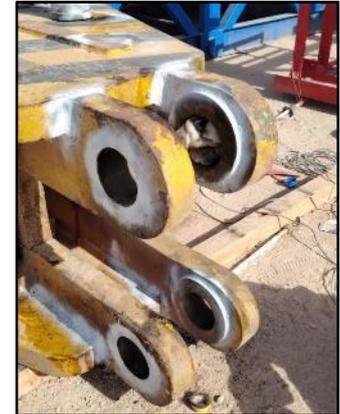
Serial Number	Description of the examined equipment	Result
YS15026	Travelling Block – Hanging Off Point	Pass
S/N:	AB450004-06 / QAI5001

Visual and MPI carried out for the above-mentioned items and found free of surface defects at the time of inspection

Identification of any part found to have a defect and a description of the defect: **None**

Particulars of any repair, renewal or alteration required to remedy the defect identified above: **None**

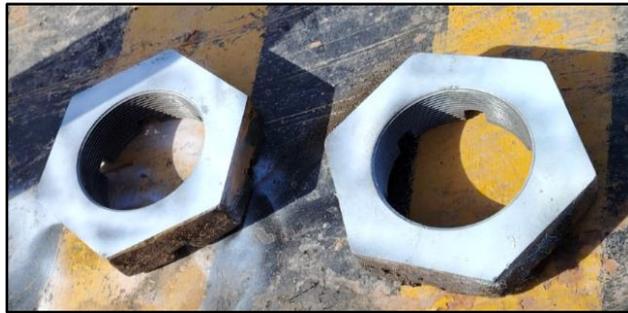
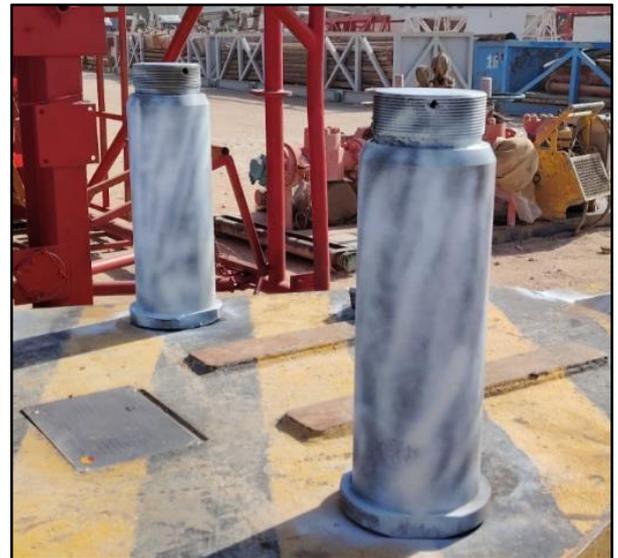
Serial Number	Description of the examined equipment	Result
YS15026	Travelling Block – Hanging Off Pins and Nuts	Pass
S/N:	P01, P02 & N01, N02

Visual and MPI carried out for the above-mentioned items and found free of surface defects at the time of inspection
Identification of any part found to have a defect and a description of the defect: None
Particulars of any repair, renewal or alteration required to remedy the defect identified above: None

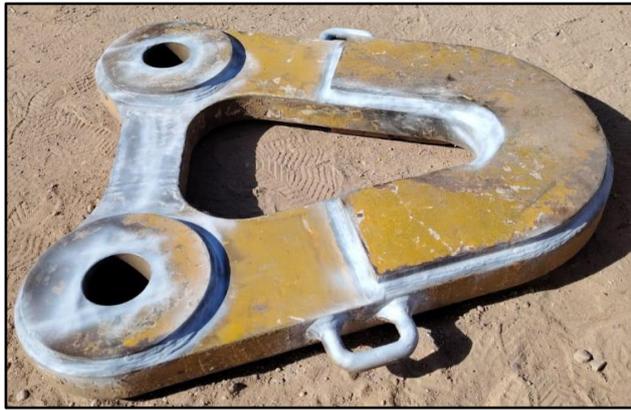
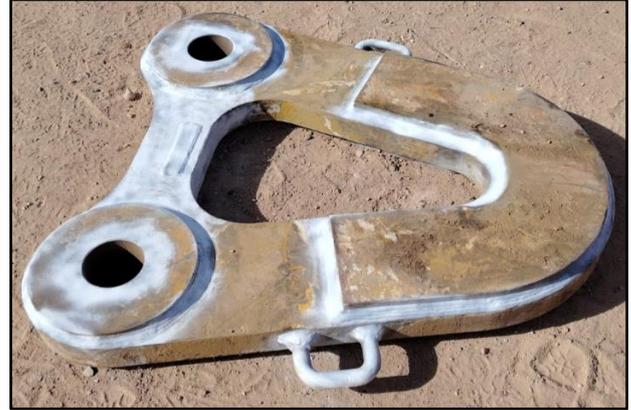
Serial Number	Description of the examined equipment	Result
YS15026	Travelling Block – Hanger Plate	Pass
S/N:	JJ745415-4502 / 11015

Visual and MPI carried out for the above-mentioned items and found free of surface defects at the time of inspection

Identification of any part found to have a defect and a description of the defect: **None**

Particulars of any repair, renewal or alteration required to remedy the defect identified above: **None**

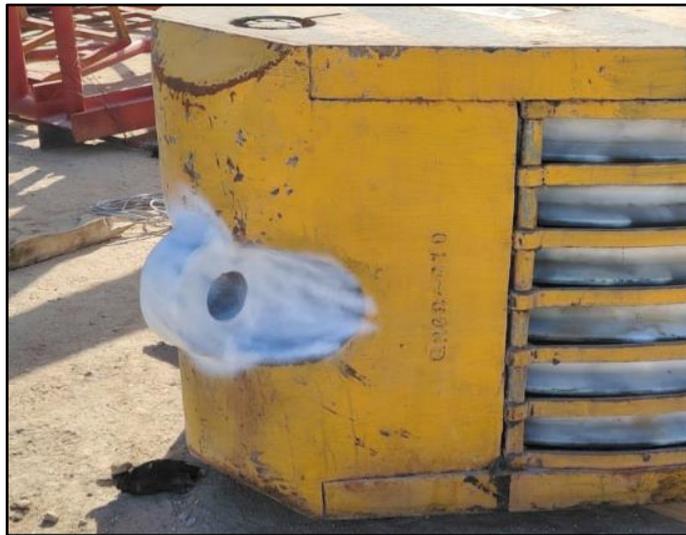
Serial Number	Description of the examined equipment	Result
YS15026	Travelling Block – Lifting Point	Pass
S/N:	YS15026

Visual and MPI carried out for the above-mentioned items and found free of surface defects at the time of inspection

Identification of any part found to have a defect and a description of the defect: **None**

Particulars of any repair, renewal or alteration required to remedy the defect identified above: **None**
