Certificate of Test and Thorough Examination of Lifting Equipment – Electrical Hoist

Owner name and address:	HILONG OIL SERVICE AND ENG CO, Iraq	**Date of Examination**	19-Dec-2024
Location of Examination:	HILONG RIG 22 / ZB-622	**Date of Certificate:**	19-Dec-2024
Certificate Number:	ATS-12-24-4682-BBH-02	**Job Number:**	ATS-12-24-4682
Date of Manufacture.:	2023	**Next Date of Examination:**	18-Dec-2025
SWL:	3.0 TON	**Serial No.:**	2306055
Description of equipment	**BIG BAGS HOIST** Manufacture: HENAN HUAZHONG Type / Model: HB Wire Rope Dia.: 13 mm Wire rope Number of Lines: 2 Hook Block Capacity / SN: 3 T / HL02 Maximum Lifting Height: 9 m Trolley Travelling Speed: 20 m / min Motive Power / Duty Grade: M3/EX-3Phases Electrical Motor		
Reference Standards	**BS EN 14492-1:2006+A1:2009 / BS 2853:2011/ ASME B30.7**

Thorough Examination of Electrical Hoist - Checklist

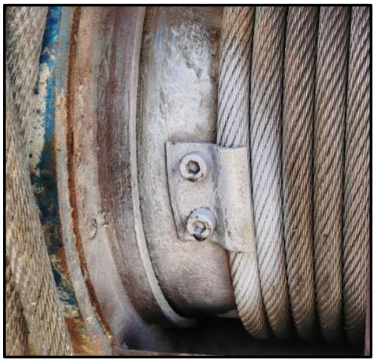
PICTORIAL:

In the light of inspection findings, the above-mentioned hoist was undergone Visual, Functional, performance, NDT (MPI) and proof load tests, and found safe to continue in service.
