# Aberdeen Technical Services and General Transportation

## Certificate of Visual Thorough Examination and Magnetic Particle Inspection (MPI)

**Item Description:** Driller's Room (Doghouse)

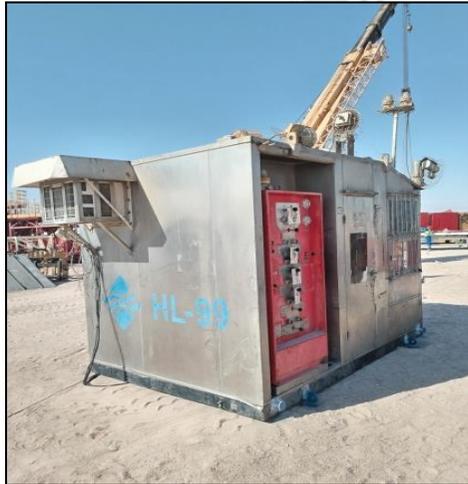
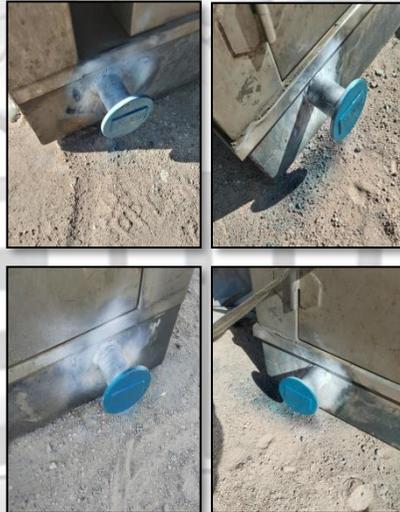
**PICTORIAL:**

Doghouse Lifting Lugs				
#	1	2	3	4
SN	SF09	SF10	SF11	SF12
SWL	16KN	16KN	16KN	16KN

**Inspection Results:**  
MPI WAS CARRIED OUT ON THE WELDING AND CRITICAL AREAS OF THE ABOVE-MENTIONED ITEM AND FOUND NO CRACKS OR RELEVANT INDICATIONS AT THE TIME OF INSPECTION.

**Remarks:** **ACCEPTED**

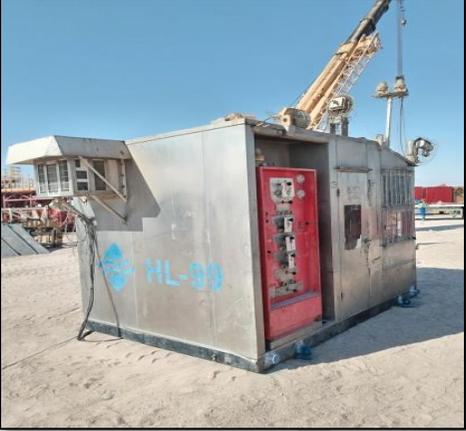
<table><tr> <th colspan="7">Doghouse Connecting Pad eyes</th> </tr></table>

Doghouse Connecting Pad eyes							#	1	2	3	4	5	6	SN	A1	A2	A3	A4	A5	A6
				Doghouse Connecting Pad eyes																				
#	1	2	3	4	5	6																		
SN	A1	A2	A3	A4	A5	A6																		
			<p><b>Serial Number:</b> Q0497</p> <p><b>Details of inspection method(s):</b> Visible magnetic particle inspection</p> <p><b>Inspection Results:</b> MPI WAS CARRIED OUT ON THE WELDING AND CRITICAL AREAS OF THE ABOVE-MENTIONED ITEM AND FOUND NO CRACKS OR RELEVANT INDICATIONS AT THE TIME OF INSPECTION.</p> <p><b>Remarks:</b> <b>ACCEPTED</b></p>																					
<b>Inspection Equipment Details</b>		<b>Personnel Details</b>		<b>Company Stamp</b>																				
<b>Equipment</b>	Ac yoke	<b>Inspector:</b>	Jaafar Badr																					
<b>Serial Number</b>	201504044	<b>Qualifications</b>	ASNT LEVEL II																					
<b>Calibration Date:</b>	17-08-2023	<b>Date:</b>	07-12-2023																					
<b>Calibration Due:</b>	16-02-2024	<b>Signature:</b>
