Certificate of Visual Thorough Examination and Magnetic Particle Inspection (MPI)

Client:	Hilong Oil Services & Engineering	Certificate Number:	ATS-12-23-2486-MPI-046
Rig Number:	HL99	Job No:	ATS-12-23-2486
Location:	RIG-99/HILONG BASE	Page No:	01 of 01
Date of Inspection:	22-12-2023	Next Inspection Date:	21-06-2024
Type of Inspection	Visual inspection & MPI (Wet Visible Method)	Ref. Standards:	ASTM E709, ASTM E 1444

Item Description: BOP Guide rails – Supporting Beam

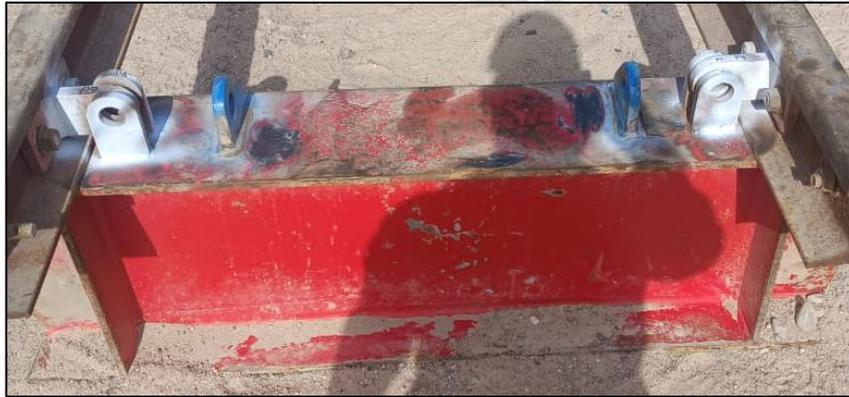
PICTORIAL:

Connection points: P8 + P10

Inspection Results:
MPI WAS CARRIED OUT ON THE WELDING AND CRITICAL AREAS OF THE ABOVE-MENTIONED ITEM AND FOUND NO CRACKS OR RELEVANT INDICATIONS AT THE TIME OF INSPECTION.

Remarks: ACCEPTED
