# Aberdeen Technical Services and General Transportation

Certificate of Visual Examination, Dye penetrant Inspection (DPI), and Magnetic Particles Inspection (MPI)

Client:	<b>Hilong Oil Services &amp; Engineering</b>	Certificate Number:	ATS-12-23-2541-MPI&DPI-001
Rig Number:	HL100	Job No:	ATS-12-23-2541
Inspection Location:	RIG-100/HILONG BASE	Page No:	01 of 01
Date of Inspection:	21-12-2023	Next Inspection Date:	20-06-2024
Type of Inspection	Visual inspection & DPI (Visible – Solvent Removable), and Visual inspection & MPI (Wet Visible Method)	Ref. Standards:	ASTM E165, ASTM E709, ASTM E 1444, & ASME PCC-1

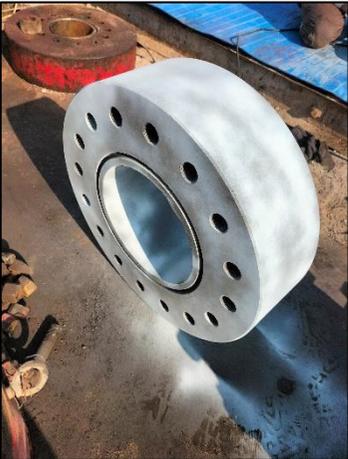
**Item Description:**  
DSA Double Stud Adapter (11" x 5M – 11" x 3M)

**Serial Number: 18076707**

**Inspection Results:**  
DPI WAS CARRIED OUT ON THE SEALING AREAS, AND MPI WAS CARRIED OUT ON THE CRITICAL AREAS OF THE ABOVE-MENTIONED ITEM AND FOUND NO CRACKS OR RELEVANT INDICATIONS AT THE TIME OF INSPECTION.

**Remarks: ACCEPTED**

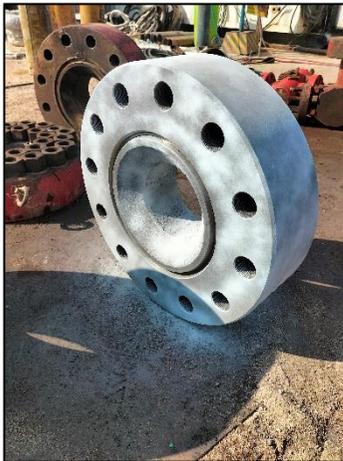
**Item Description:**  
DSA Double Stud Adapter (11" x 5M – 7/16" x 3M)

**Serial Number: 18076711**

**Inspection Results:**  
DPI WAS CARRIED OUT ON THE SEALING AREAS, AND MPI WAS CARRIED OUT ON THE CRITICAL AREAS OF THE ABOVE-MENTIONED ITEM AND FOUND NO CRACKS OR RELEVANT INDICATIONS AT THE TIME OF INSPECTION.

**Remarks: ACCEPTED**
