# Aberdeen Technical Services and General Transportation

## Certificate of Visual Thorough Examination and Magnetic Particle Inspection (MPI)

Power Tong Post Connection Pad Eyes & Foundation

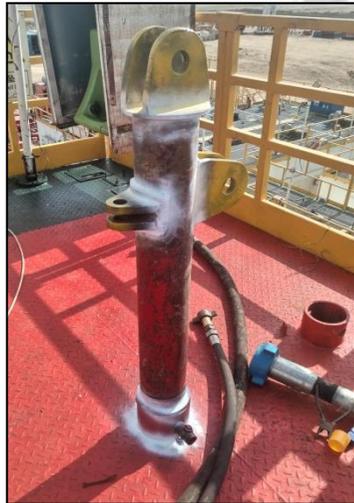
**PICTORIAL:**

MPI WAS CARRIED OUT ON THE WELDING AND CRITICAL AREAS OF THE ABOVE-MENTIONED ITEM AND FOUND NO CRACKS OR RELEVANT INDICATIONS AT THE TIME OF INSPECTION.

**Remarks: Accepted**
