Customer:	Hilong Oil Services & Engineering	Date Of Service:	01-03-2024
Type Of Inspection:	CAT III INSPECTION	Report No:	ATS-02-24-2999-HS-006
Rig & Rig Number:	RIG-100	Specification:	API RP 7L

Equipment:	Hand Slip (Drill collar slip), DCS.S 4 – 4 7/8
SN:	807087
Date of Manufacture:	-
Manufacturer/Model:	JIANGSU RUTONG PTERO-MACHINERY CO
Reference Standard:	API RP 7L
Next Examination Date:	After 06 Months

Visual & Magnetic Particles Examination Report

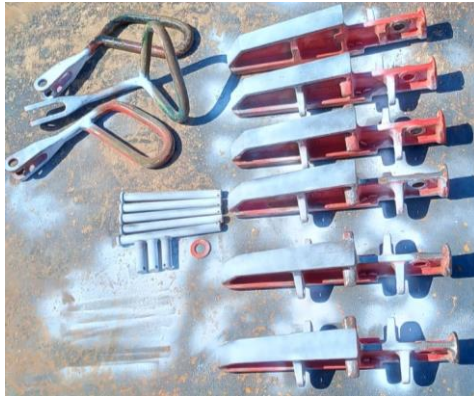
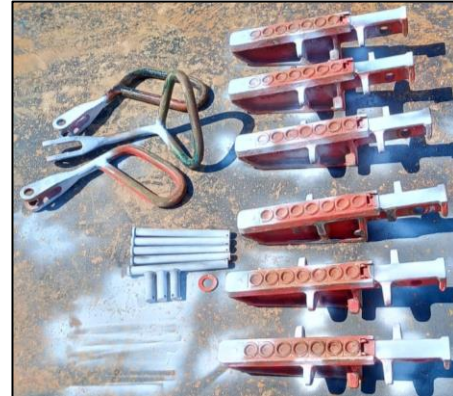
Serial Number	Description of the examined equipment	Result
807087	Hand Slip (Drill collar slip), DCS.S 4 – 4 7/8	Pass
S/N:	807087

Visual and MPI carried out for the above description and found free of surface defects at the time of inspection

Identification of any part found to have a defect and a description of the defect: **None**

Particulars of any repair, renewal or alteration required to remedy the defect identified above: **None**
