Customer:	Hilong Oil Services & Engineering	Date Of Service:	01-03-2024
Type Of Inspection:	CAT III INSPECTION	Report No:	ATS-02-24-2999-TEL-001
Rig & Rig Number:	RIG-100	Specification:	API RP 8C

The Rig Was Equipped with Jiangsu Rutong Petro-Machinery Co. Ltd. Square shoulder Elevator, with The Following Specification:

Equipment:	Square Shoulder drill collar elevator, DD(TA) 4 ¾ , 100 ZIP
Model/SN:	DD(TA)
SN:	80423
Size:	4 ¾ ”
SWL:	-
Date of Manufacture:	-
Manufacturer:	Jiangsu Rutong Petro-Machinery Co. Ltd.
Reference Standard:	API RP 8C
Next Examination Date:	After 06 Months

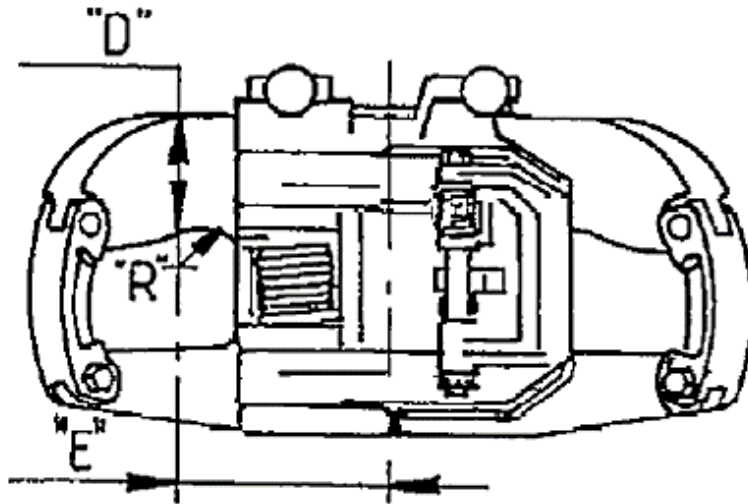
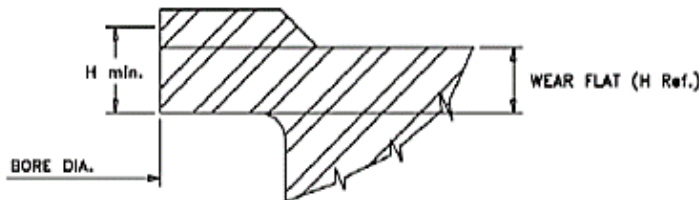
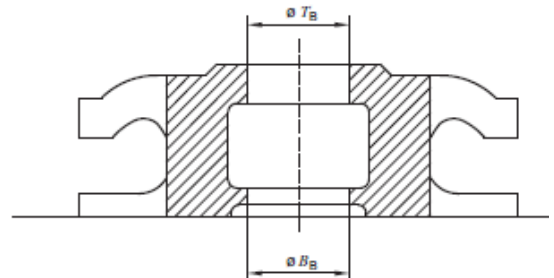
- The Elevator Has Been Inspected and Found Conformable to the Relevant Standard(s)
- Elevator Found Ready for CAT III Inspection.

Action	Result
• Visually check for the serial number and Identification	Pass
• Prepare and clean the elevator body and accessories to the extent necessary for inspection.	Pass
• Visually check for any damage, missing parts or cracks	Pass
• Dismantle the elevator to the extent necessary to perform the CAT III inspection.	Pass
• Visually check & MPI as per manufacture's recommendations	Pass
• Visually check for damage, deformation or cracks on the hinge's Ears, handles, Critical areas & hinges	Pass
• Measure the wear of bores, and ear thickness as per manufacture's recommendations.	Pass
• Visually check after Reassembly	Pass
• Repaint the Elevator	Pass
• Prepare and submit the inspection report.	Pass

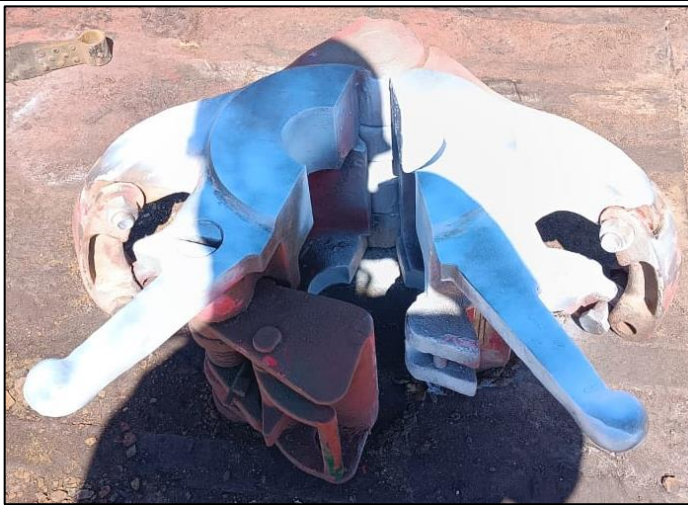
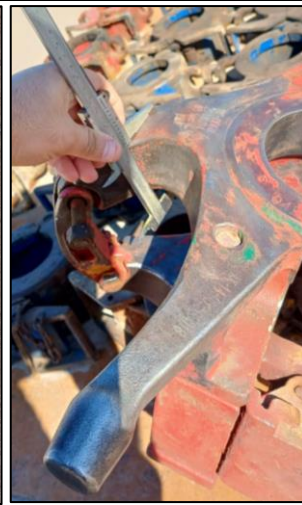
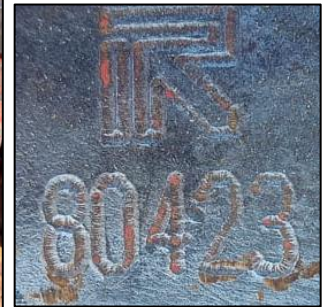
Serial Number	Description of the examined equipment	Result
80423	Square Shoulder drill collar elevator, DD(TA) 4 3/4 , 100 ZIP	Pass
S/N:	80423

Visual and MPI carried out for the above description and found free of surface defects at the time of inspection

Identification of any part found to have a defect and a description of the defect: **None**

Particulars of any repair, renewal or alteration required to remedy the defect identified above: **None**
