Customer:	Hilong Oil Services & Engineering	Date Of Service:	01-03-2024
Type Of Inspection:	CAT III INSPECTION	Report No:	ATS-02-24-2999-TEL-002
Rig & Rig Number:	RIG-100	Specification:	API RP 8C

The Rig Was Equipped with Jiangsu Rutong Petro-Machinery Co. Ltd. Square shoulder Elevator, with The Following Specification:

Equipment:	Square Shoulder elevator, DD 3 ½ , 150
Model/SN:	DD
SN:	80832
Size:	3 ½ ”
SWL:	150 tons
Date of Manufacture:	2018-08
Manufacturer:	Jiangsu Rutong Petro-Machinery Co. Ltd.
Reference Standard:	API RP 8C
Next Examination Date:	After 06 Months

Visual & Magnetic Particles Examination Report

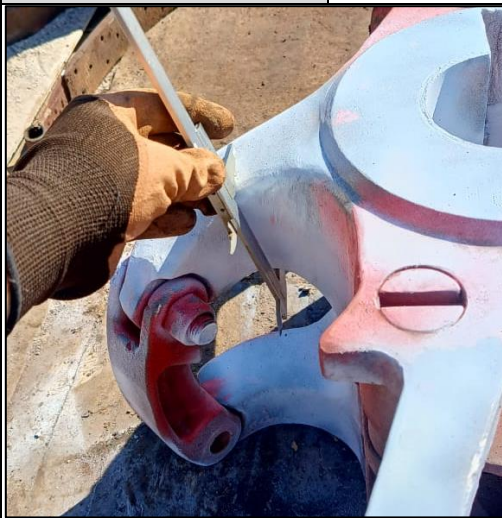
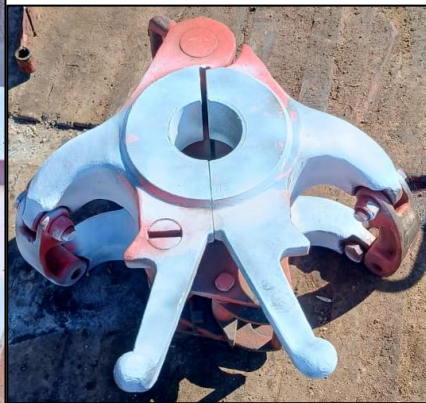
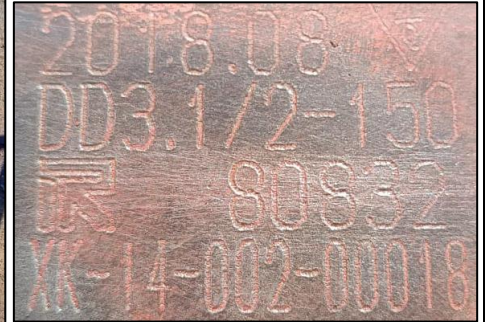
Serial Number	Description of the examined equipment	Result
80832	Square Shoulder NU tubing elevator, DD 3 1/2 , 150	Pass
S/N:	80832

Visual and MPI carried out for the above description and found free of surface defects at the time of inspection

Identification of any part found to have a defect and a description of the defect: **None**

Particulars of any repair, renewal or alteration required to remedy the defect identified above: **None**
