Customer:	Hilong Oil Services & Engineering	Date Of Service:	01-03-2024
Type Of Inspection:	CAT III INSPECTION	Report No:	ATS-02-24-2999-TEL-004
Rig & Rig Number:	RIG-100	Specification:	API RP 8C

The Rig Was Equipped with Jiangsu Rutong Petro-Machinery Co. Ltd. Square shoulder Elevator, with The Following Specification:

Equipment:	Square Shoulder elevator , DD 4 , 150
Model/SN:	DD 150
SN:	80907
Size:	4 ”
SWL:	150 tons
Date of Manufacture:	2018-09
Manufacturer:	Jiangsu Rutong Petro-Machinery Co. Ltd.
Reference Standard:	API RP 8C
Next Examination Date:	After 06 Months

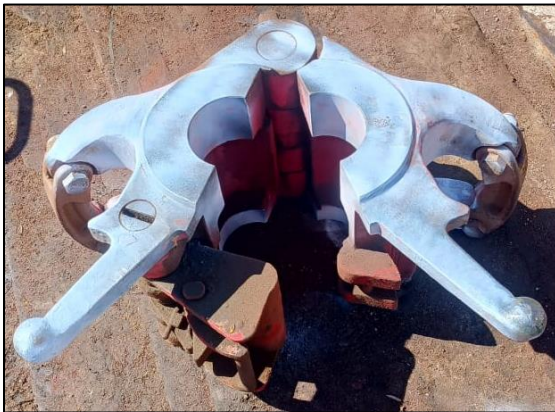
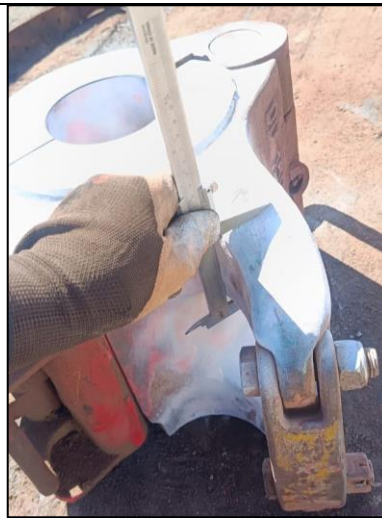
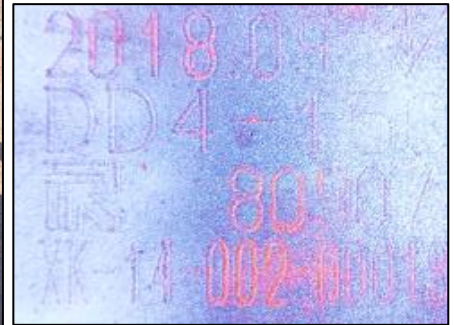
Visual and MPI carried out for the above description and found free of surface defects at the time of inspection

Identification of any part found to have a defect and a description of the defect: **None**

Particulars of any repair, renewal or alteration required to remedy the defect identified above: **None**
